EMERGENCY ORDER TO VACATE

Site Visit Follow-Up Report for Pelican Pointe Condominiums, Folly Beach, SC

Re: Immediate halt of use for all stairs....

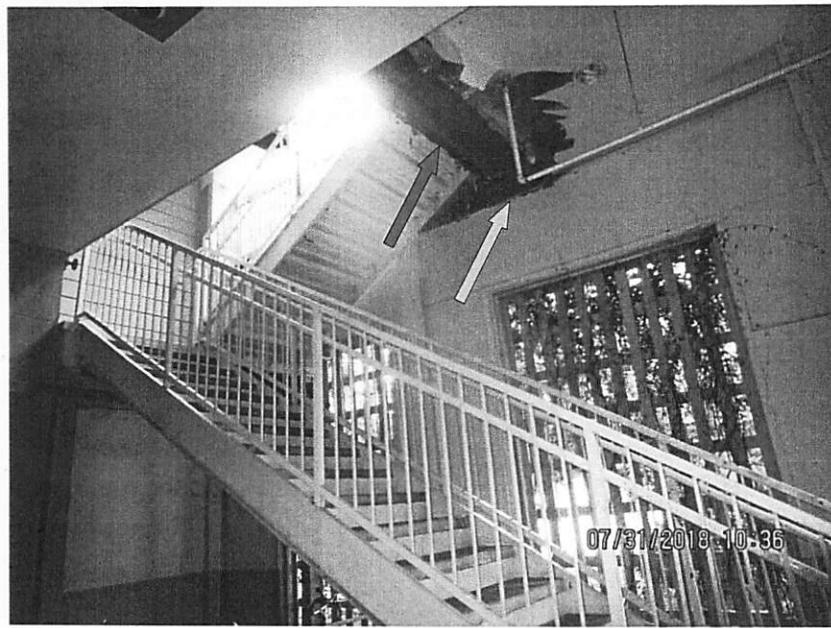
Photo 1 – Extreme beam damage at the intermediate and second floor landing at Building B. Extreme damage to surrounding structure at Building B (orange arrow)

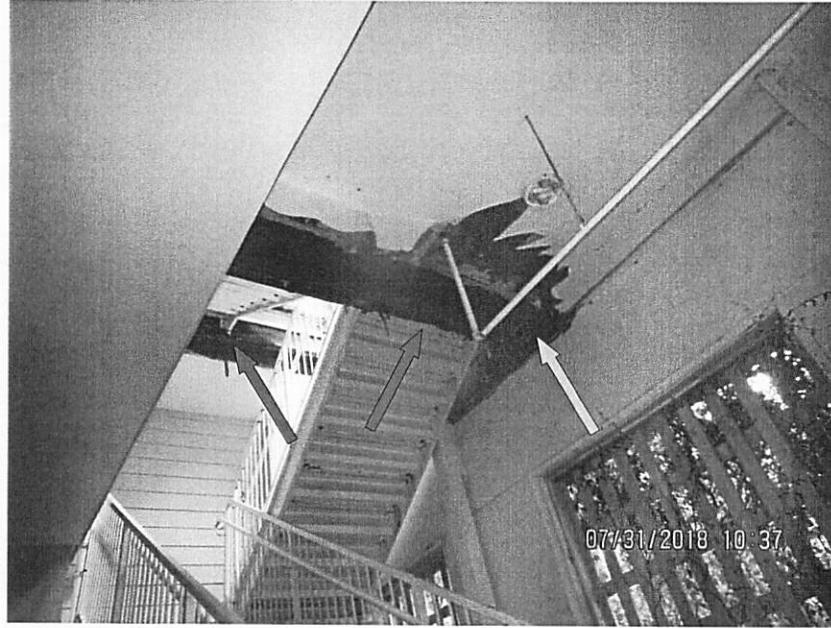
Photo 2 – Extreme beam damage at the second intermediate and second floor landing at Building B. Extreme damage to surrounding structure at Building B (orange arrow).

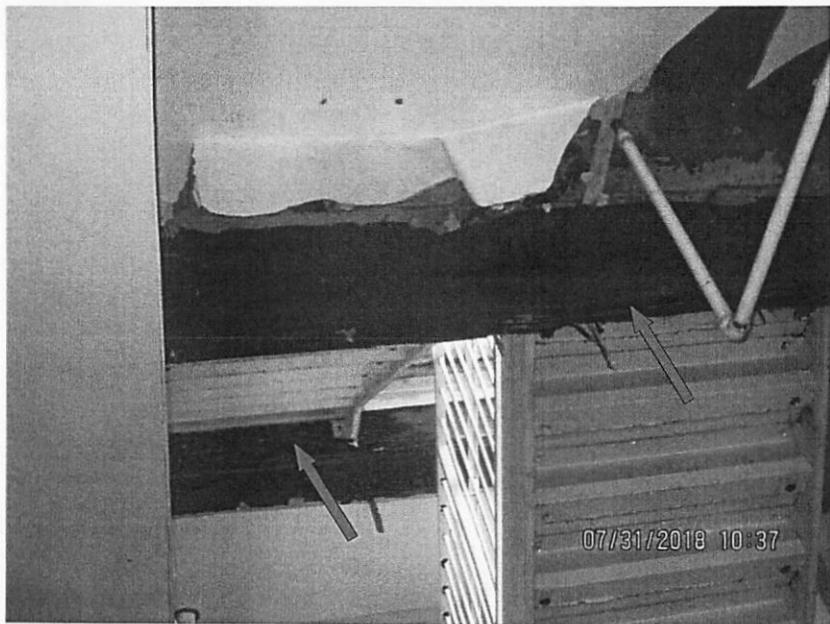
Photo 3 - Extreme beam damage at the second intermediate and second floor landing at Building B.

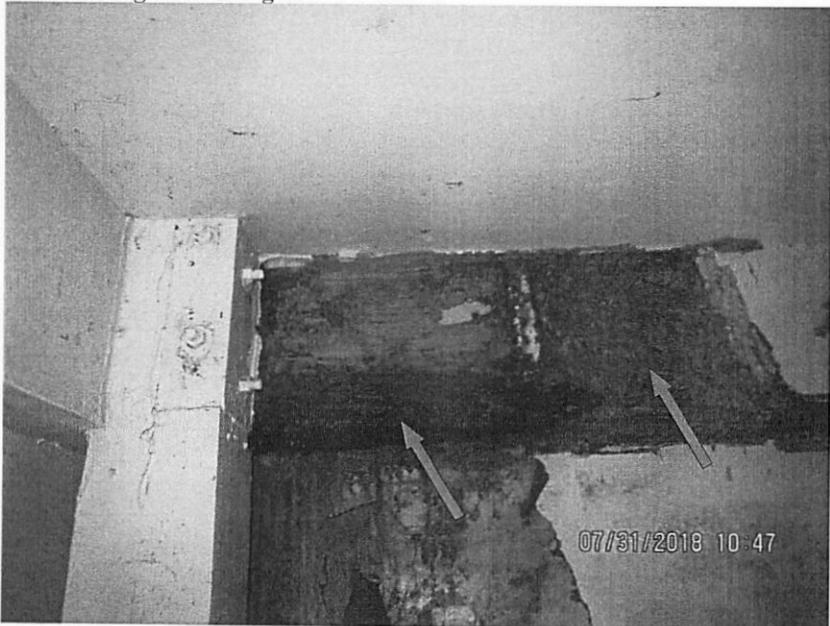
Photo 4 - Extreme beam termite and moisture damage at structure underneath heated space at Building B.

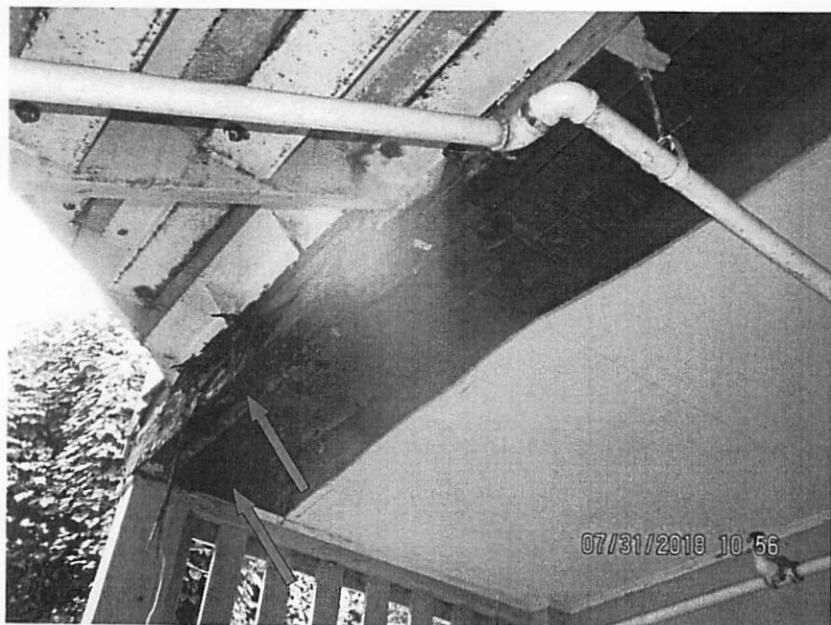
Photo 5 - Extreme beam damage at the second floor landing at Building A.

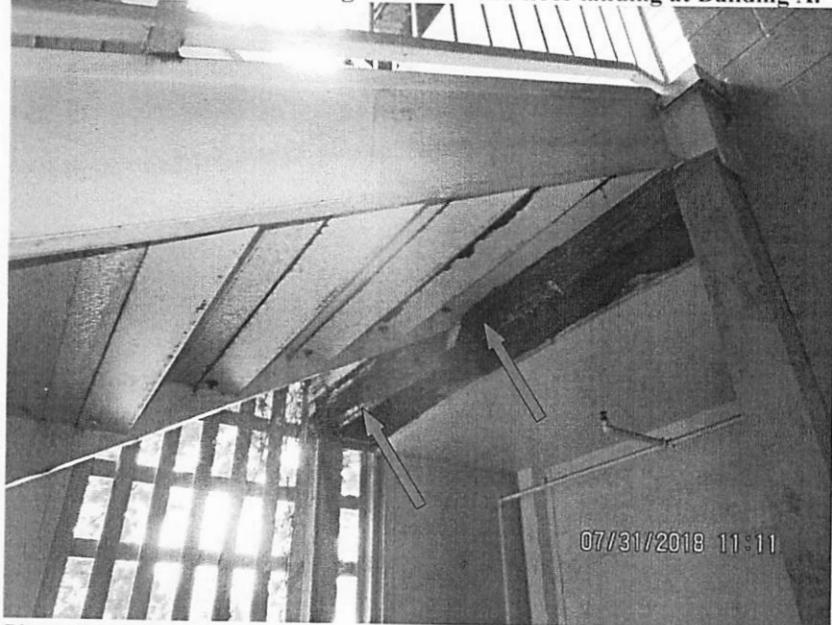
Photo 6 - Extreme beam damage at the second floor landing at Building A.

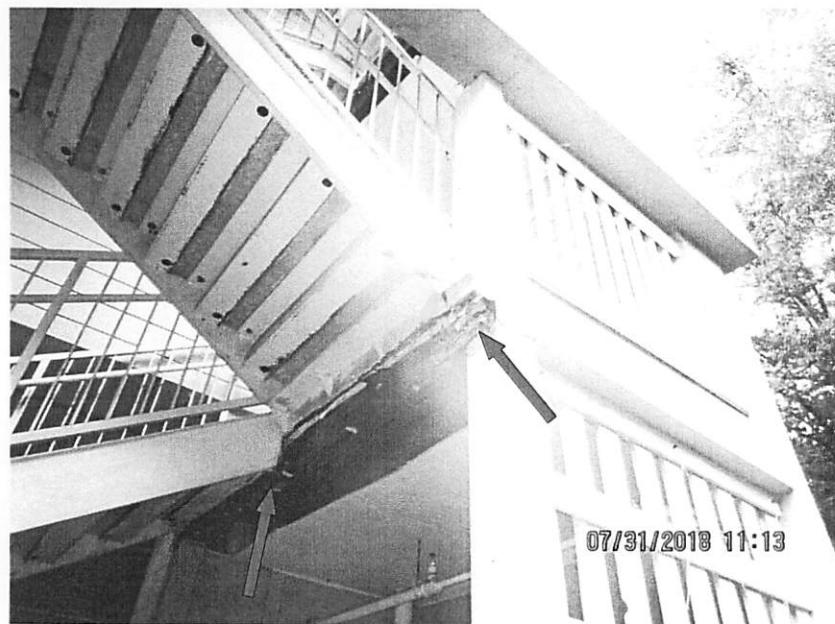
Photo 7 - Extreme beam damage at the second floor landing at Building A
