4.0 Wall Analysis

4.2 Analysis of Existing Structure

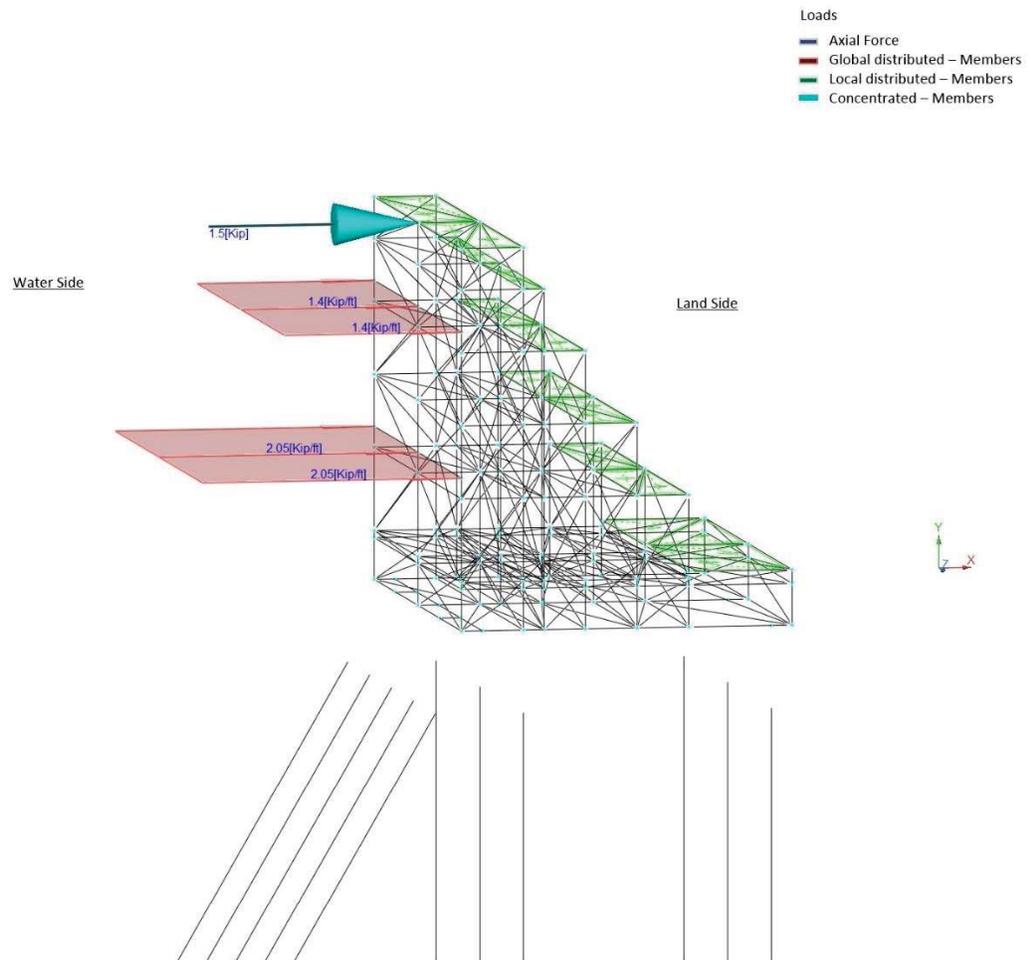
In looking at the wall from a historic loading/analysis perspective, the present day code-driven loads (described above) have been placed on the wall to ascertain their reactions to the support system. As such, the first phase was to examine the present environmental loads on the original structure to see the performance. JMT used RAM structural modeling software to analyze this scenario. Below is a partial graphic of the structural modeling depicting this scenario.

The preliminary results of this scenario indicated that the 1910 “good condition” system, as originally built with full capacity, was nearing the stress and design limits of the system under present day loading. This was estimated to be at 90-95% of the capacities of the piles and the wall system.
