A Report on Three Specific Structural Issues On the Exterior of the Read Brothers Buildings

593 King Street, Charleston, South Carolina

Submitted to:
Edye Graves, CBO, City of Charleston
April 17, 2017
Addendum 1: April 30, 2017

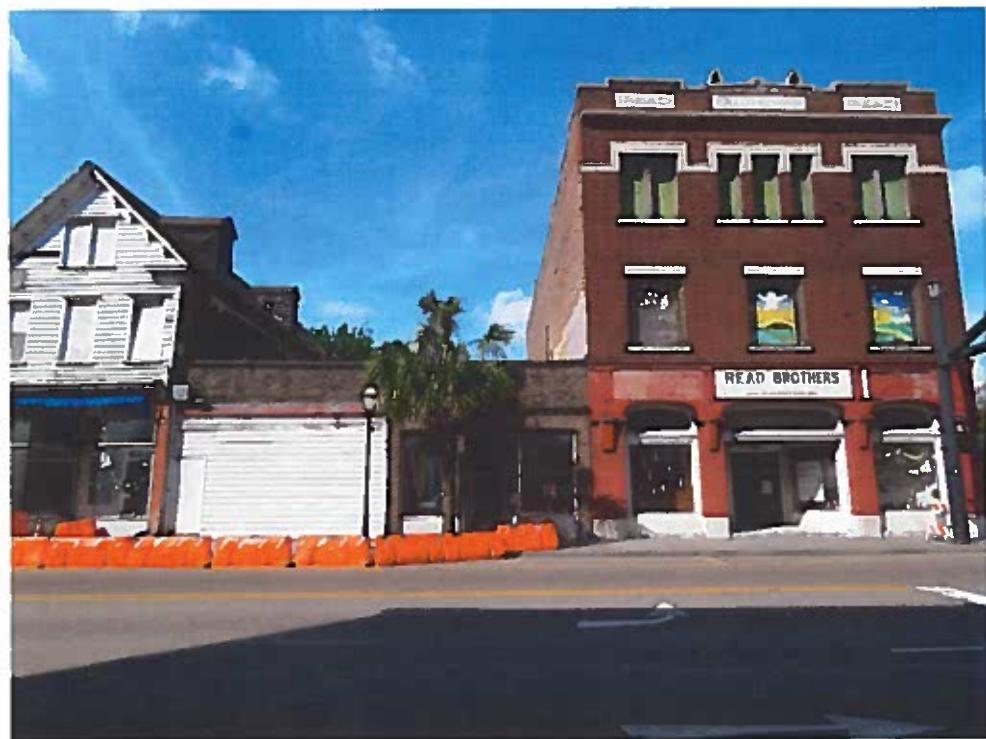
Figure 1 - Read Brothers Buildings.

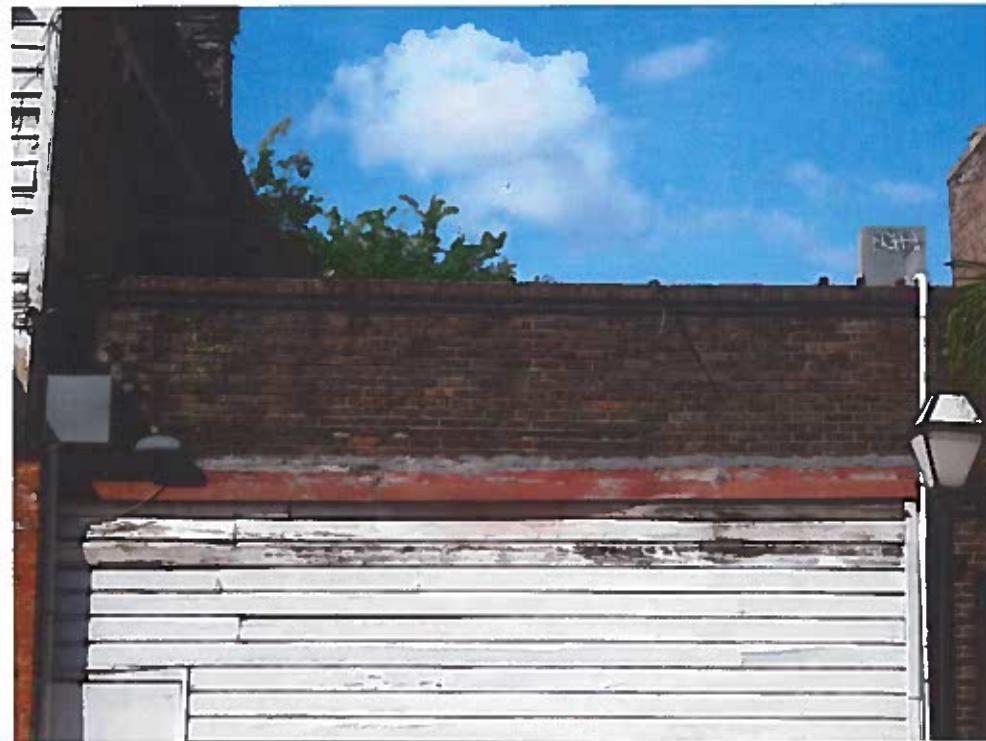
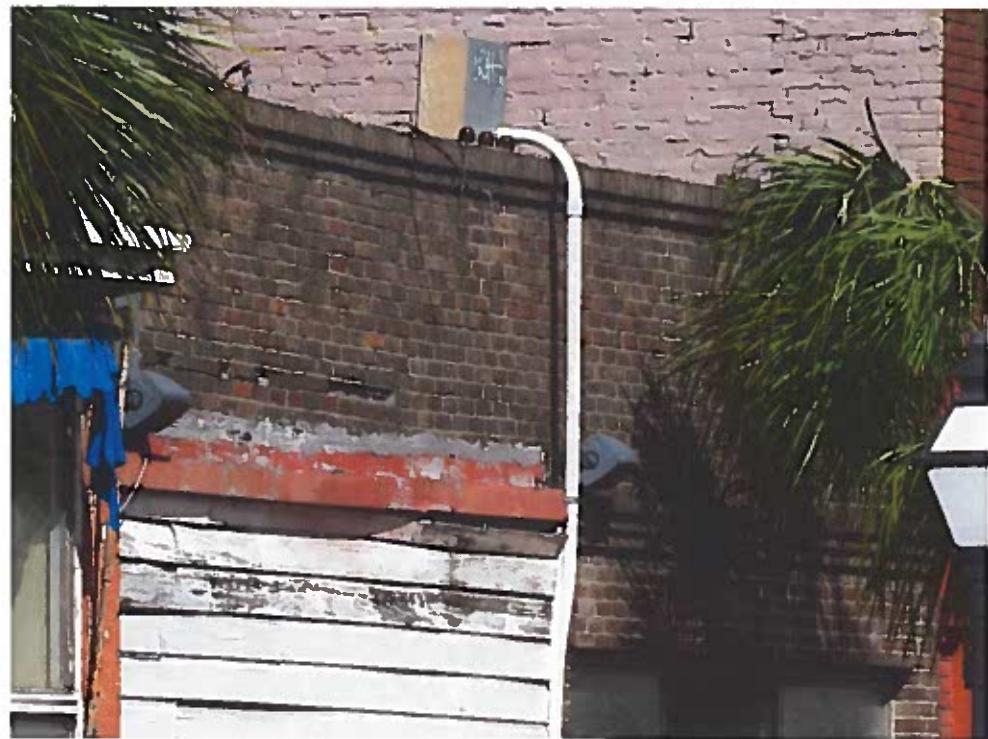
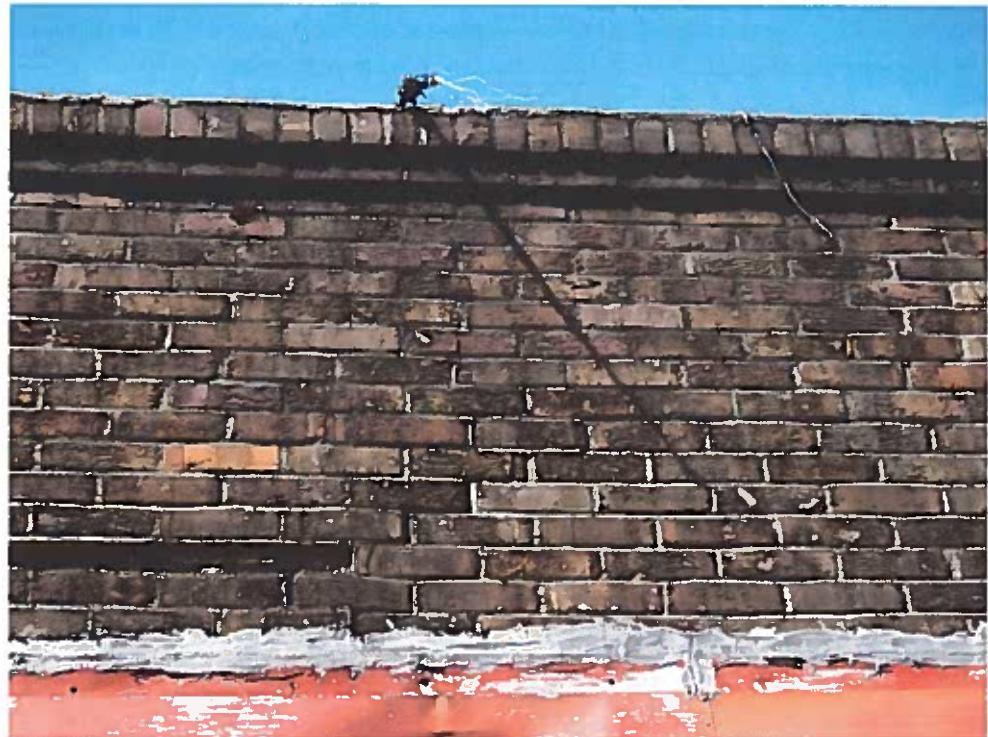
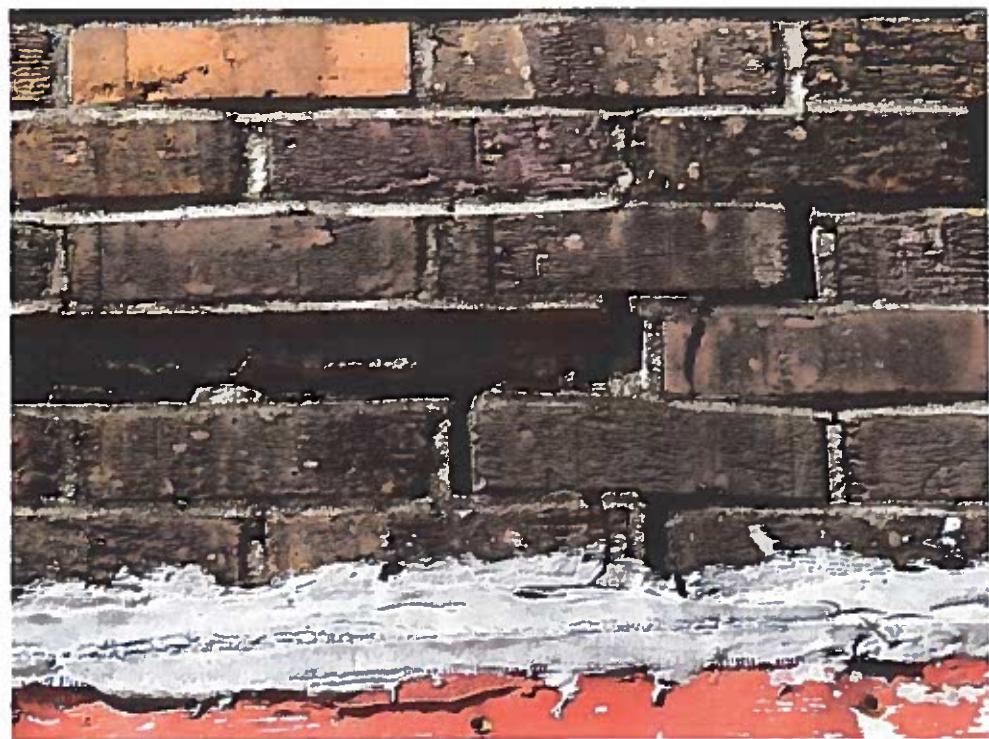
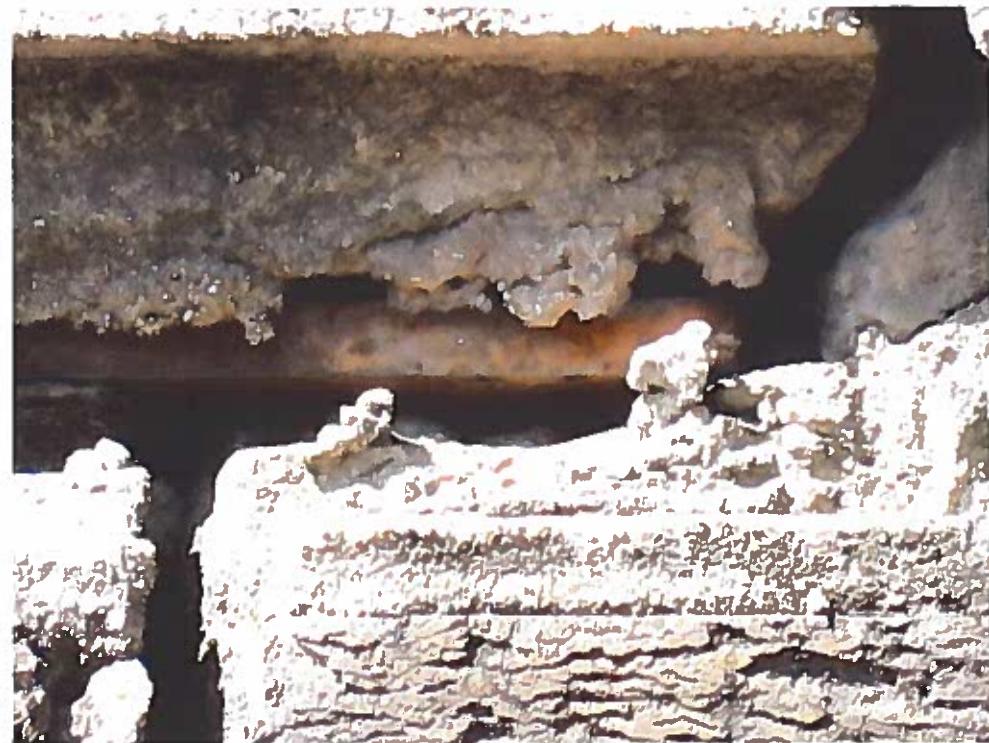
Examination of the one-story buildings to the south of 593 King, the corner building, showed, first, that the buildings appeared to be made up of two smaller buildings that had been joined together, roughly in the middle, and that the brick veneer of the upper façade of the south-most of the two was deformed and apparently failing. It appeared that the south-most two thirds of the upper façade of the south building was supported by a steel beam, one of whose flanges was damaging the brick veneer. It appeared that whatever was supporting the north end of the steel beam was failing. At the north end of the beam, the brick veneer was fractured, separating and failing, and several veneer bricks had fallen to the sidewalk. In addition, several more appeared to be in danger of falling. Fortunately, the sidewalk was blocked in that area, so there was relatively little danger to the public. See Figures 2 through 6.

Figure 2 - South-most building.

Figure 3 - Fractured upper facade.

Figure 4 - Break in veneer at end of embedded steel beam.

Figure 5 - Same.

Figure 6 - End of steel beam.

We recommend to the City that the sidewalk in front of the south-most one-story building remain closed until whatever needed structural strengthening under the north end of the steel beam has been successfully accomplished, and all of the bricks in the façade have been stabilized.

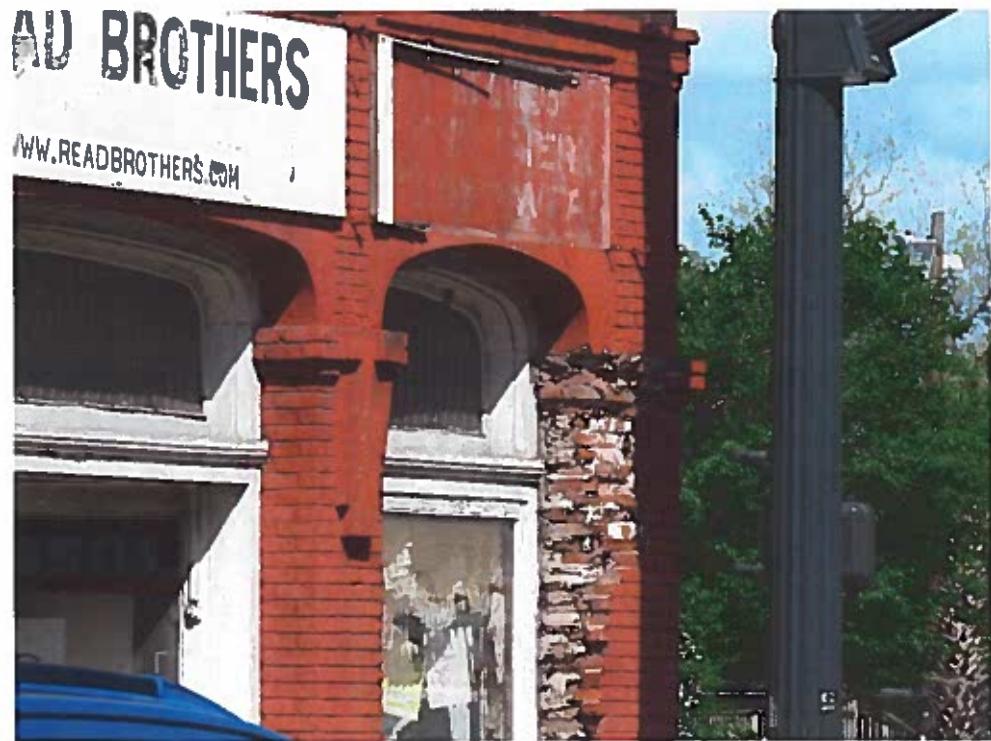
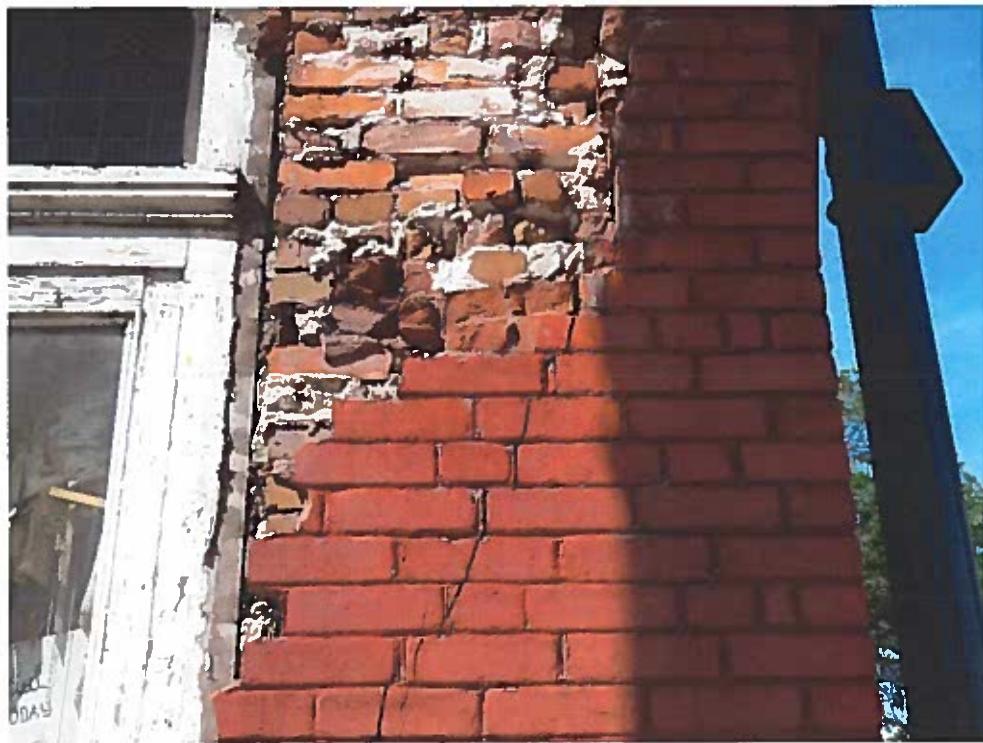
At the three-story building, the main Read Brothers fabric store at 593 King, three issues of concern were found. The first, and the most obvious, was that the column at the northeast corner of the building has been damaged, reportedly by a construction vehicle. See Figures 7 and 8. There was a significant shear fracture in the remaining portion of the brick masonry column. It could not be determined by examination whether the column was a structural load-bearing brick masonry column or whether the brick masonry simply encapsulated a steel column supporting the beam over the front entry. While it is most likely that there is a steel column encapsulated within the brick masonry, it is exceptionally important that this be confirmed, as the present condition of the column poses a grave danger to the public if there is no embedded steel.

Figure 7 - Damaged corner column.

Figure 8 - Shear fracture in column.

Finally, we recommend to the City that the owners of the building confirm to the city, through testing, that there is an embedded steel column within the brick masonry column. If the owners are unable to confirm that there is a steel column embedded in the masonry, we recommend that the City have the owners shore the beam and wall above the column and repair the structural damage to the masonry column. Again, if there is no embedded steel column, we further recommend that the adjacent portions of both King and Spring Streets be closed to all traffic until the masonry can be shored or repaired.

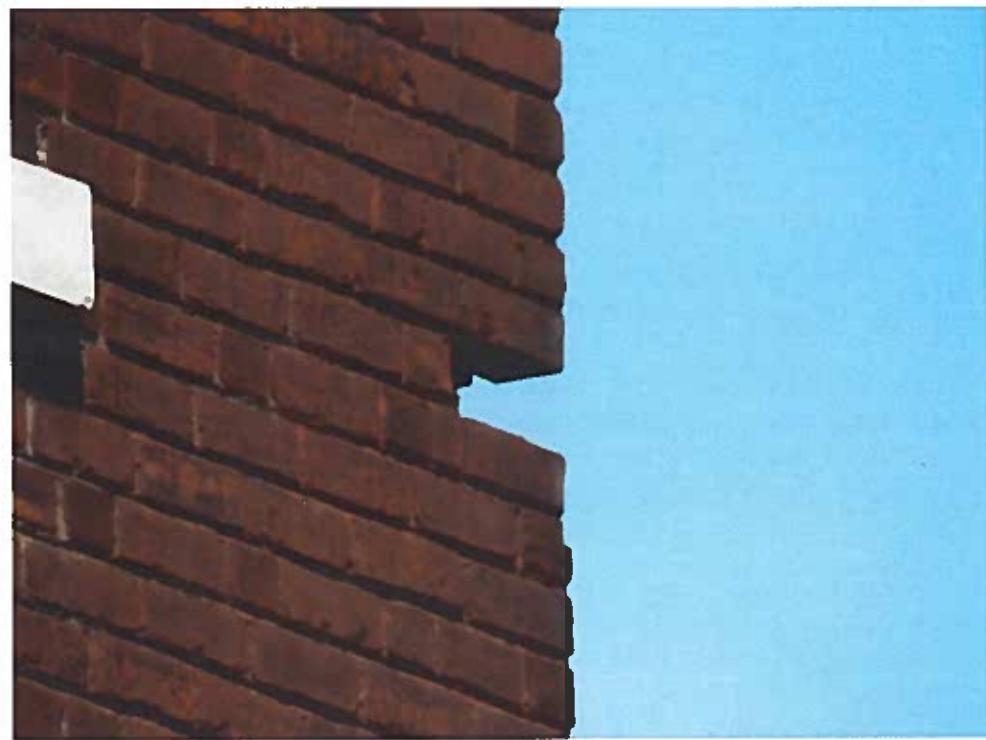
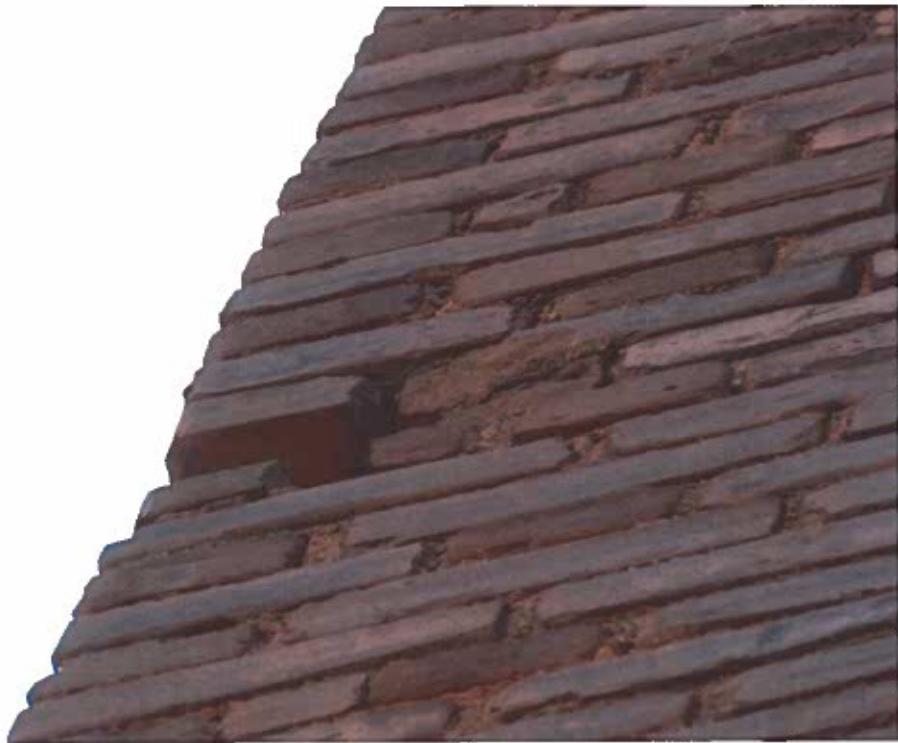
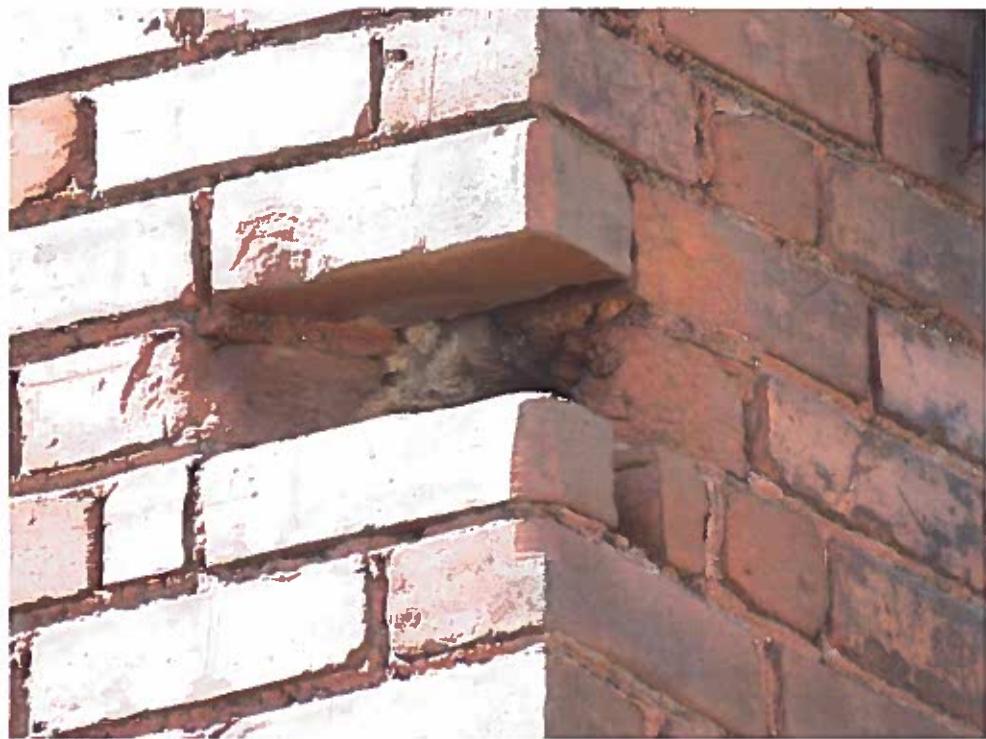
A second area of concern was found at the upper corners of the parapet at the southwest and northwest corners of the three-story building. See Figures 9 through 11. It was obvious from both King Street and Spring Street that both corners had moved outward. While there did not appear to be a significant danger to the public under gravity load alone, it appeared that there would be a significant danger to the public if there were vibration or lateral movement from either a seismic event or severe winds. It is possible that there could even be movement with vibration from nearby pile driving.

Figure 9 - Missing brick at third floor, corner.

Figure 10 - Same.

Figure 11 - Same.

We recommend that the City have the owners of the building replace the corroding steel lintels in the third floor west windows and tie the northwest and southwest corners of the parapet and uppermost portion of the façade back to the remainder of the building.

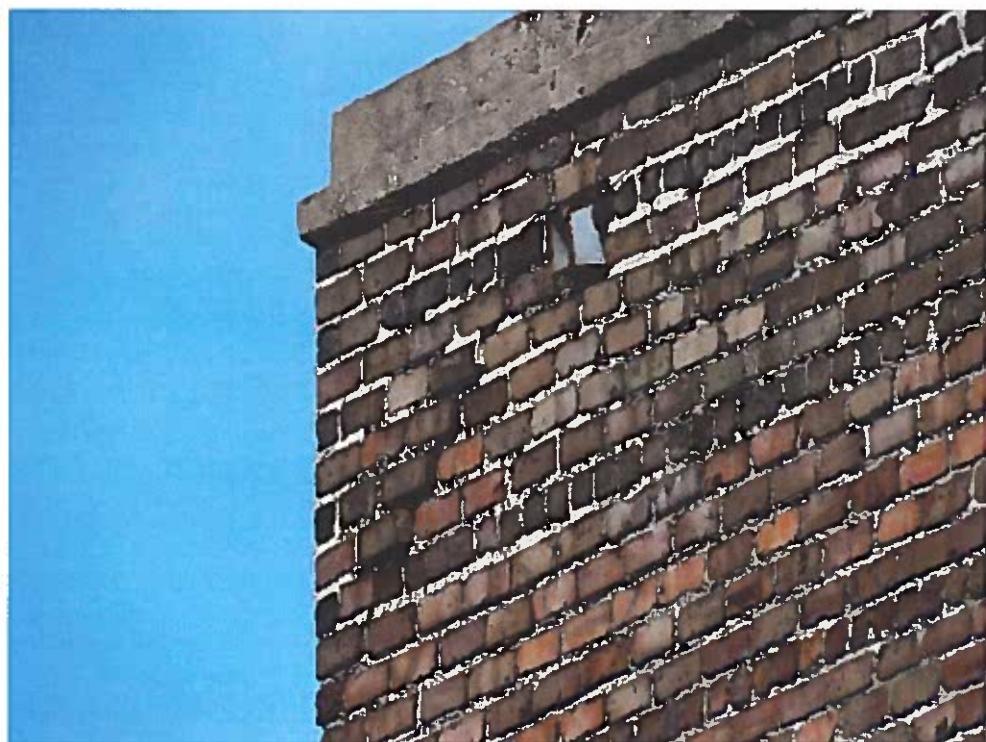
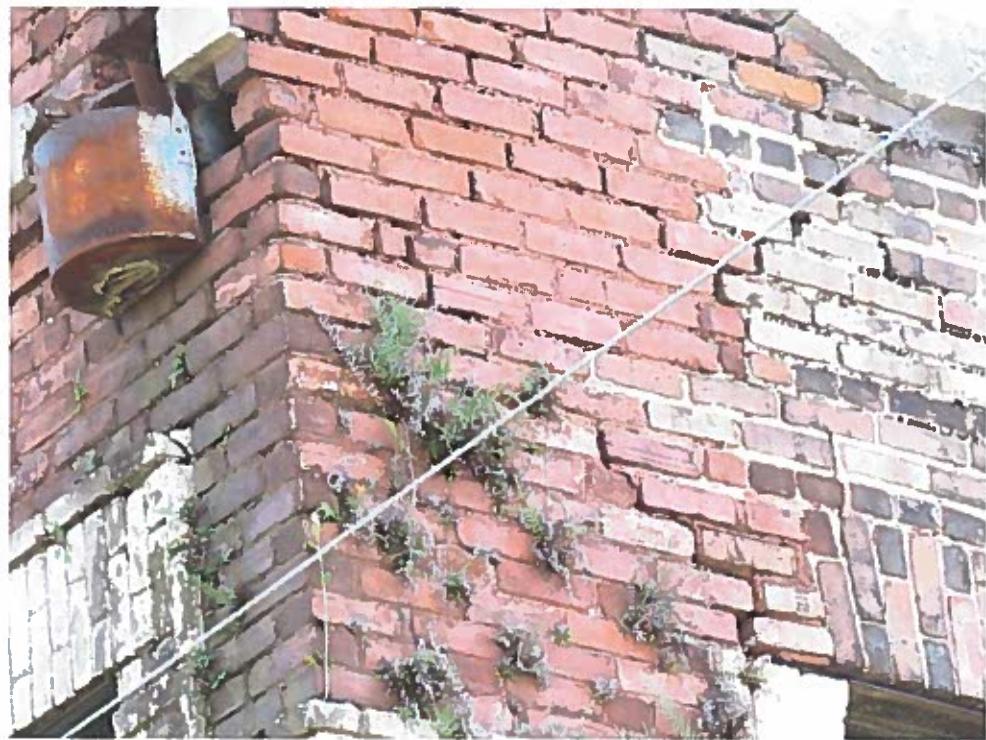
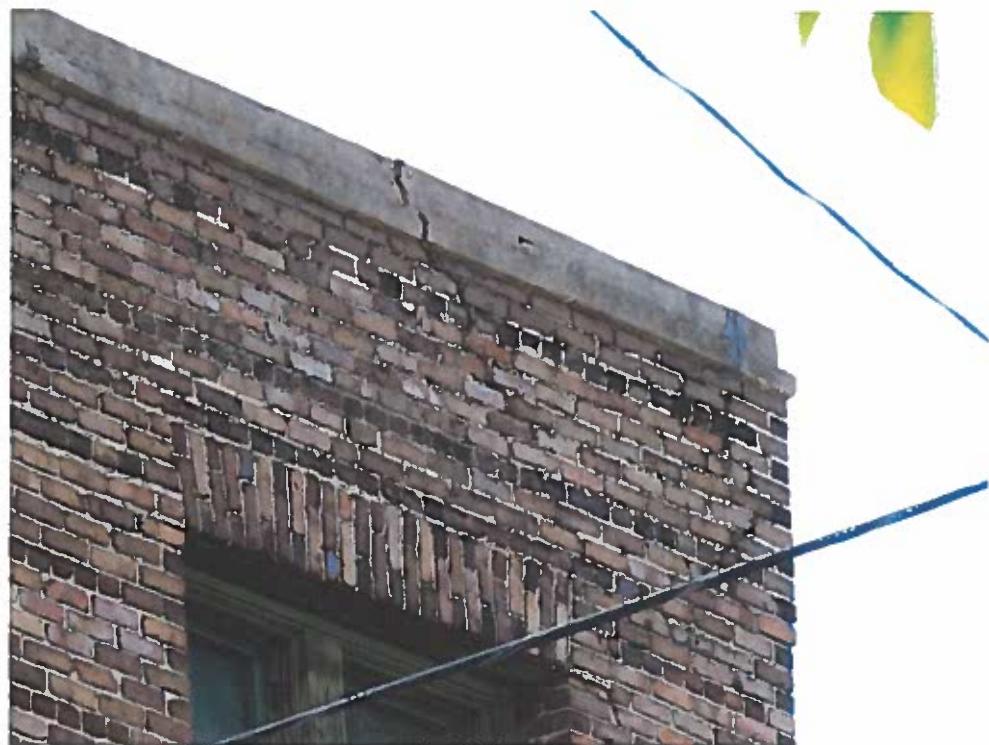
Of less concern was a missing brick at the second floor level of the northeast corner of the three-story building. We could see no cause for that damage other than perhaps the installation of electrical equipment nearby on the façade. See Figures 12 through 14.

Figure 12 - Damage at south side of southwest corner.

Figure 13 - Damage at northwest corner caused by expansion of corroding lintel.

Figure 14 - Similar damage at southwest corner.

We further recommend to the City that the City have the owners of the buildings check the area at the second floor on the northeast corner, where the brick is missing, to make sure that there is no inherent cause for further brick loss in that area.

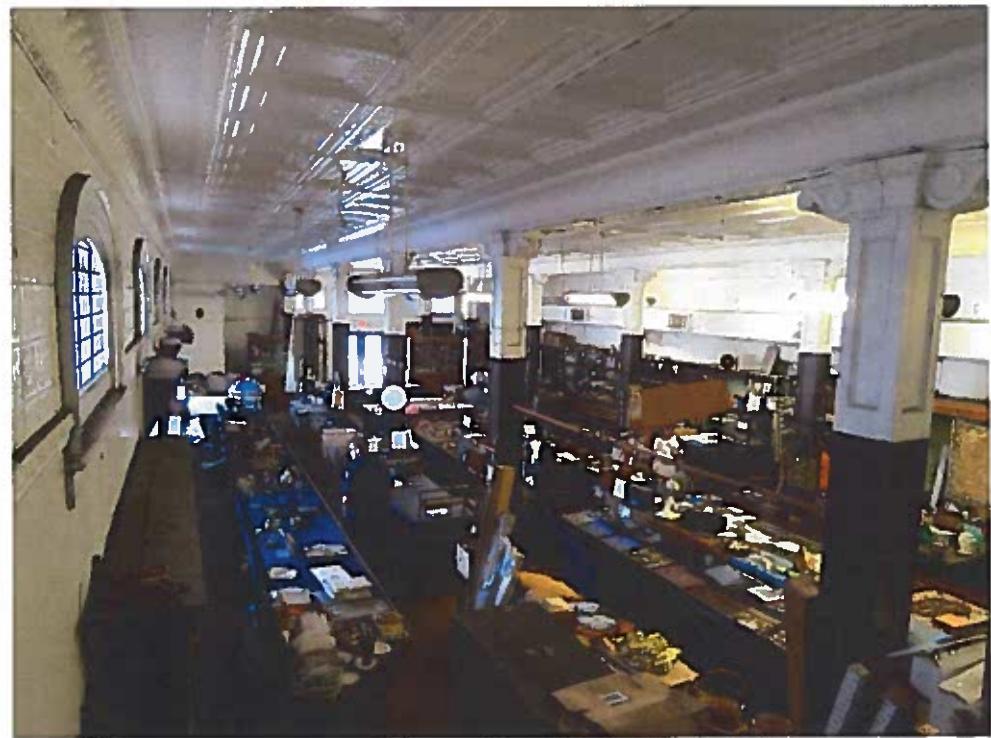
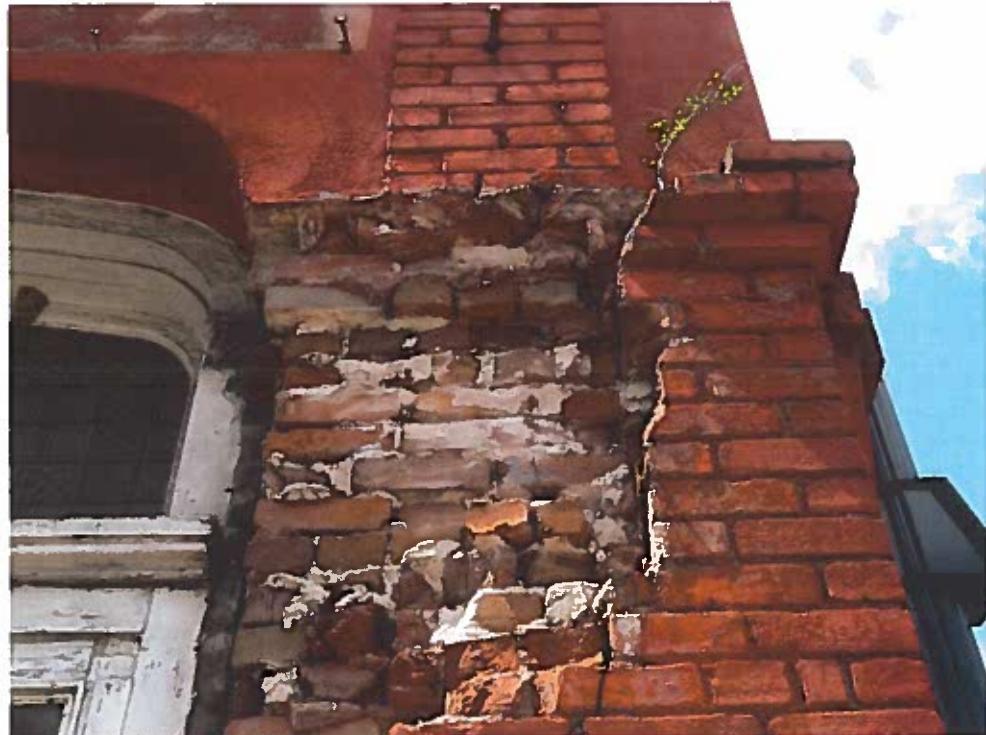
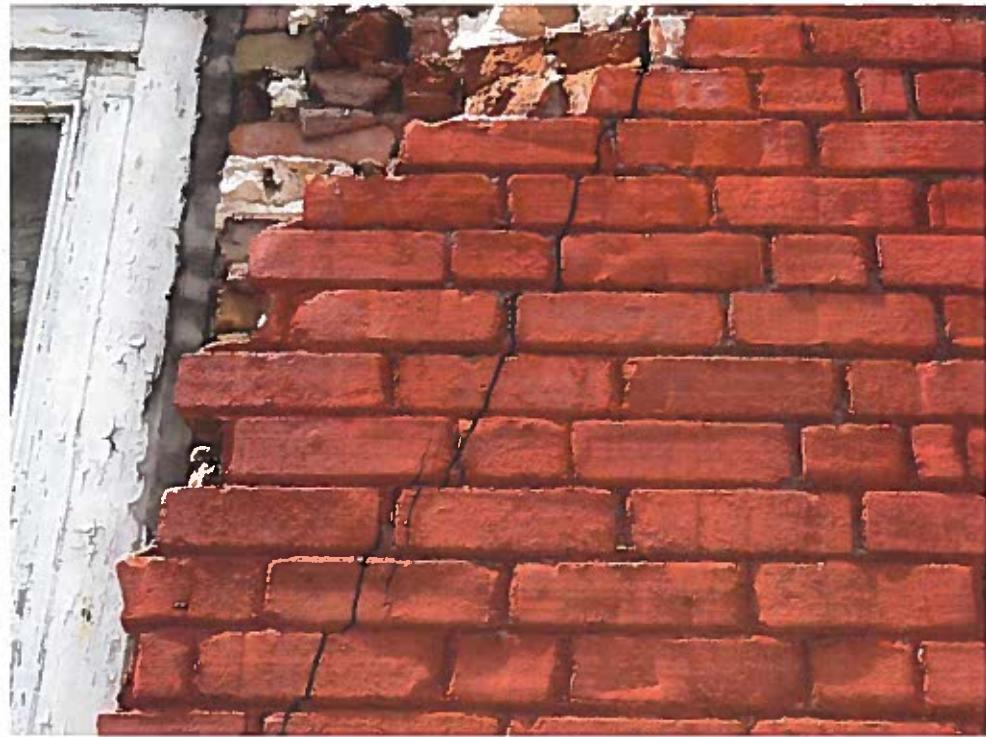
The first floor of the 593 King Street Building appeared to be in acceptable shape except for the severely damaged brick masonry column on the northeast corner of the building. Close examination of that column indicated both that it was unlikely that there was any internal steel in the column and that the column supported a concrete arch over the north window on the east façade. See Figures 15, 16 and 17.

Figure 15 - First floor of 593 King Street building.

Figure 16 - Northeast corner column supporting concrete arch.

Figure 17 - Fracture in the same column.

- That the sidewalk and parking lane in front of 589 1/2 King remain closed until the façade and its supporting structure have been repaired.
- That the northeast corner column of the 593 King Street building be clamped to prevent a possible sliding shear failure and that it be repaired as soon as possible. Clamping will almost certainly require removal of the glass on both the south and west sides of the column.

- That the same column be permanently repaired with grout injection and the installation of internal tie rods and plates, to prevent the sliding shear failure previously mentioned.

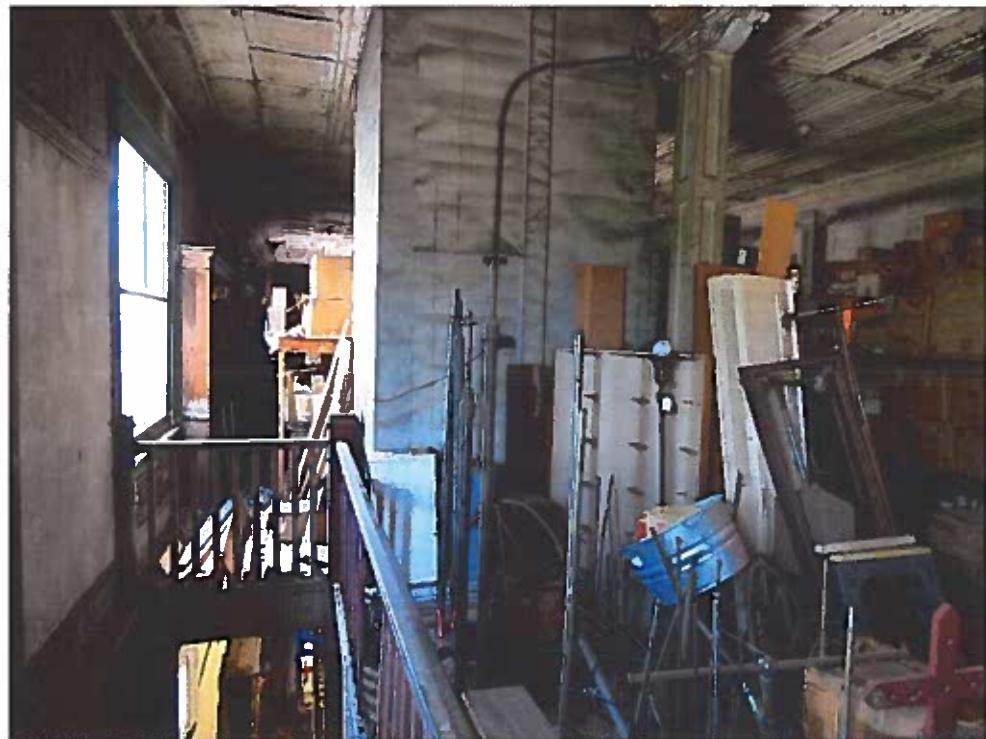
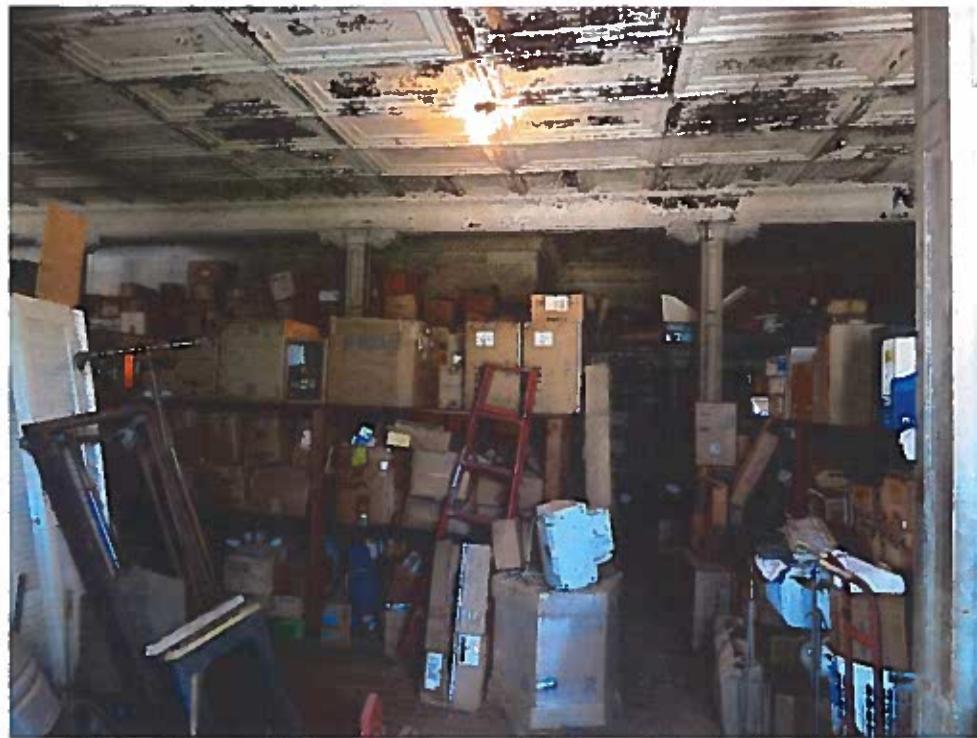
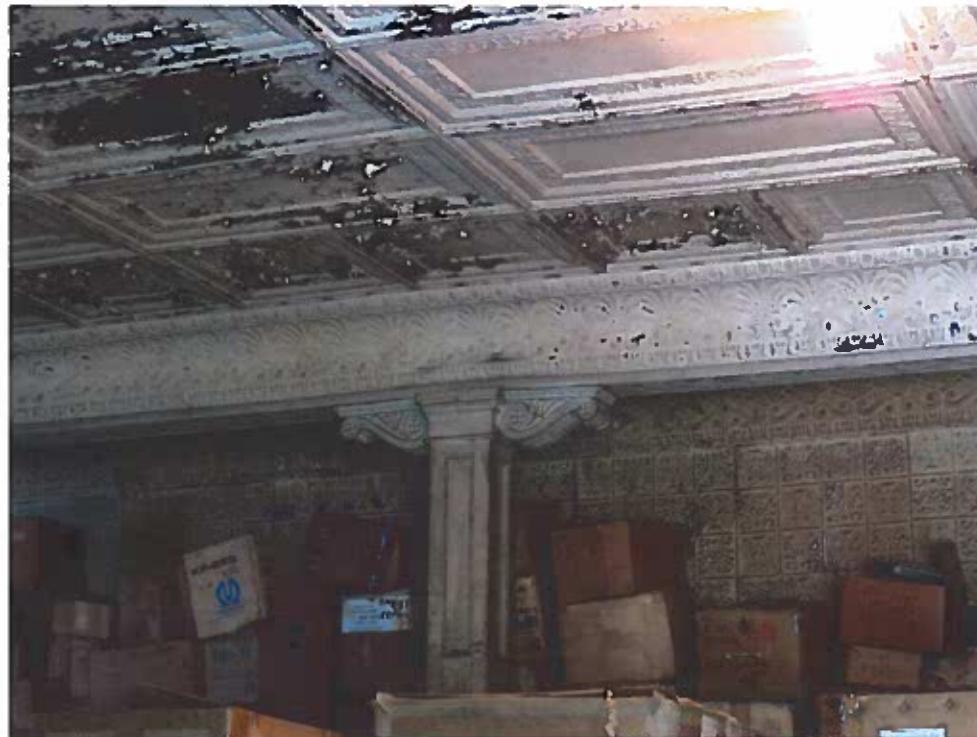
A tour of the upper levels of the same building showed that the second floor was in relatively poor condition and that it was used for stacked storage. Deformations of the girders supporting the second and third floors indicated the likelihood of significant overload. See Figures 18, 19 and 20. The third floor was in significantly worse condition than the second, with roof leaks, fallen plaster, deteriorating steel lintels, and deteriorating millwork. See Figures 21, 22 and 23.

Figure 18 - Second floor used for storage.

Figure 19 - Same.

Figure 20 - Same.

- That the loading on the upper floors of 593 King Street be reduced significantly.
- That the 589 1/2 King building not be occupied until the roof has been replaced and the structural framing thoroughly checked.

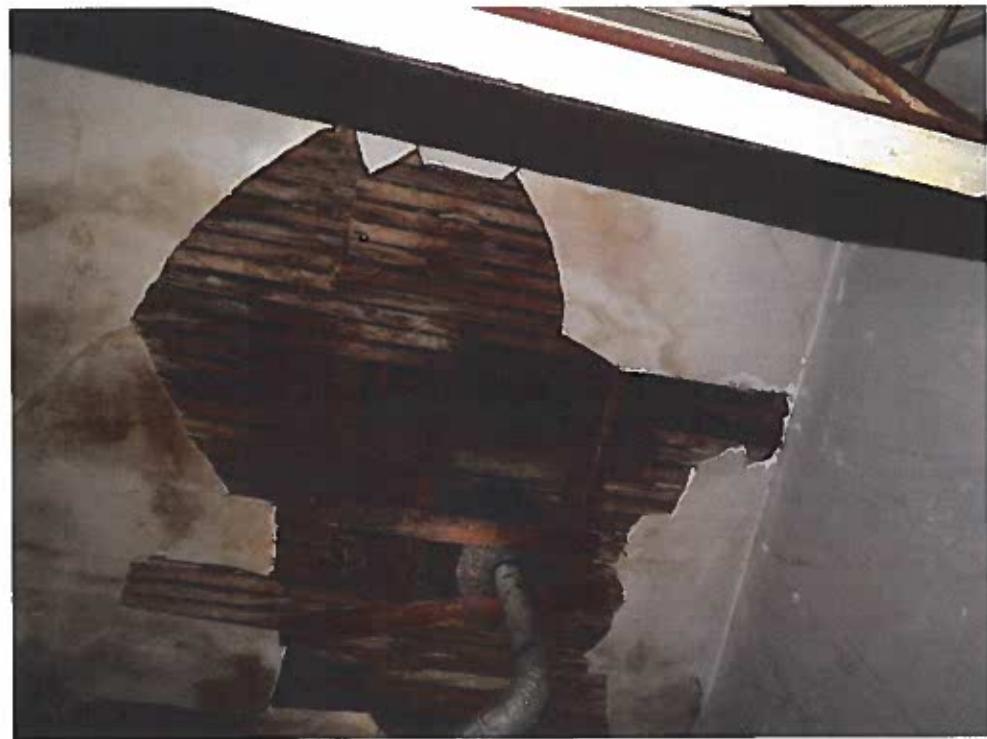
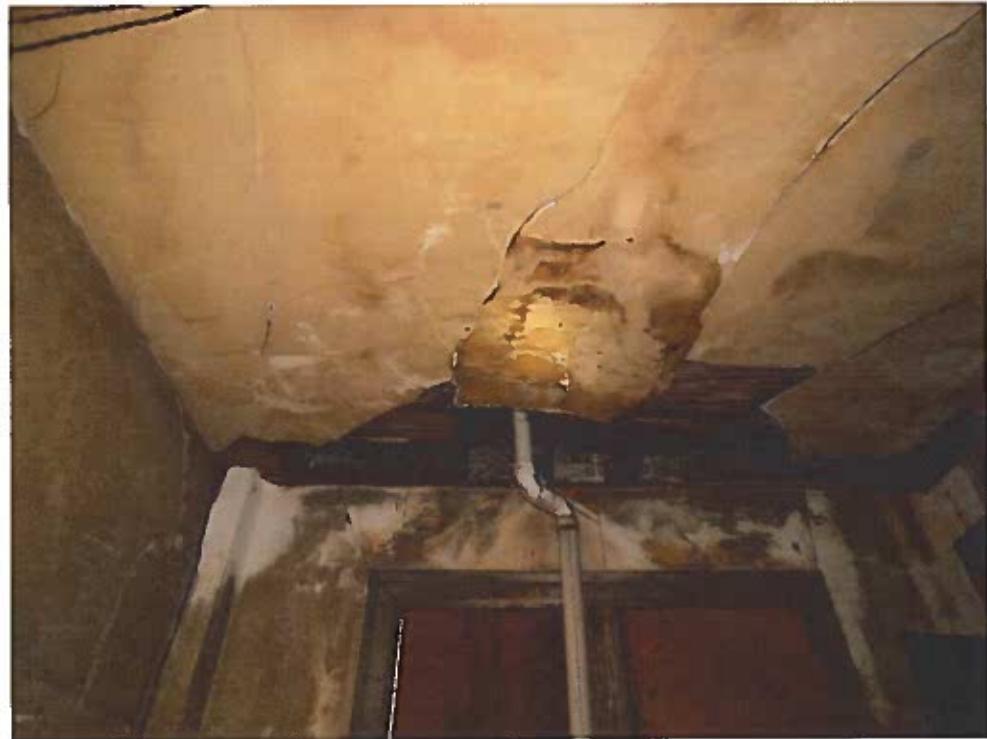
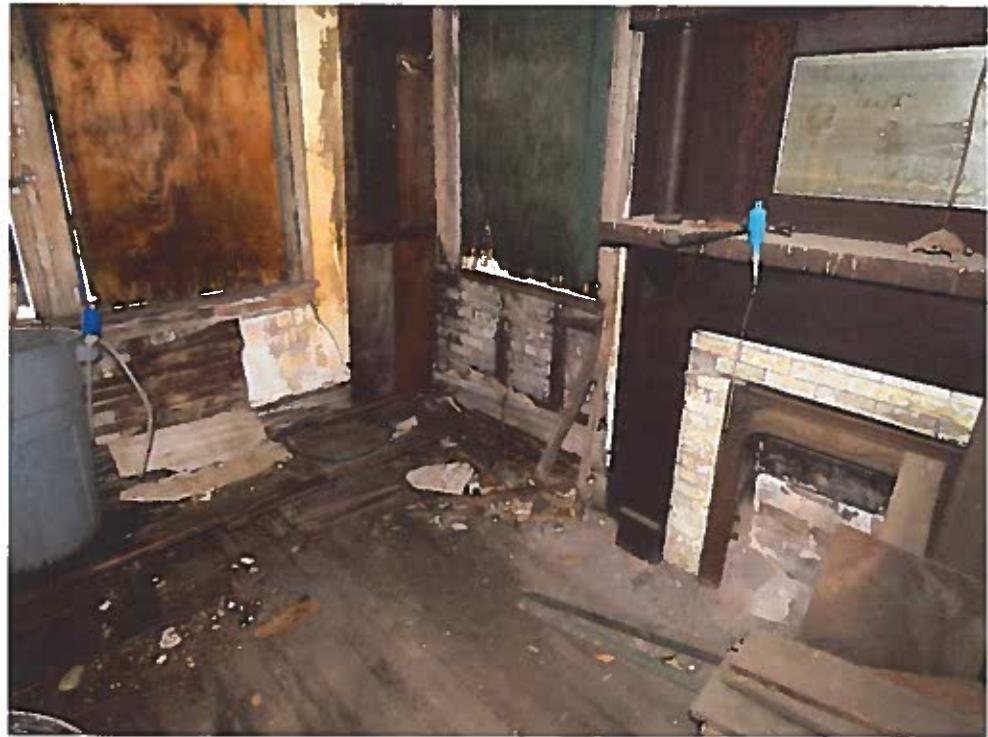
Figure 21 - Roof leak on the third floor.

Figure 22 - Same.

Figure 23 - Same. Note fallen plaster in the northwest corner of building.

- That the roof of the 593 King building be repaired, that the third floor steel lintels on the west façade be removed, treated and replaced, and that the loose brick masonry be repaired and tied back to the building.

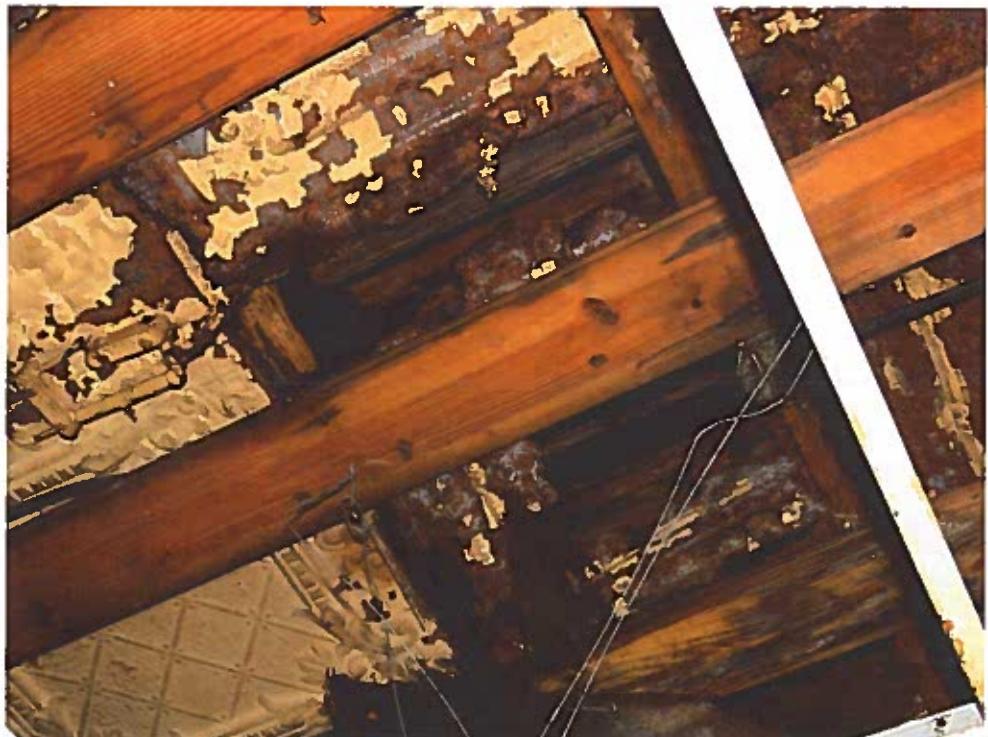
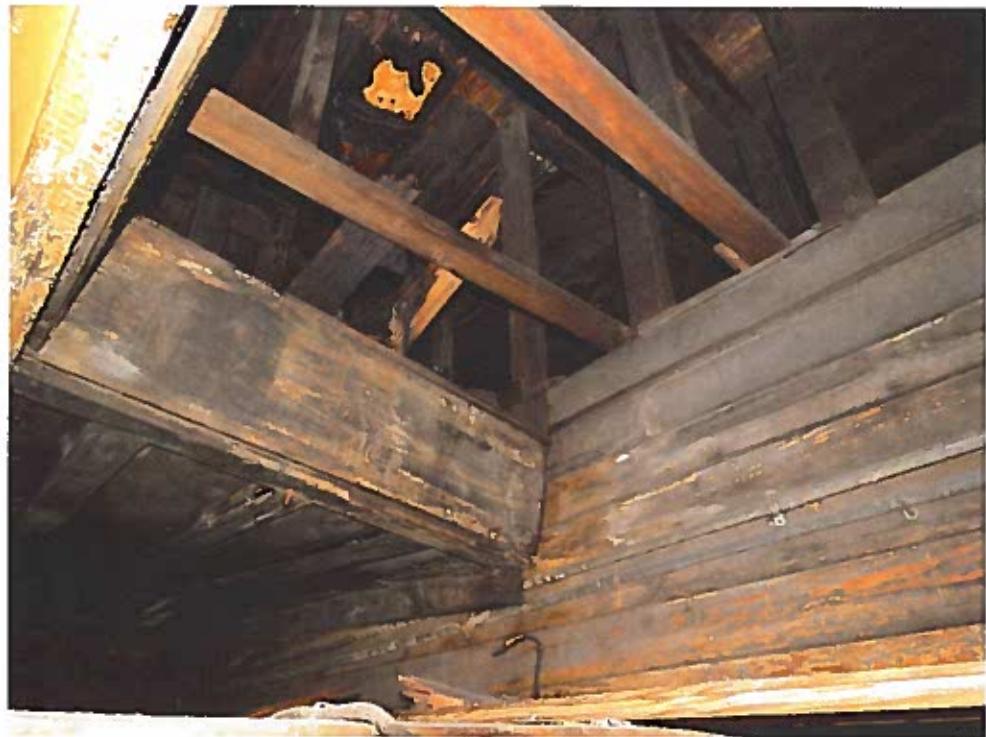
The one story building immediately south of 593 King appeared to be in better condition than the second building to the south (589 1/2 King), which showed severe deterioration from water intrusion, both on the King Street façade and along the column line supporting the roof system. See Figures 24 and 25.

Figure 24 - Ceiling of 589 1/2 King Street building.

Figure 25 - Damaged roof structure in the same building.
