# **Appendix B**

Photographs of General Conditions  
from the “Walk-by” and “Float-by” Inspection  
of the Low Battery Seawall

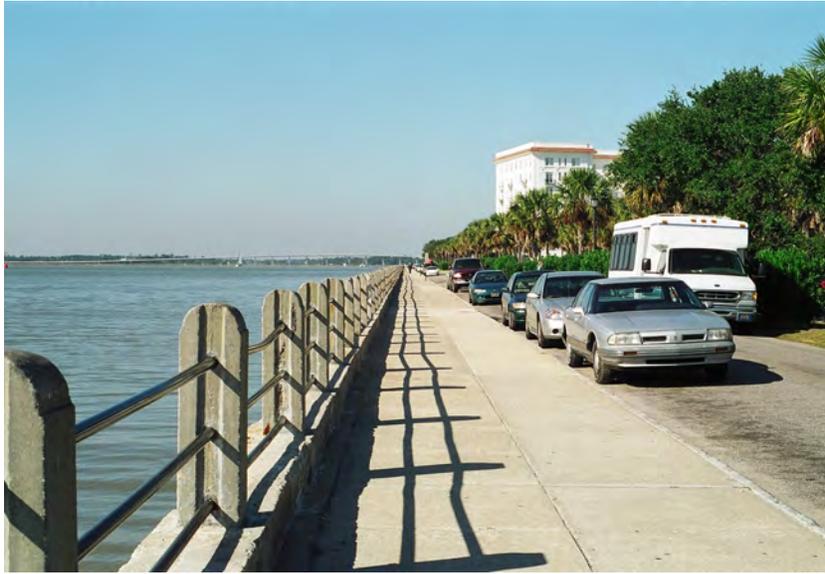
This is a view looking to the west along the Low Battery seawall in the vicinity of White Point Gardens. The sidewalk is in good condition to King Street.

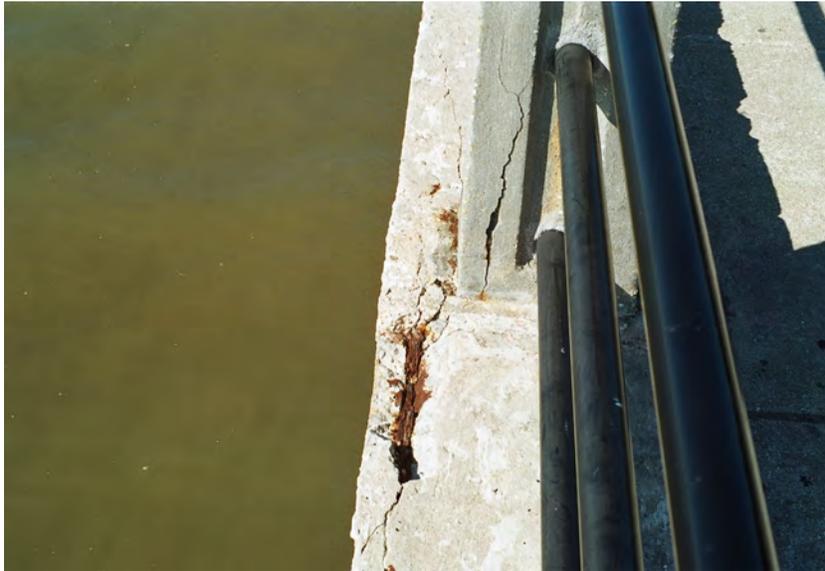
This is a view of the Low Battery seawall east of King Street. Note the exposed and corroded steel reinforcing bars in the concrete coping and the wide crack in the railing pedestal.

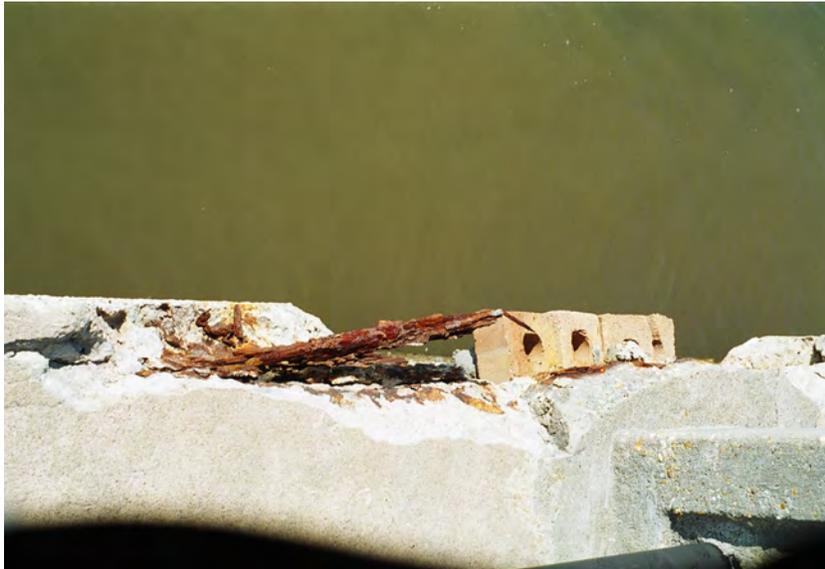
This is a view of the Low Battery seawall east of King Street. Note the exposed and corroded steel reinforcing bars in the spalled concrete coping. Note the bricks used to fill a void.

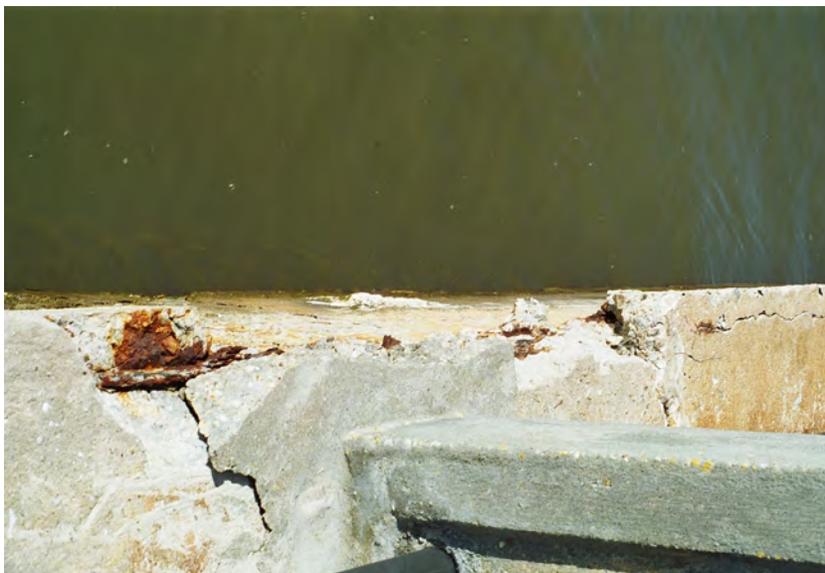
This is a view of the Low Battery seawall east of King Street. Note the exposed and corroded steel reinforcing bars in the spalled concrete coping at the base of a railing pedestal.

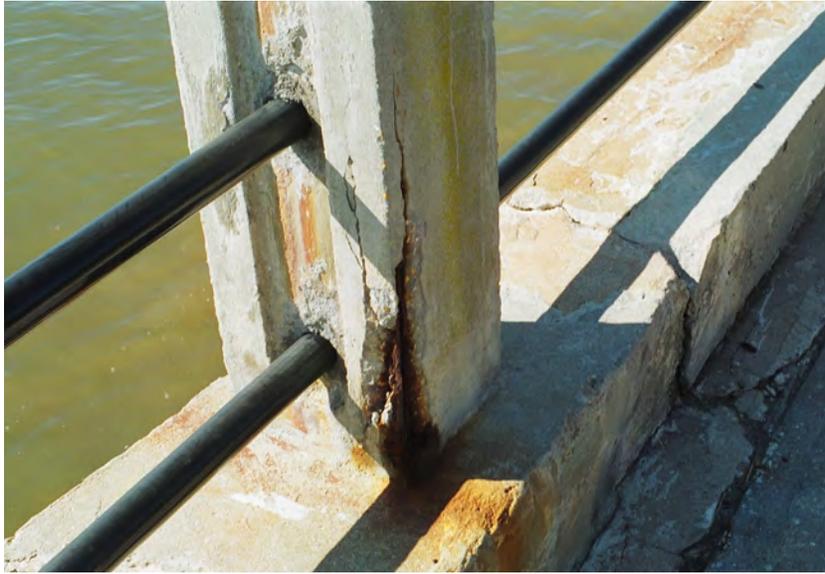
This is a view of the Low Battery seawall east of King Street. Note the exposed and corroded steel reinforcing bars in the cracked and spalled concrete railing pedestal.

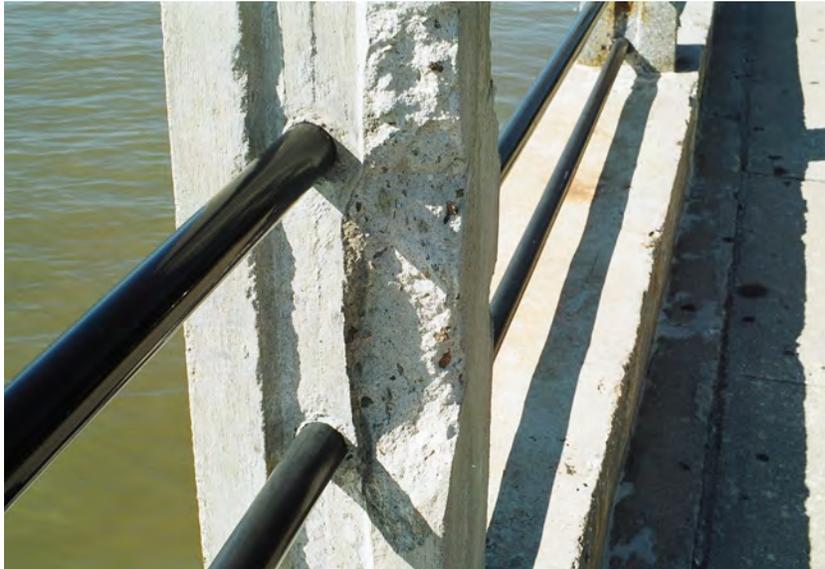
This is a view of the Low Battery seawall east of King Street. Note the spalled concrete railing pedestal.

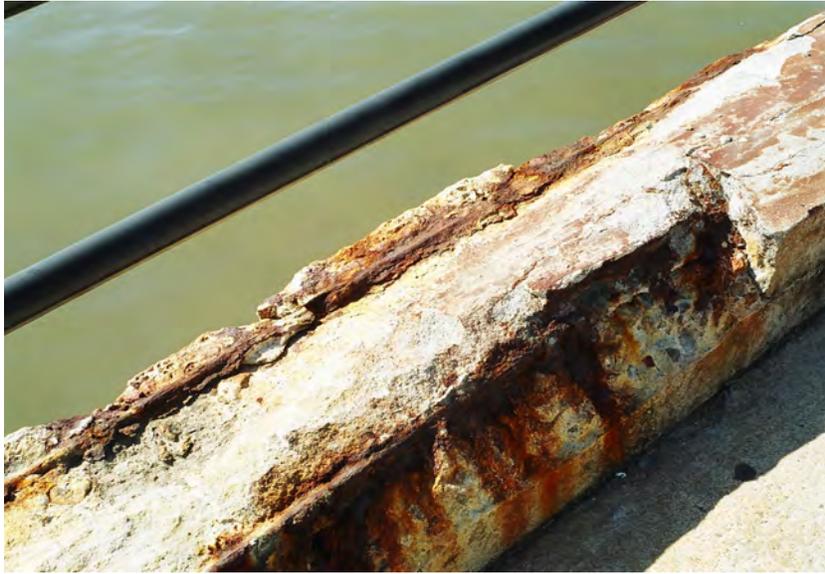
This is a view of the Low Battery seawall east of King Street. Note the exposed and corroded steel reinforcing bars in the spalled concrete coping.

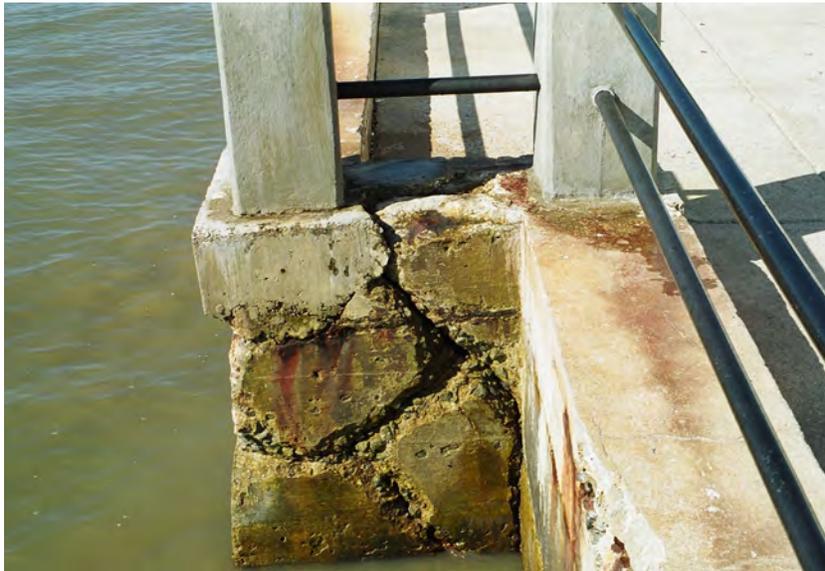
This is a view of the Low Battery seawall in the vicinity of the Fort Sumter House and King Street. Note the general condition of the seaward face of the seawall.

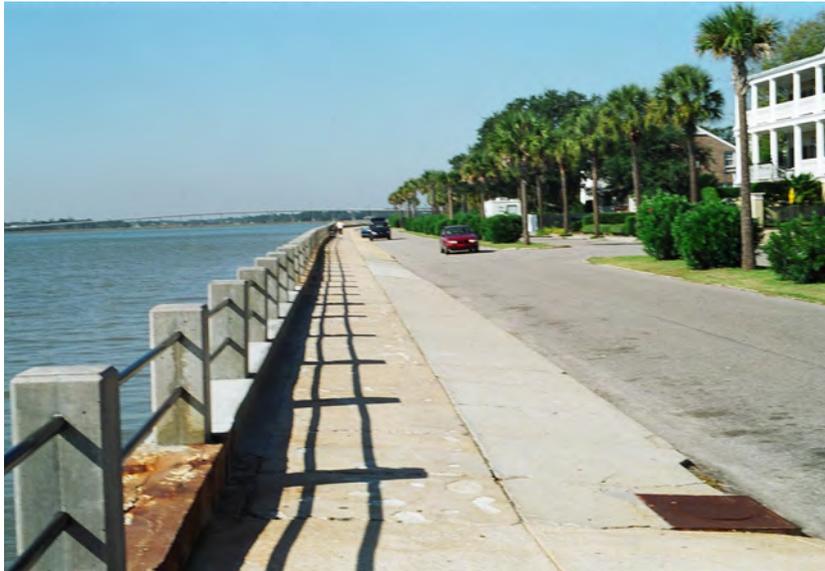
This is a view of the Low Battery in the vicinity of 14 Murray Boulevard. The seaward section of sidewalk has a slight downward slope and the street-side section of sidewalk has a steeper downward slope toward the street. Note the shallow surface scaling of the seaward section of sidewalk.

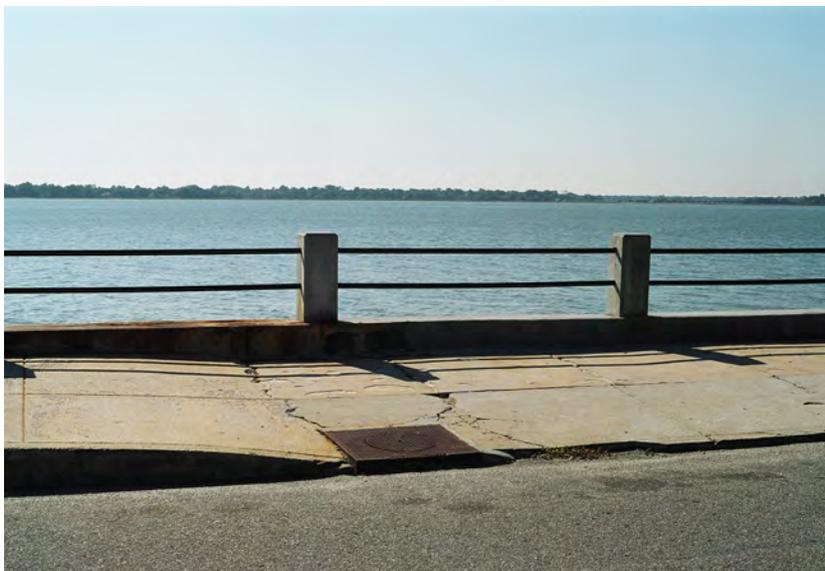
This is a view of the Low Battery in the vicinity of 14 Murray Boulevard. The sidewalk to the left of the storm drain inlet is level and in good condition. The sidewalk to the right of the inlet is in poor condition and slopes noticeably downward to the street. Note the change in the elevation of the top of the sidewalk at this location.

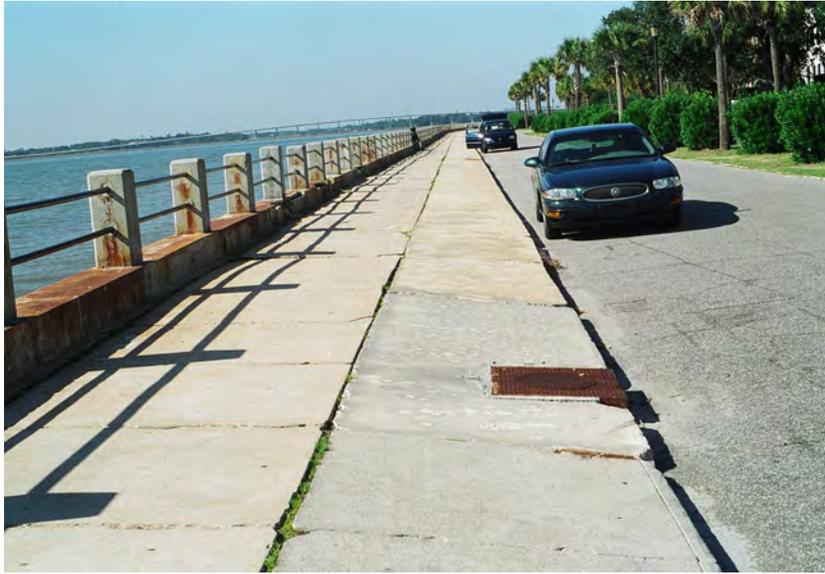
The seaward section of the Low Battery sidewalk has a slight downward slope and the street-side section of sidewalk has a steeper downward slope toward the street.

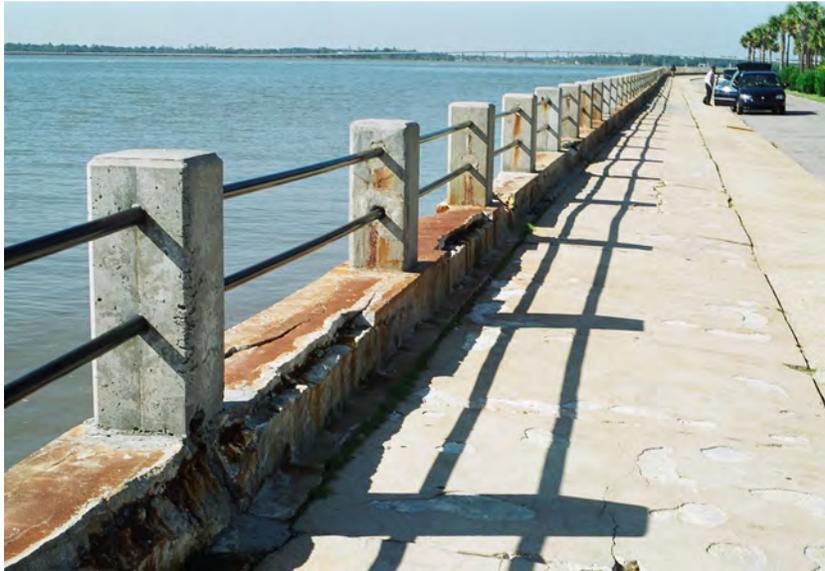
Note the long spalls along the landside edges of the concrete coping and the shallow surface scaling of the seaward section of the concrete sidewalk.

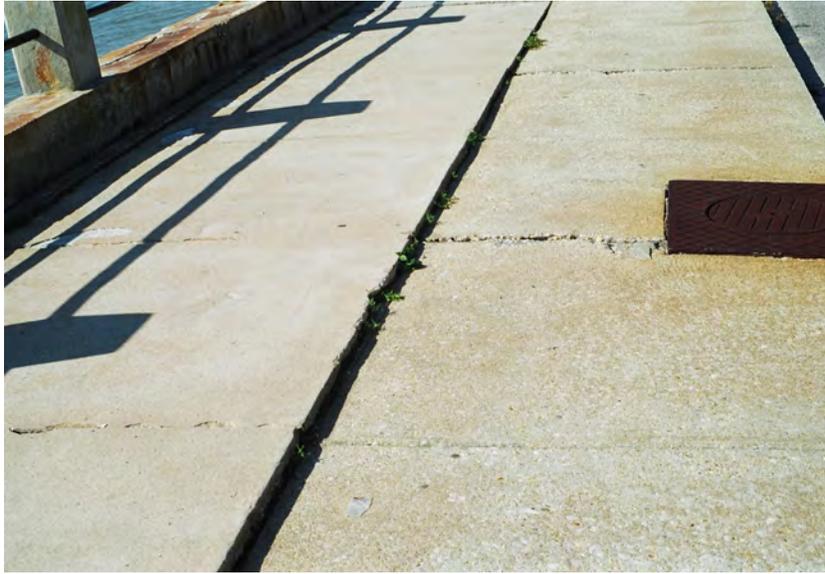
This is a view of the Low Battery in the vicinity of 22 Murray Boulevard. Note the drop in elevation along the joint between the seaward section of sidewalk and the street-side section of sidewalk.

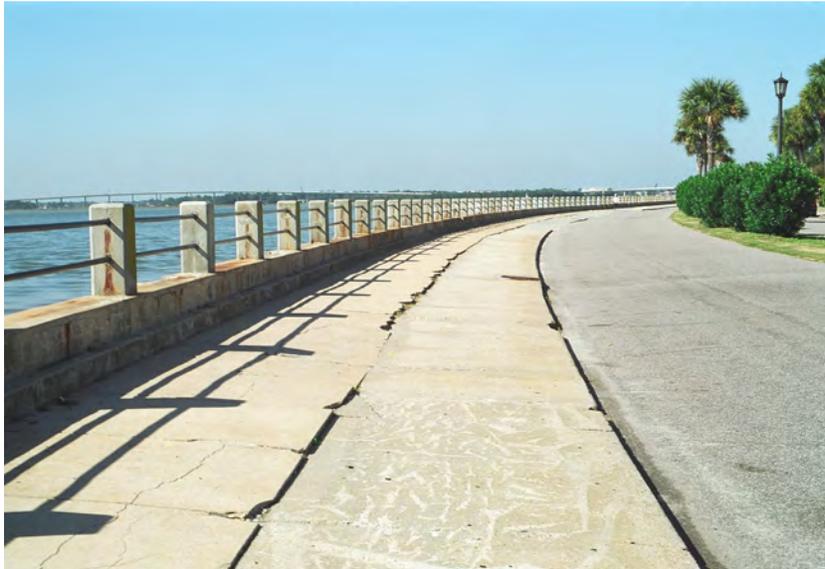
This is a view of the Low Battery in the vicinity of 36 Murray Boulevard. Note the drop along the joint between the seaward section of sidewalk and the street-side section of sidewalk. The seaward section of sidewalk has a slight downward slope and the street-side section of sidewalk has a steeper downward slope toward the street.

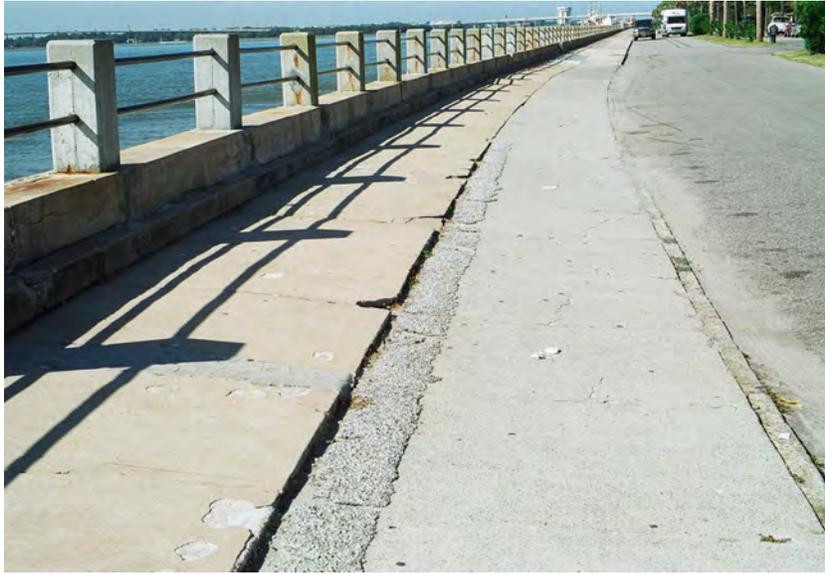
This is a view of the Low Battery in the vicinity of 50 Murray Boulevard. Note the drop along the joint between the seaward section of sidewalk and the street-side section of sidewalk and the attempt to transition between the sections with asphalt. The seaward section of sidewalk has a slight downward slope and the street-side section of sidewalk has a steeper downward slope toward the street.

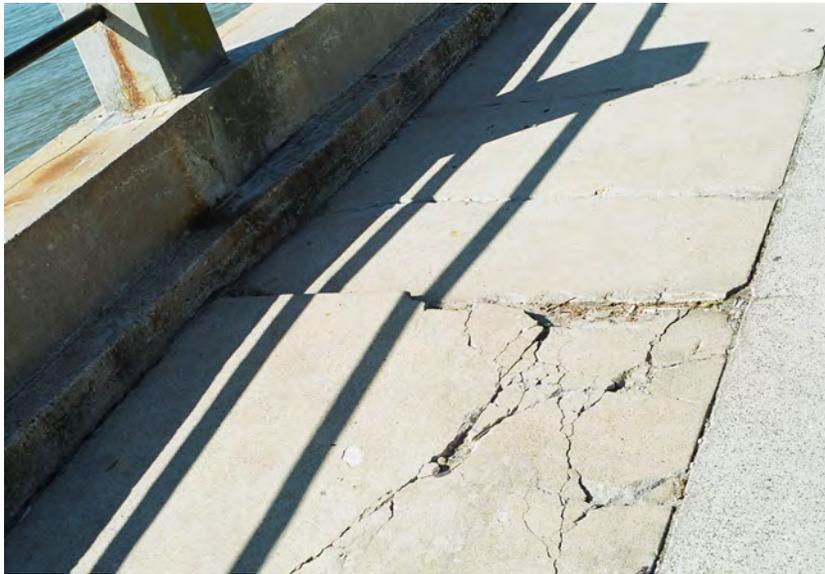
This is a view of a seaward section of sidewalk in the vicinity of 50 Murray Boulevard.

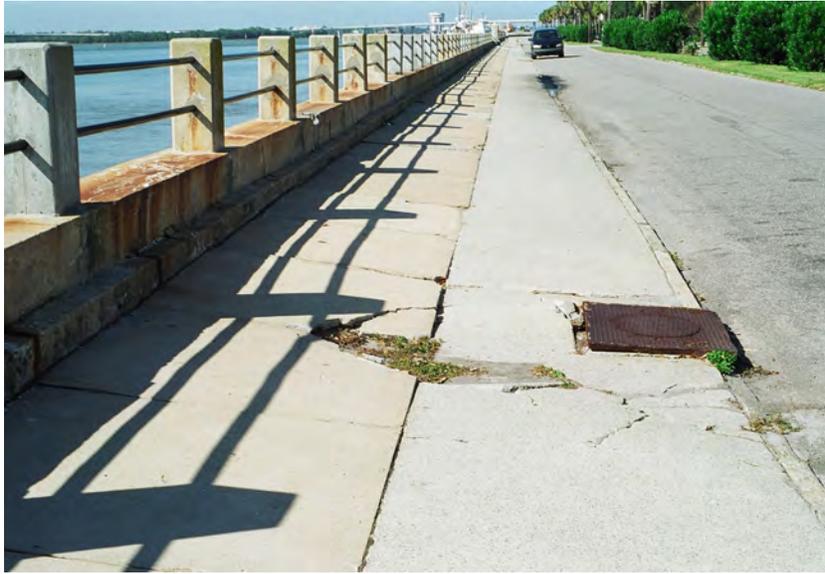
This is a view of the Low Battery in the vicinity of Council Street. Note the condition of the sidewalk around the storm drain inlet. From the vicinity of Council Street to Tradd Street, both the seaward section and the street-side section of sidewalk slope steeply and uniformly downward toward the street.

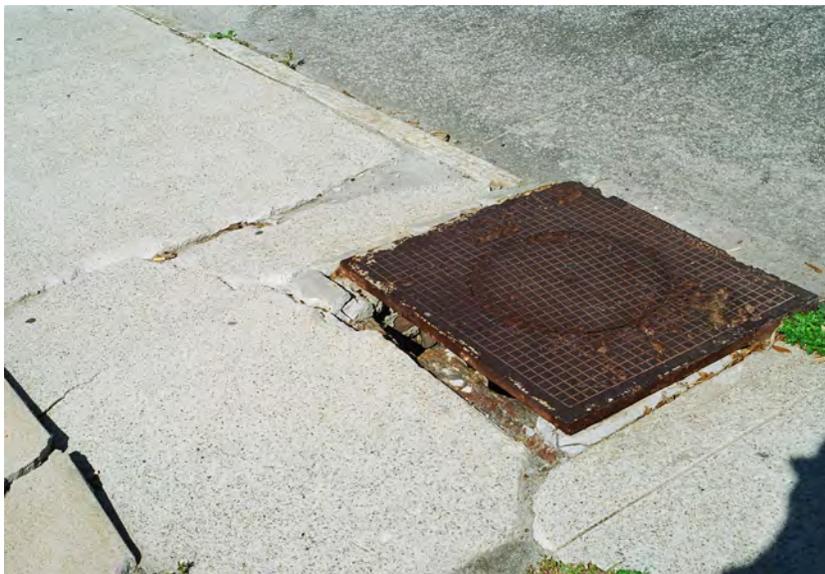
This is a view of the Low Battery sidewalk in the vicinity of Council Street. Note the condition of the sidewalk around the storm drain inlet.

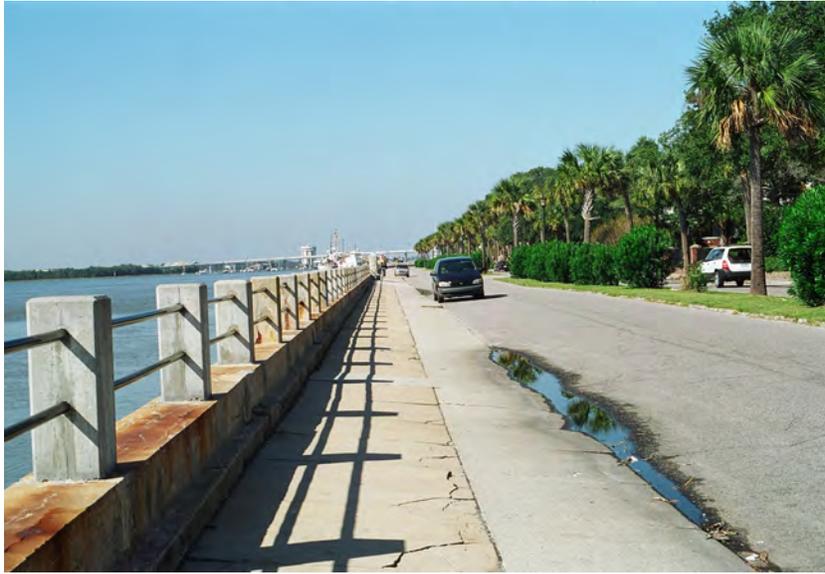
This is a view of the Low Battery in the vicinity of 68 Murray Boulevard.  
Note the seemingly perpetual puddle in this particular location.

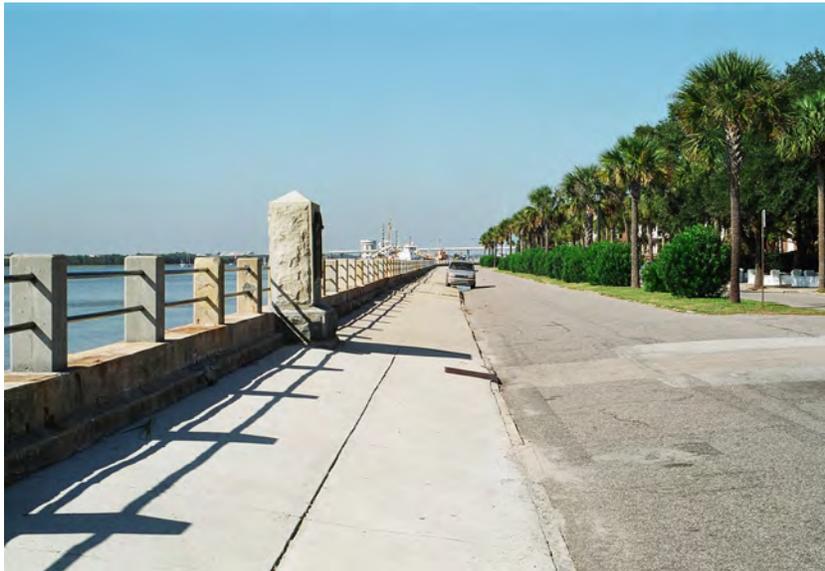
This is a view of the Low Battery in the vicinity of Rutledge Boulevard.  
Note the consistent and steep downward slope of the sidewalk to the street.  
The top of the sidewalk adjacent to the seawall is 16 inches below the top  
of the coping.

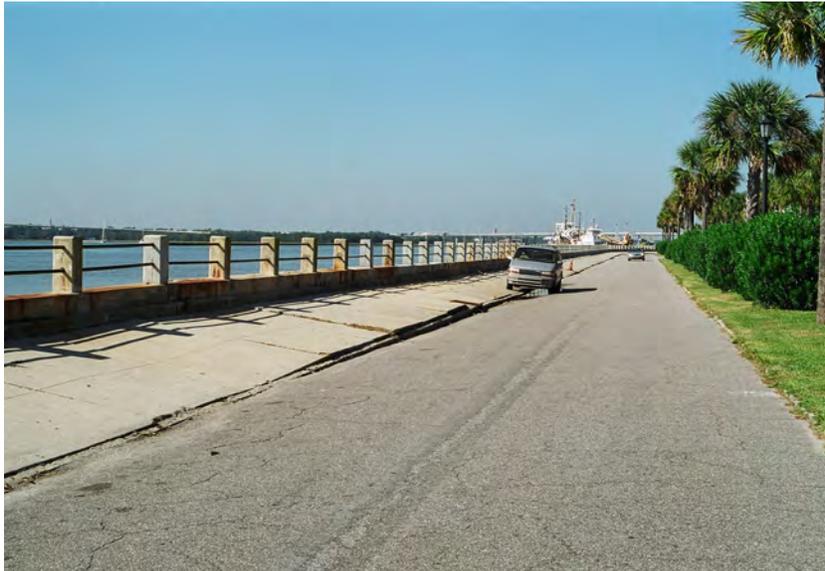
This is a view of the Low Battery seawall in the vicinity of Rutledge Boulevard. The sidewalk has a steep downward slope to the street. The section of sidewalk in front of the storm drain inlet appears to be higher than the other sections of sidewalk.

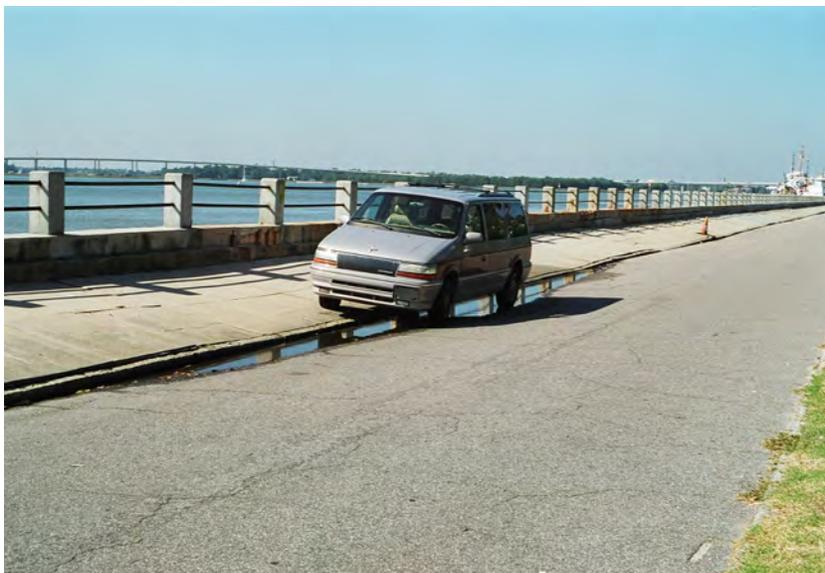
This is a view of the Low Battery in the vicinity of 78 Murray Boulevard. Note the seemingly perpetual puddle in this particular location and the relatively steep downward slope of the sidewalk toward the street.

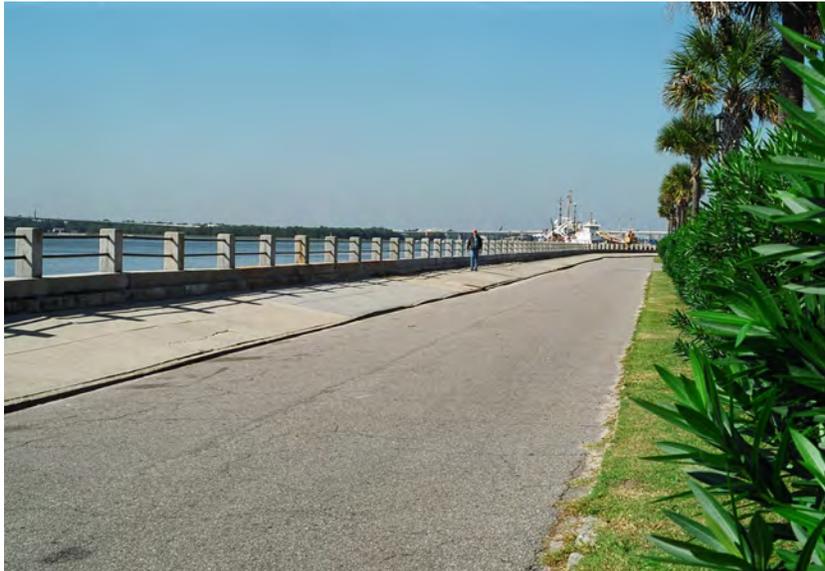
This is a view of the Low Battery seawall in the vicinity of 82 Murray Boulevard. Note the relatively steep downward slope of the sidewalk toward the street.

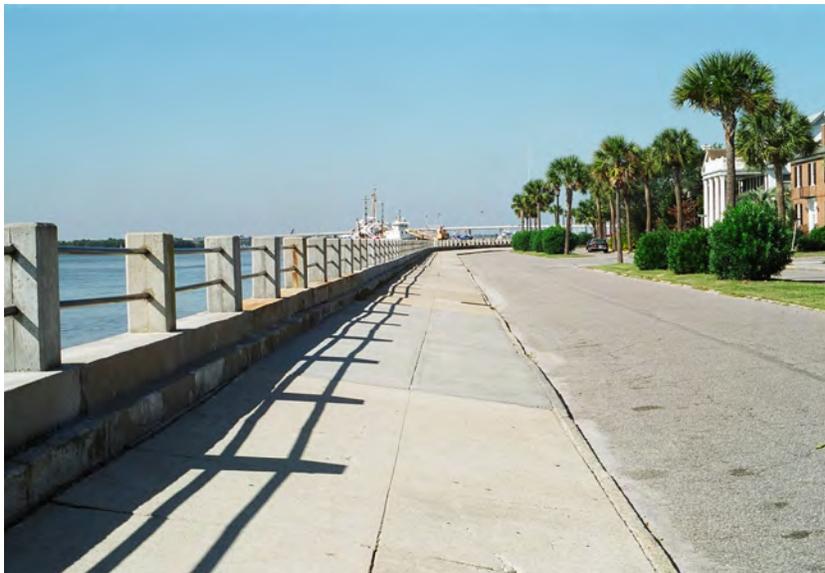
This is a view of the Low Battery in the vicinity of 82 Murray Boulevard. Note the uniform and steep downward slope of the sidewalk toward the street. The top of the sidewalk adjacent to the seawall is 18 inches below the top of the coping.

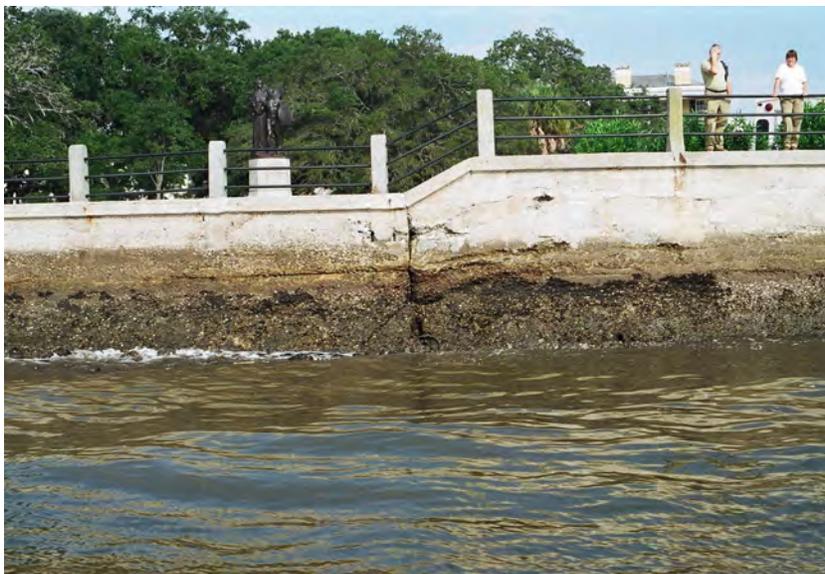
This is a view of the Low Battery seawall at the intersection with the High Battery in the vicinity White Point Garden. Note the deteriorated conditions at the vertical expansion joint where the two seawalls intersect.

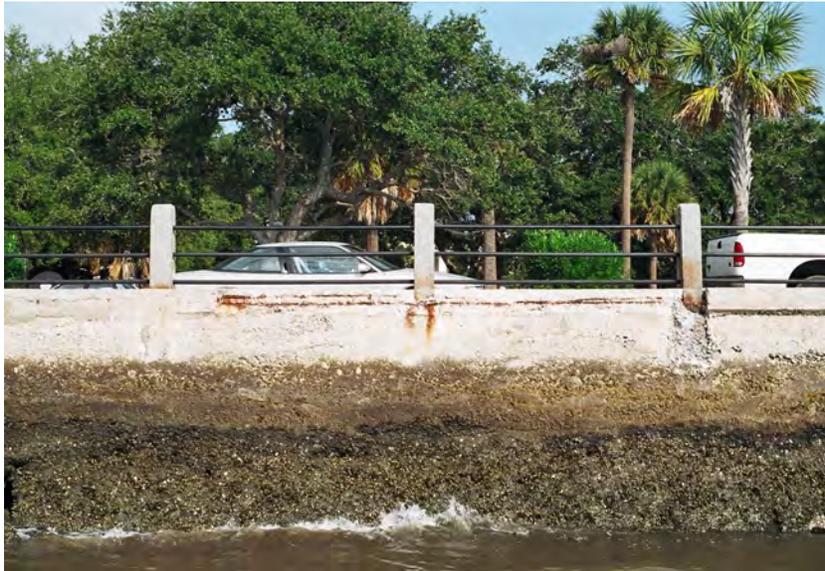
This is a view of the Low Battery seawall in the vicinity of White Point Garden. Note the general conditions of the seawall and the concrete coping below the railing pedestals. Note the spall below the railing pedestal on the right side of the photograph. Note the exposed and corroded horizontal reinforcing bars.

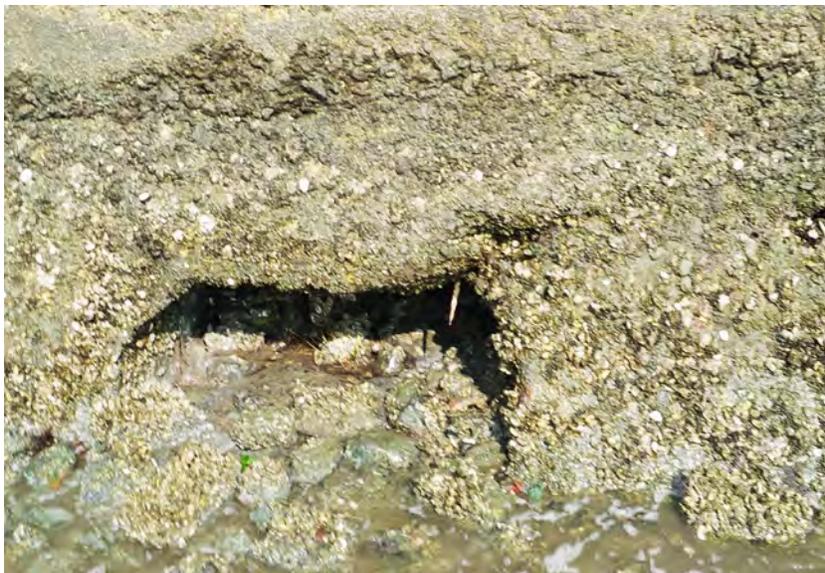
This is a view of the Low Battery seawall in the vicinity White Point Garden. It was initially believed that the hole was in the protective concrete slabs at the base of the seawall. However, subsequent detailed investigations of similarly positioned cracks indicate that the hole is positioned within the concrete mass of the pile supported seawall. Note the remains of a steel reinforcing bar in the top right side of the opening.

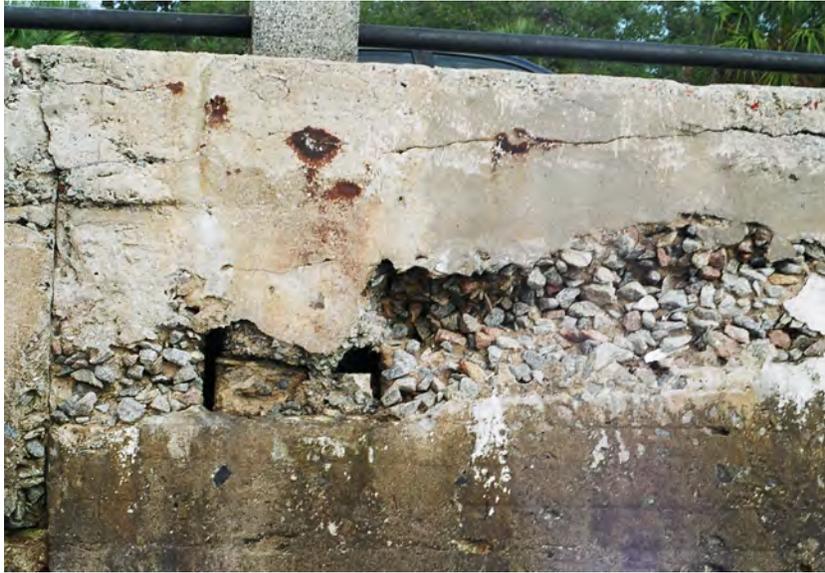
This is a view of the Low Battery seawall in the vicinity White Point Garden. Note the spall in the face of the seawall. The exposed underlying concrete appears to be composed predominately of coarse aggregate with very small amounts of fine aggregate and cement.

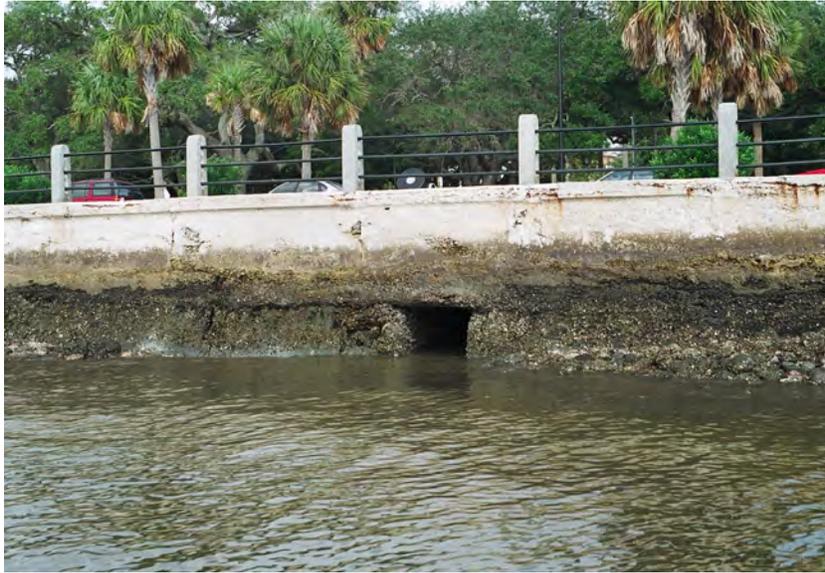
This is a view of the Low Battery seawall and an outlet in the vicinity of White Point Garden. Note the long horizontal crack extending from the top left corner of the outlet. It was initially believed that the protective concrete slabs had slipped downward from the base of the pile supported seawall and the crack was along the joint between the protective concrete slabs and the base of the pile supported seawall. However, subsequent detailed investigations of similarly positioned cracks indicate that the crack is positioned several feet above this joint and is within the concrete mass of the pile supported seawall.

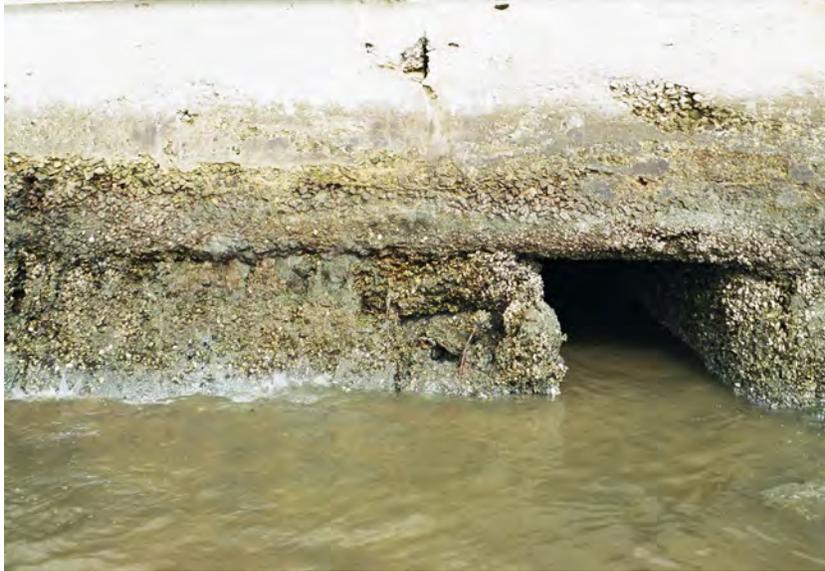
This is a view of the Low Battery seawall and an outlet in the vicinity of White Point Garden. Note the long horizontal crack extending from the top left corner of the outlet. It was initially believed that the protective concrete slabs had slipped downward from the base of the pile supported seawall and the crack was along the joint between the protective concrete slabs and the base of the pile supported seawall. However, subsequent detailed investigations of similarly positioned cracks indicate that the crack is positioned several feet above this joint and is within the concrete mass of the pile supported seawall.

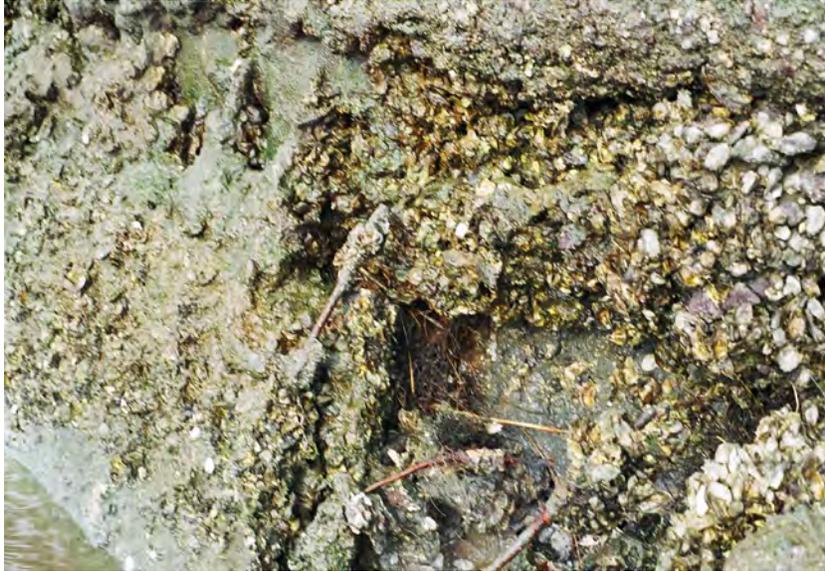
This is a close-up view of the Low Battery seawall near the outlet in the vicinity of White Point Garden. It was initially believed that the protective concrete slabs had slipped downward from the base of the pile supported seawall and the crack was along the joint between the protective concrete slabs and the base of the pile supported seawall. However, subsequent detailed investigations of similarly positioned cracks indicate that the crack is positioned several feet above this joint and is within the concrete mass of the pile supported seawall. Note the steel reinforcing bars that have become exposed.

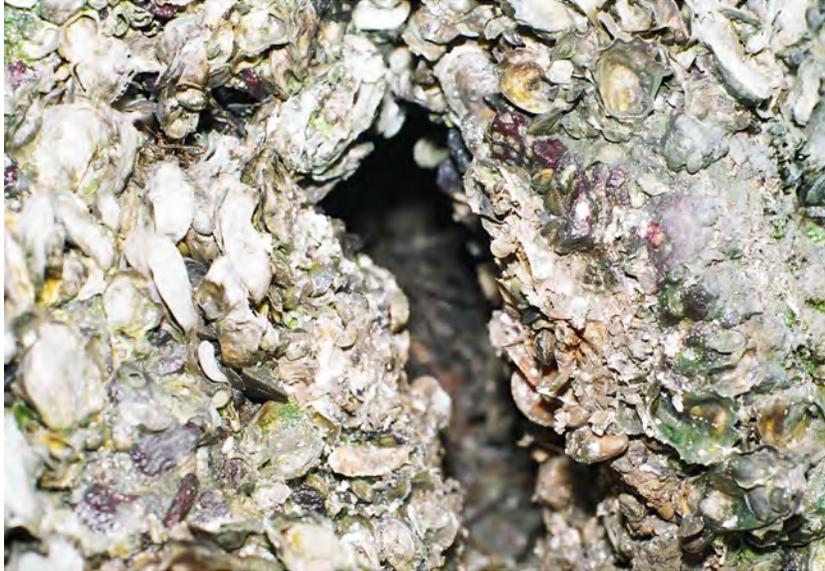
This is a close up view of the Low Battery seawall in the vicinity of White Point Gardens. It was initially believed that the hole was in the protective concrete slabs at the base of the pile supported seawall. However, subsequent detailed investigations of similarly positioned cracks indicate that the hole is positioned within the concrete mass of the pile supported seawall.

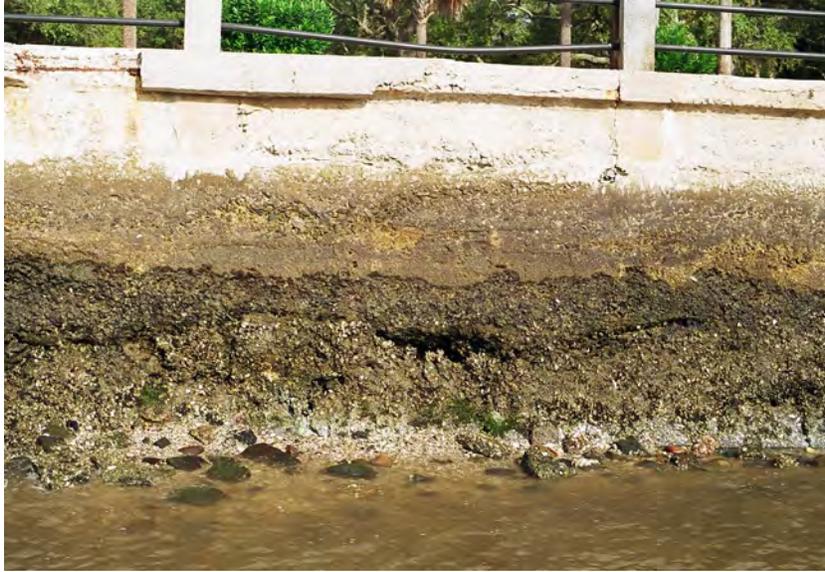
This is a view of the Low Battery seawall in the vicinity of White Point Garden. It was initially believed that the hole was in the protective concrete slabs was at the base of the pile supported seawall. However, subsequent detailed investigations of similarly positioned cracks indicate that the hole is positioned within the concrete mass of the pile supported seawall.

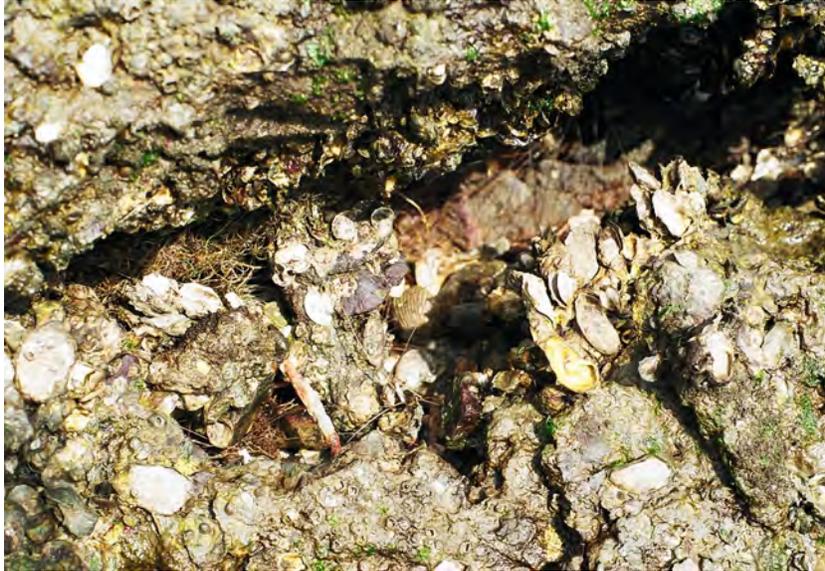
This is a view of the Low Battery seawall in the vicinity of White Point Garden. It was initially believed that the protective concrete slabs had slipped downward from the base of the pile supported seawall and the crack was along the joint between the protective concrete slabs and the base of the pile supported seawall. However, subsequent detailed investigations of similarly positioned cracks indicate that the crack is positioned several feet above this joint and is within the concrete mass of the pile supported seawall. Note the remains of steel reinforcing bars that have become exposed.

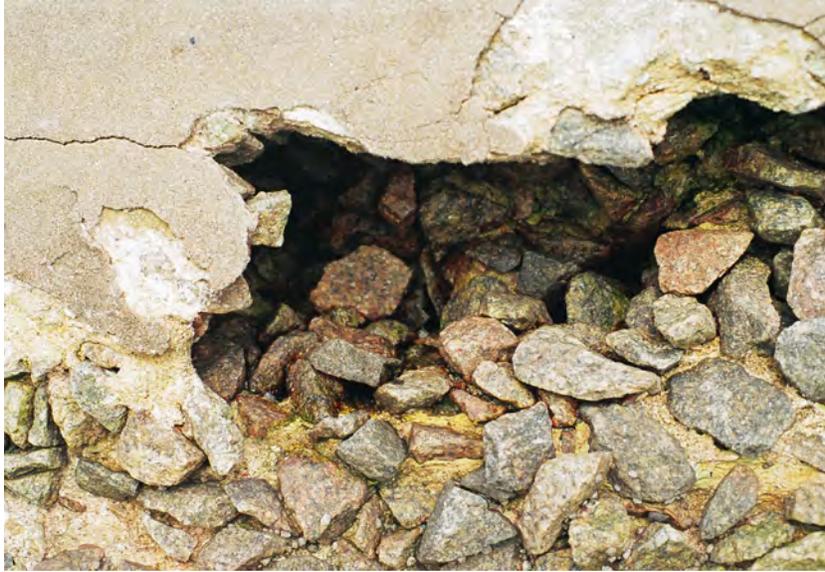
This is a view of a spall in the face the Low Battery seawall in the vicinity of White Point Garden. The exposed underlying concrete appears to be composed predominately of coarse aggregate with very small amounts of fine aggregate and cement.

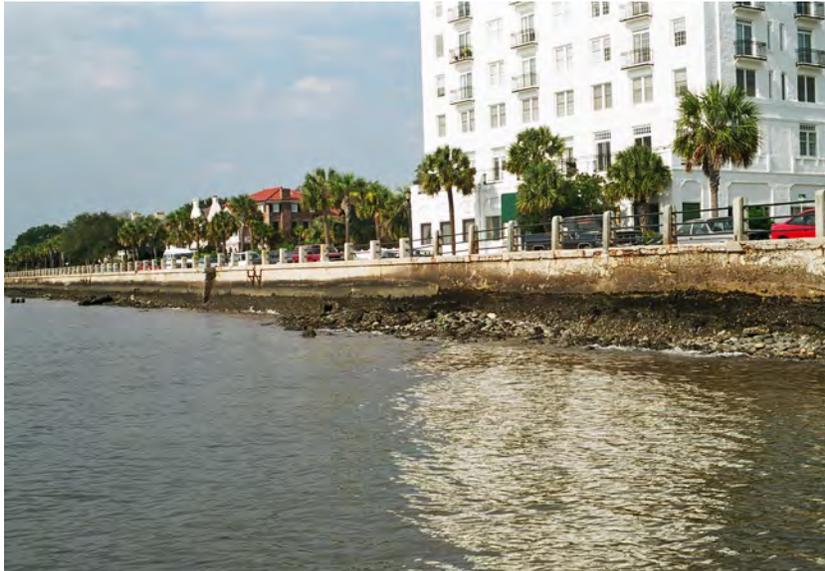
This is a view of the Low Battery seawall near the intersection with King Street. Note the deteriorated general conditions of the seawall east of King Street.

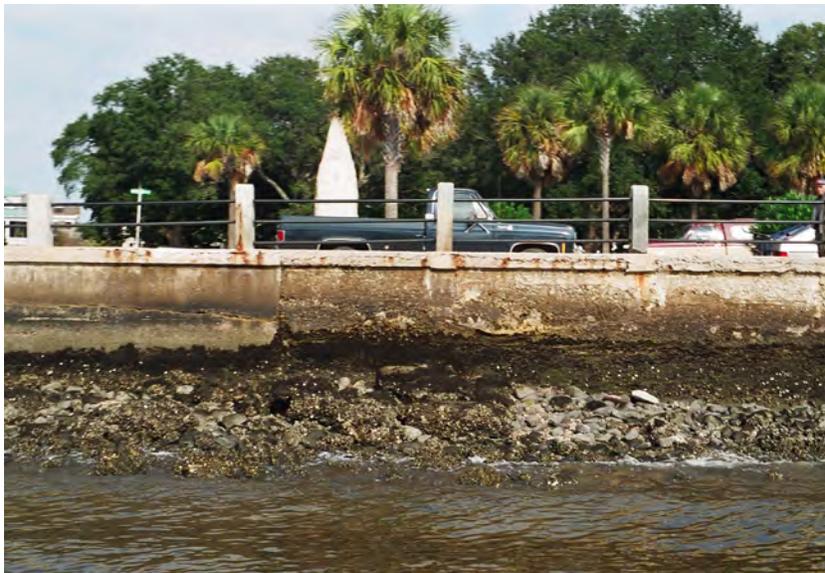
This is a view of the Low Battery seawall near the intersection with King Street. Note the deteriorated general conditions of the seawall.

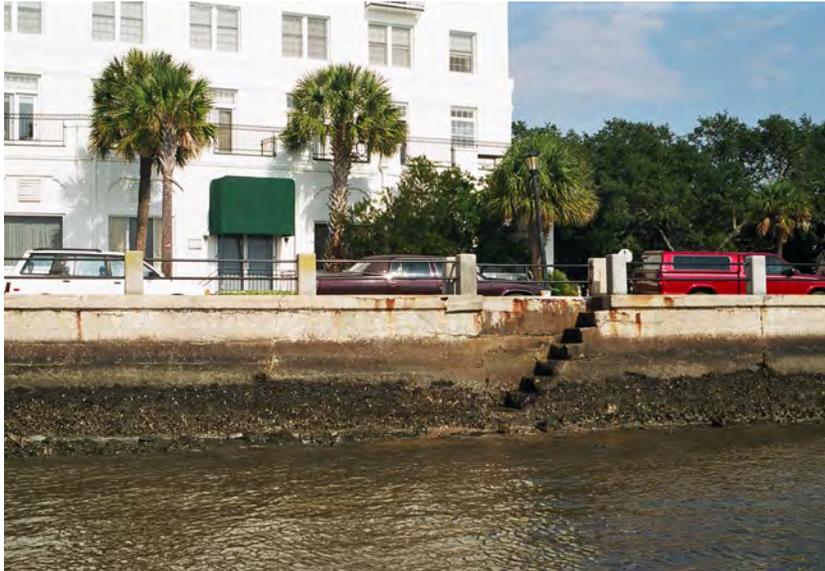
This is a view of the Low Battery seawall near the Fort Sumter House and the intersection with King Street. Note the rust streaks from corroding steel reinforcing bars and the horizontal cracks below the coping.

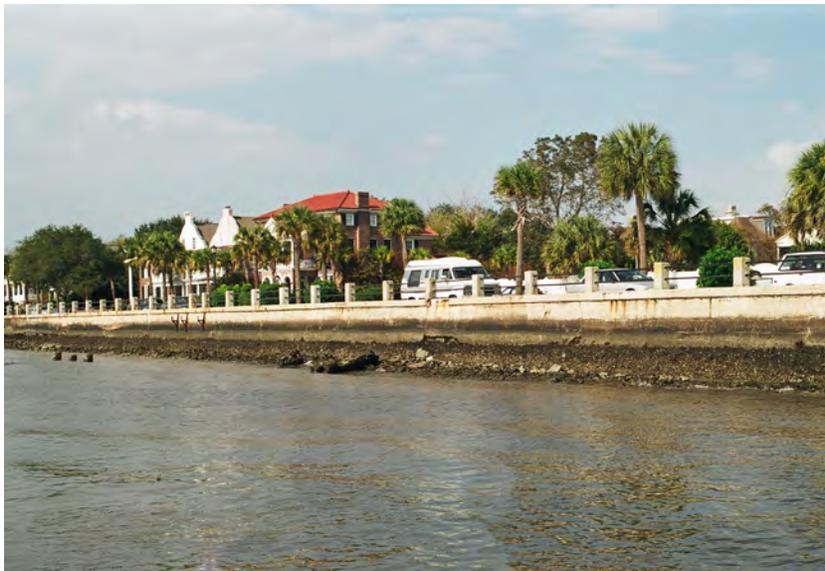
This is a view of the general conditions of the Low Battery seawall just to west of the Fort Sumter House. Note the rust streaks from corroding steel reinforcing bars below the coping.

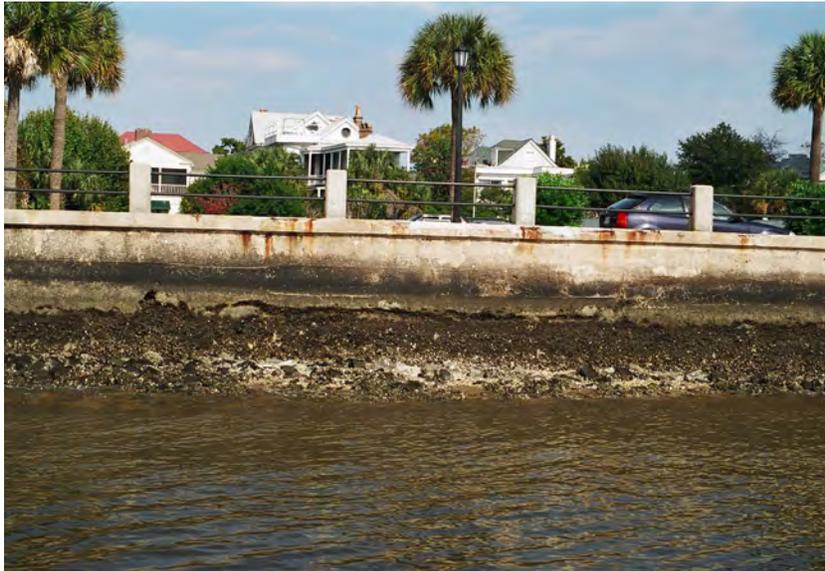
This is a view of the general conditions of the Low Battery seawall just to the west of the Fort Sumter House. Note the rust streaks from exposed and corroding steel reinforcing bars in and below the coping.

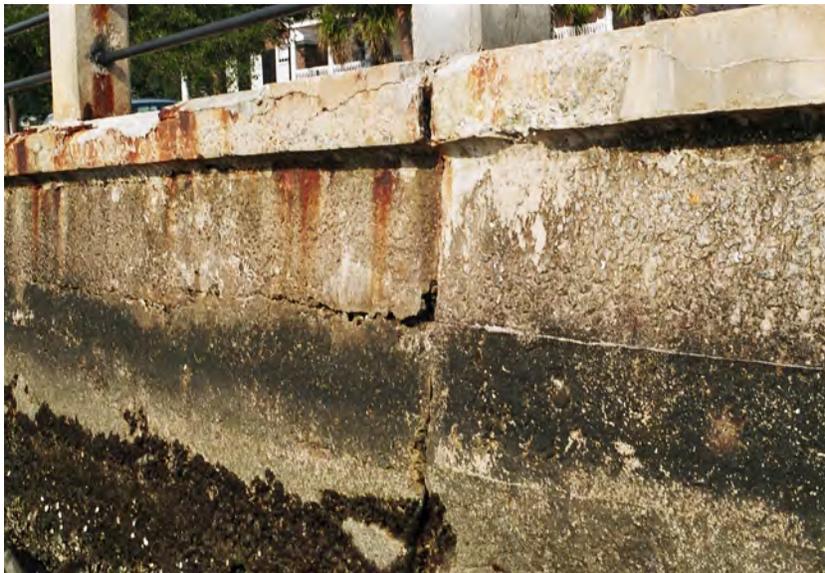
This is a close-up view of the general conditions of the Low Battery seawall just to the west of the Fort Sumter House. Note the spalls in the coping with rust streaks from exposed and corroding steel reinforcing bars. Note the face of the seawall is heavily pitted with spalls and horizontal cracks near the vertical expansion joint.

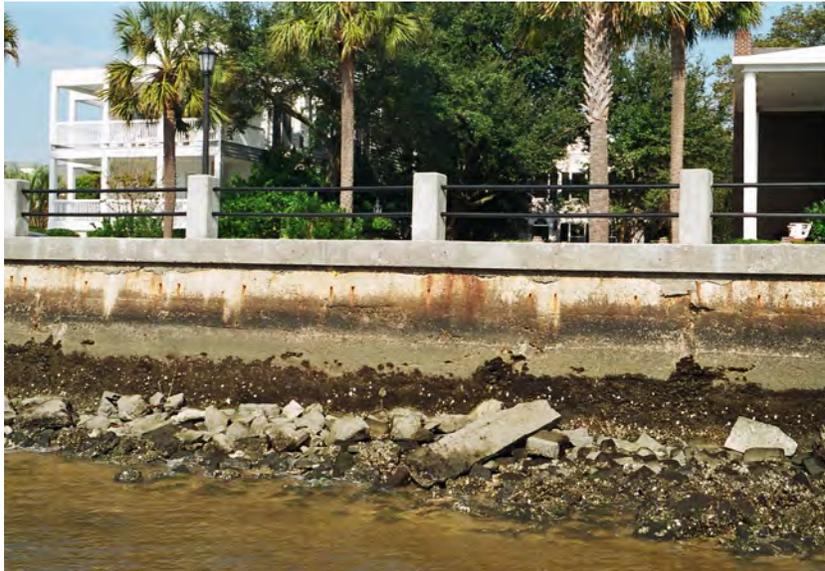
This is a view of the general conditions of the Low Battery seawall in the vicinity of 14 Murray Boulevard. Note the rebuilt concrete coping and the rust streaks from corroding steel bolts below.
