# **Appendix B**

Photographs of General Conditions  
from the “Walk-by” and “Float-by” Inspection  
of the Low Battery Seawall

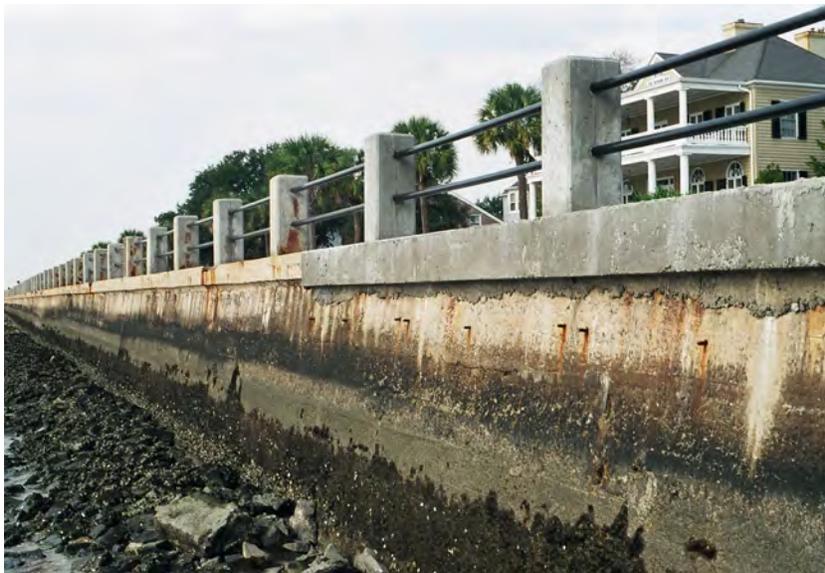
This is a close-up view of the general conditions of the Low Battery seawall in the vicinity of the 18 Murray Boulevard. Rebuilt section of concrete coping and rust streaks from corroding steel bolts.

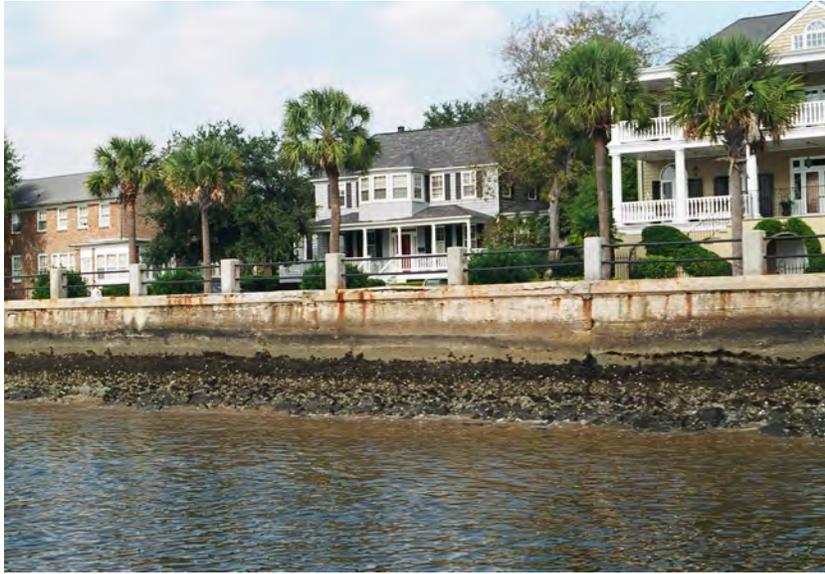
This is a view of the general conditions of the Low Battery seawall in the vicinity of the 20 Murray Boulevard. Note the rust streaks from exposed and corroding steel reinforcing bars in the coping and below the coping. Also note the horizontal crack in the face of the seawall just above the shore line on the right side of the photograph.

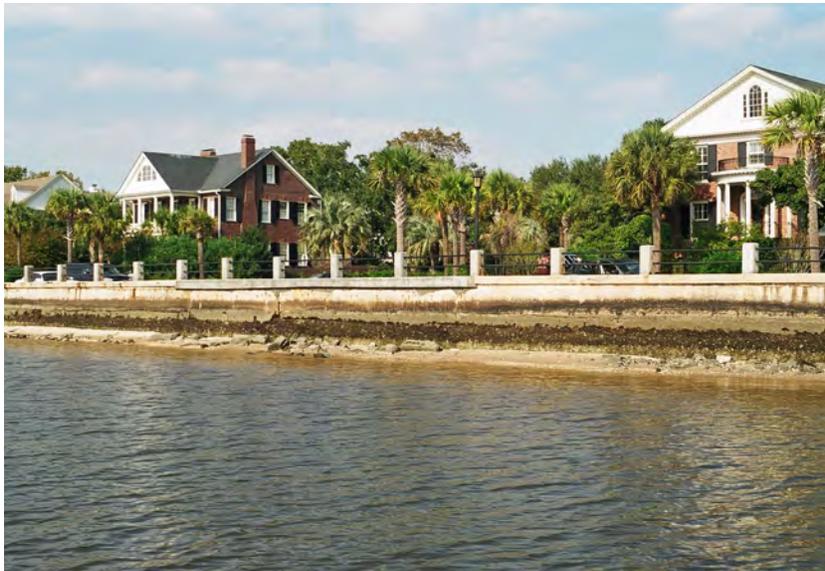
This is a view of the general conditions of the Low Battery seawall in the vicinity of the 28 Murray Boulevard. Note the rebuilt section of concrete coping in the center of the photograph. Note the rust streaks from exposed and corroding steel reinforcing bars in the coping on the left side of the photograph. Also note the horizontal crack in the face of the seawall just above the shore line from the left side to the middle of the photograph.

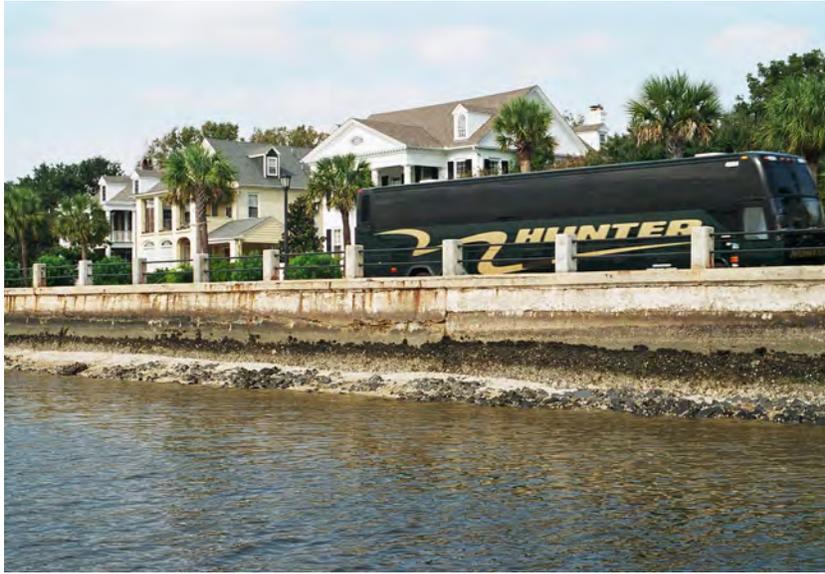
This is a view of the general conditions of the Low Battery seawall in the vicinity of the 32 Murray Boulevard. Note the rust streaks from exposed and corroding steel reinforcing bars in the coping on the left side of the photograph. Note the horizontal crack in the face of the seawall just above the shore line from the left side to the middle of the photograph.

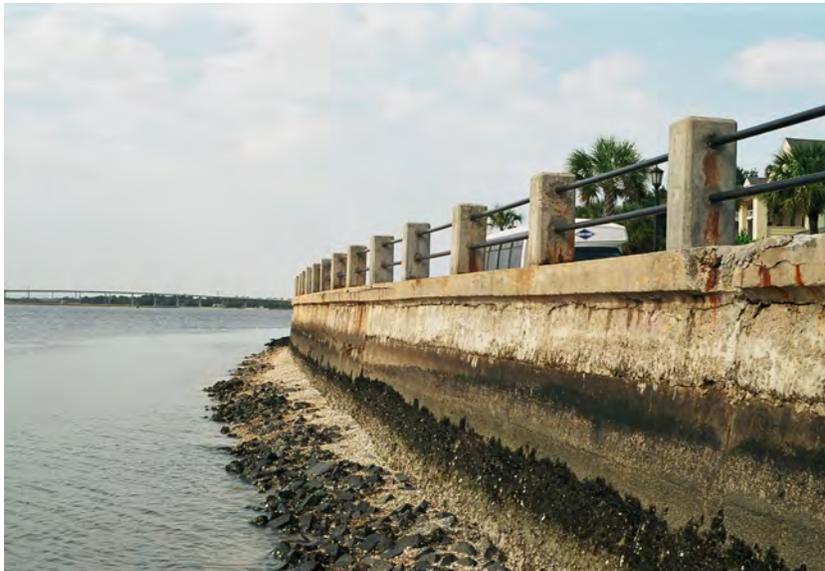
This is a view of general conditions of the curve in the Low Battery seawall in the vicinity of the 36 Murray Boulevard. Note the rust streaks from exposed and corroding steel reinforcing bars in the coping and the horizontal cracks below the coping.

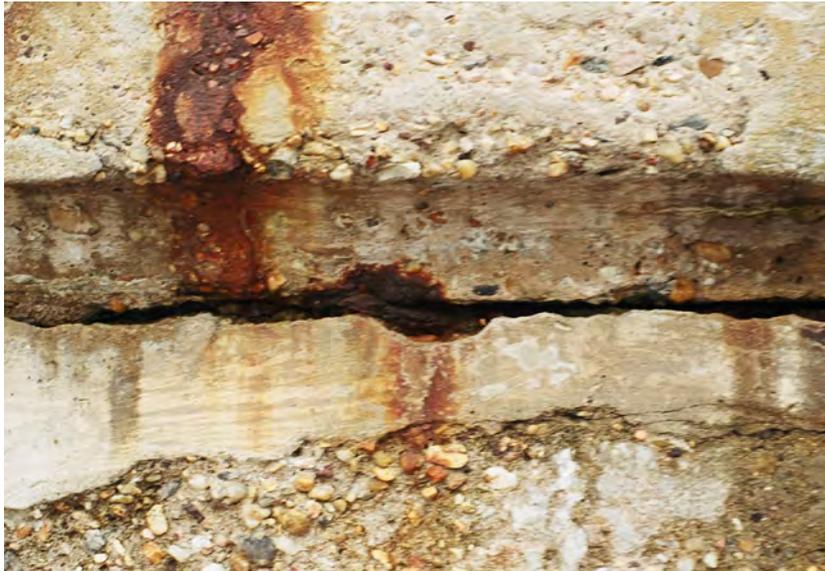
This is a close-up of the Low Battery seawall in the vicinity of 36 Murray Boulevard. Note the wide horizontal crack below the coping with exposed and corroding steel reinforcing bars.

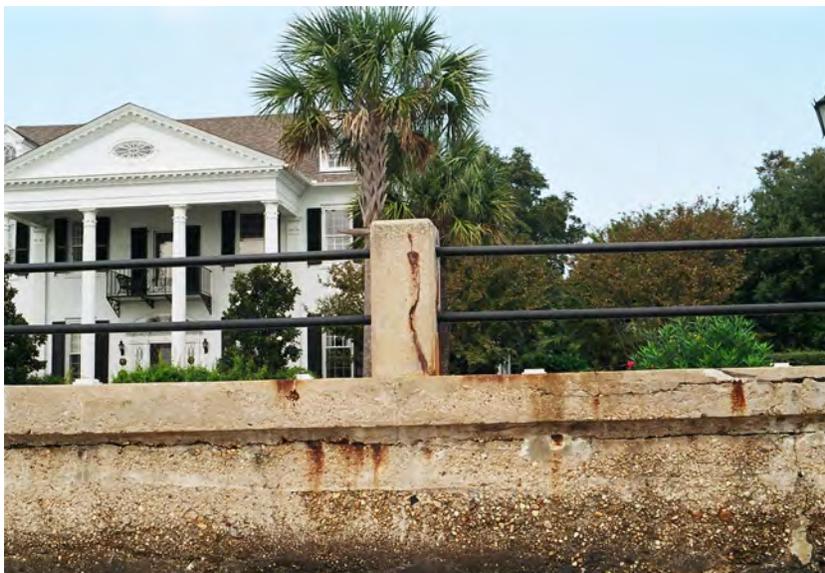
This is a view of the Low Battery seawall in the vicinity of the 36 Murray Boulevard. Note the rust streaks from corroding steel reinforcing bars and the horizontal cracks in the coping and below the coping. Also note the crack with a rust streak on the railing pedestal.

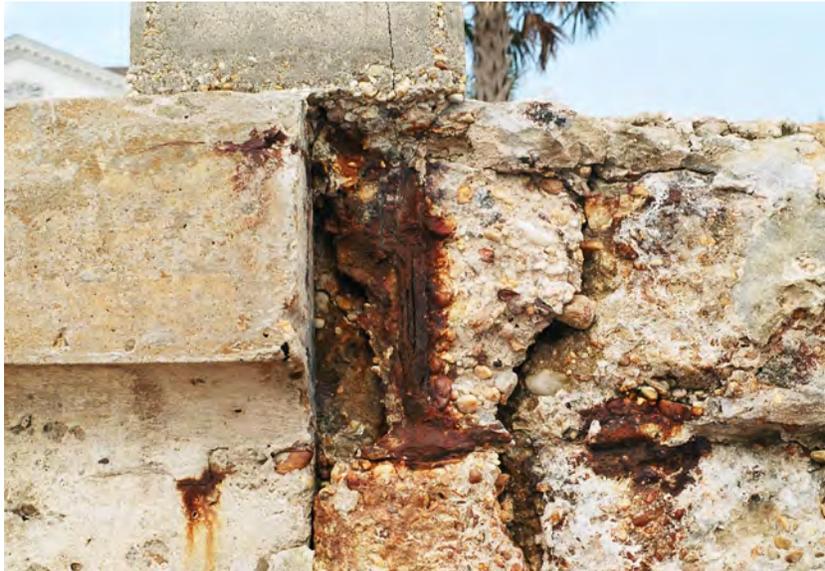
This is a view of the Low Battery seawall in the vicinity of 38 Murray Boulevard. Note the spall with exposed and corroded steel reinforcing bars at the base of a railing pedestal.

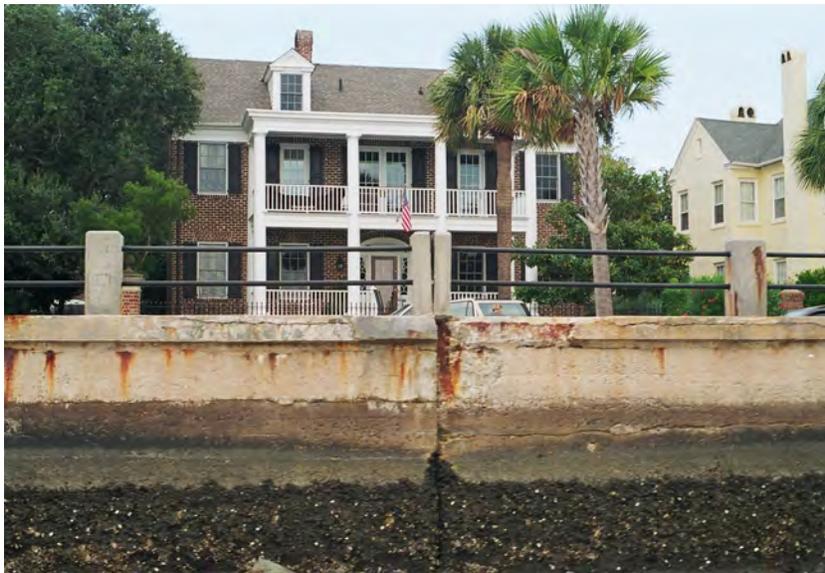
This is a view of the general conditions of the Low Battery seawall in the vicinity of 40 Murray Boulevard. Note the split railing pedestal above a vertical expansion joint in the seawall. Note the severe spalling at the expansion joint. Also note the rust streaks from corroding steel reinforcing bars and the horizontal cracks in the coping and in the seawall below the coping.

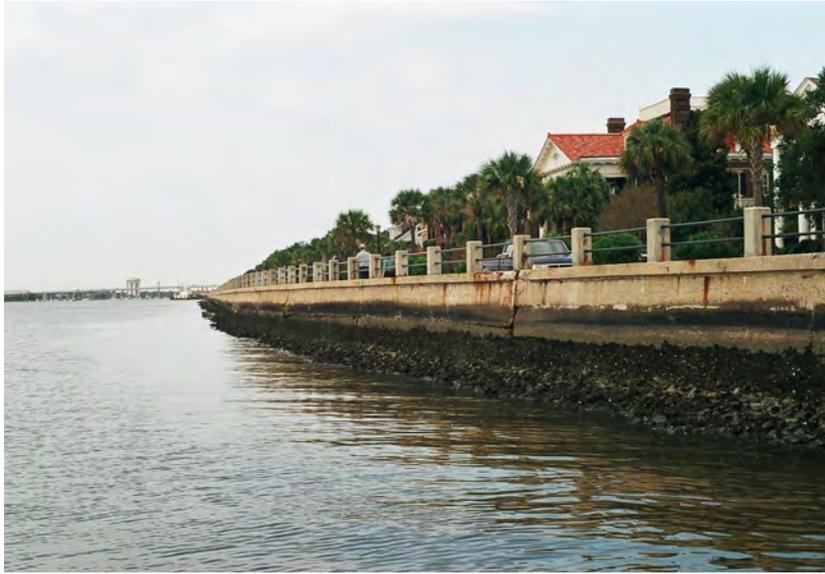
This is a view of the general conditions of the Low Battery seawall in the vicinity of 46 Murray Boulevard. Note the rust streaks from corroding steel reinforcing bars in the coping. Note the horizontal crack in the face of the seawall just above the shore line from left side to the middle of the photograph.

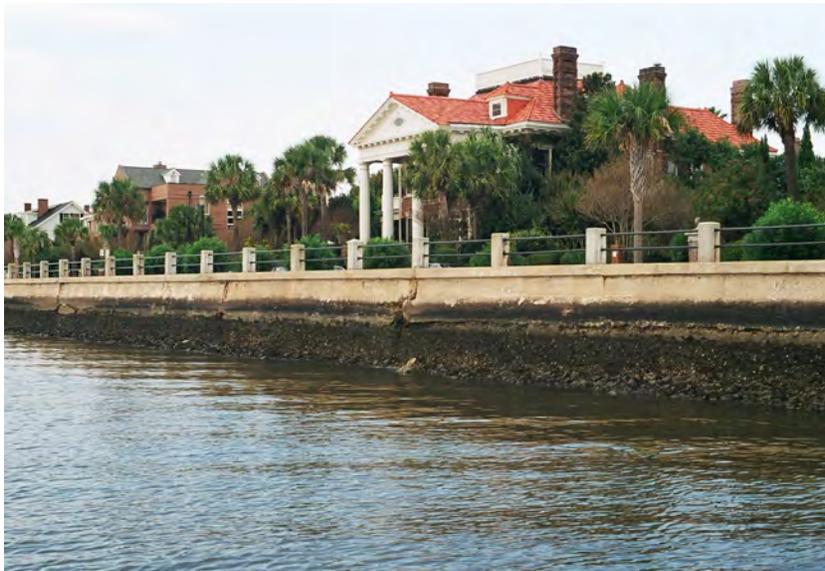
This is a view of the general conditions of the Low Battery seawall in the vicinity of 48 Murray Boulevard. Note the horizontal crack in the face of the seawall just above the shore line from the left side to the middle of the photograph.

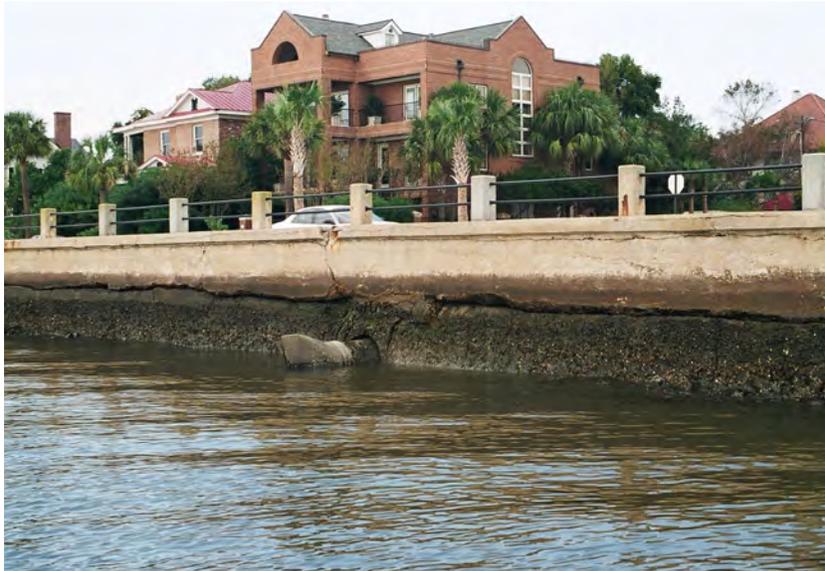
This is a view of the general conditions of the Low Battery seawall in the vicinity of 58 Murray Boulevard near intersection with Limehouse Street. Note the horizontal crack in the face of the seawall just above the shore line extends the entire width of the photograph.

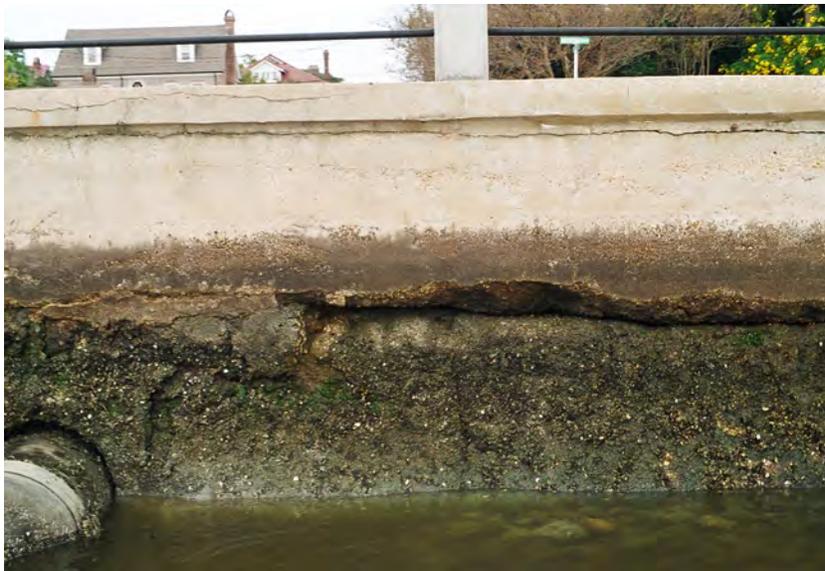
This is a view of the general conditions of the Low Battery seawall in the vicinity of 58 Murray Boulevard near intersection with Limehouse Street. Note the horizontal crack in the face of the seawall just above the shore line and the outlet extends the entire width of the photograph. Also note the horizontal cracks just below the coping and on the coping on the left side of the photograph.

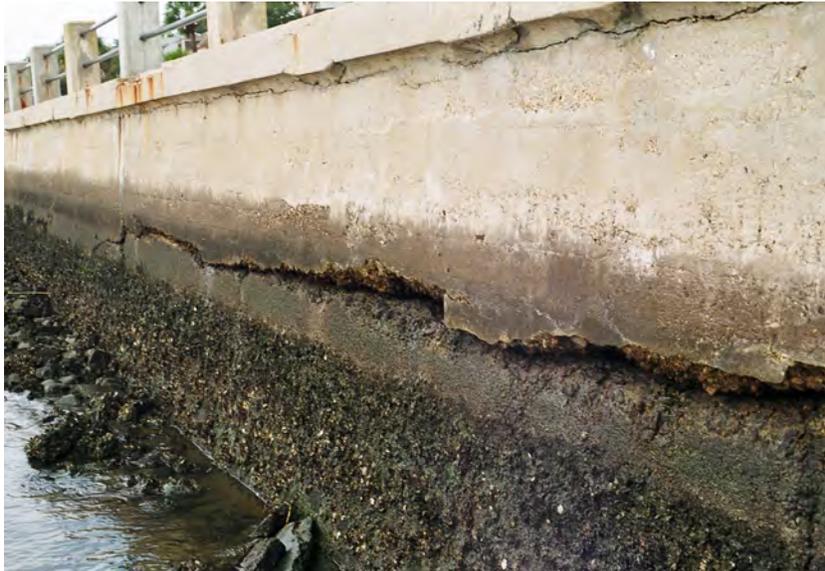
This is a view of the general conditions of the Low Battery seawall in the vicinity of 58 Murray Boulevard. Note the very wide horizontal crack in the face of the seawall just above the shore line. Note the horizontal cracks just below the coping.

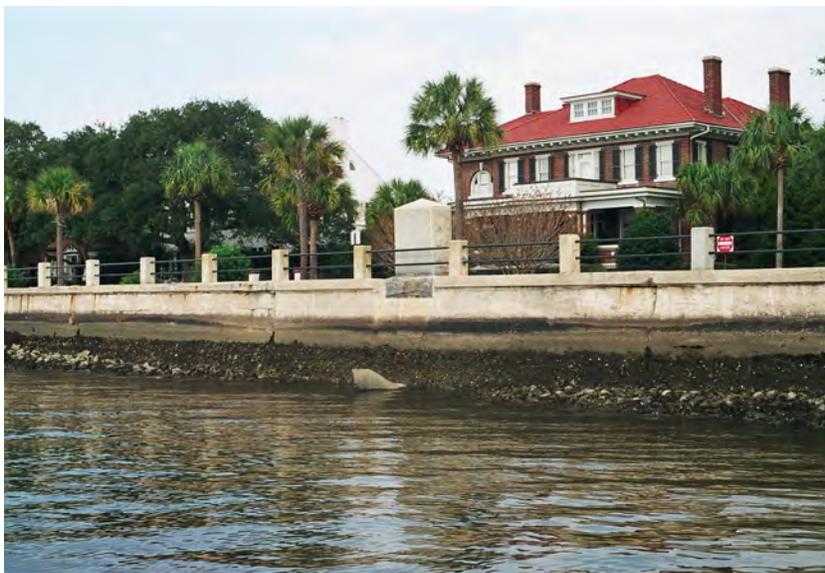
This is a view of the general conditions of the Low Battery seawall in the vicinity of 76 Murray Boulevard. Note the horizontal cracks just below the coping extend the width of the photograph.

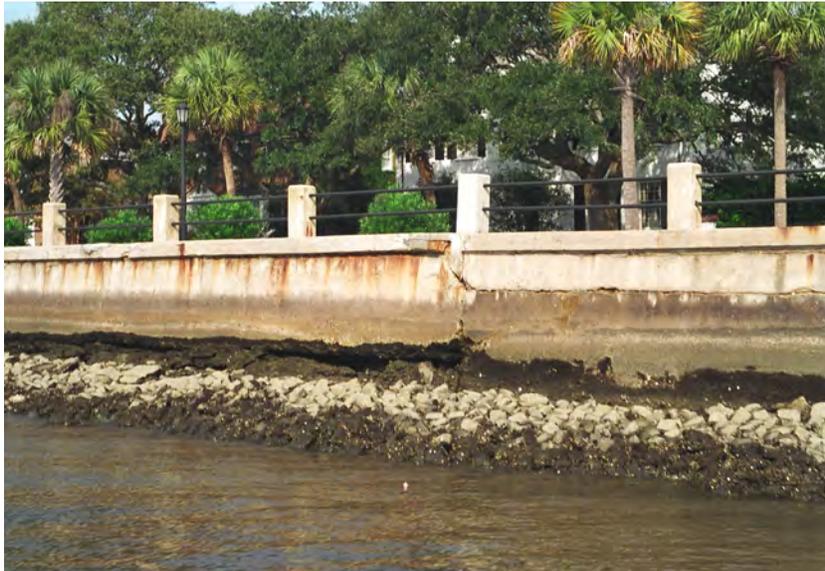
This is a view of the general conditions of the Low Battery seawall in the vicinity of 80 Murray Boulevard. Note the horizontal cracks just below the coping extend the entire width of the photograph. Also, note the horizontal crack approximately one foot below the coping on the right side of the photograph.

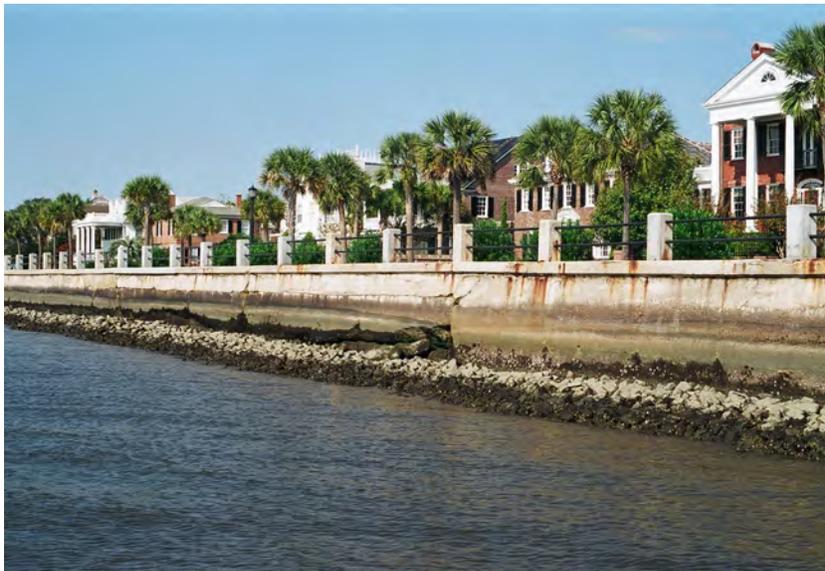
This is a view of the general conditions of the Low Battery seawall in the vicinity of 86 Murray Boulevard. Note the horizontal cracks just below the coping extend the entire width of the photograph. Note the severe conditions in face of seawall on the left side of the photograph. Also, note the condition of the vertical expansion joint in the center of the photograph.

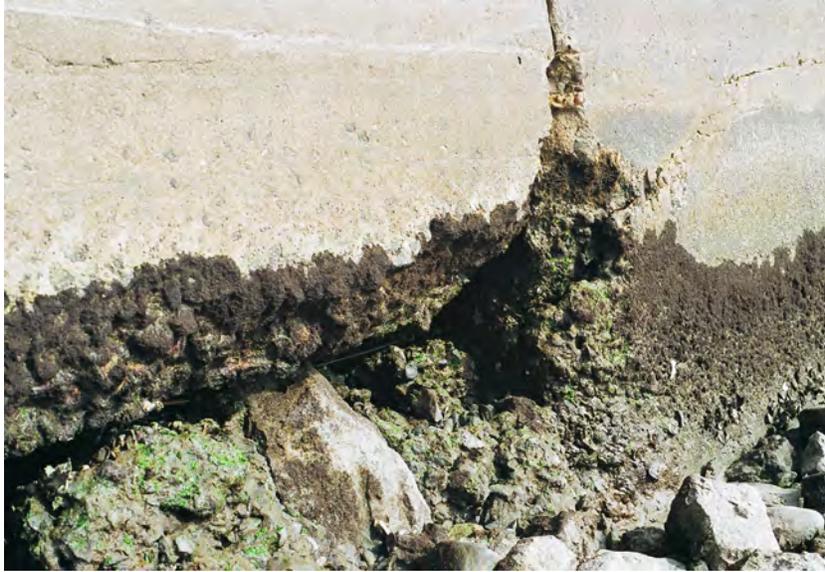
This is a close-up view of the Low Battery seawall in the vicinity of 86 Murray Boulevard. These are the conditions of the seawall to the west of the vertical expansion joint. It was initially believed that the protective concrete slabs had slipped downward from the base of the pile supported seawall and the crack was along the joint between the protective concrete slabs and the base of the pile supported seawall. However, subsequent detailed investigations of similarly positioned cracks indicate that the crack is positioned several feet above this joint and is within the concrete mass of the pile supported seawall.

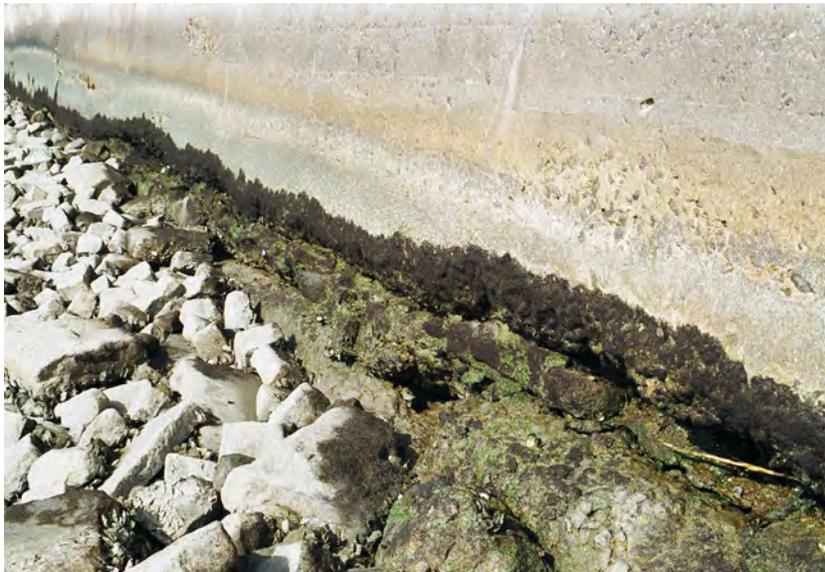
This is a view along the base of the Low Battery seawall in the vicinity of 86 Murray Boulevard. These are the conditions of the seawall to the west of the vertical expansion joint. It was initially believed that the protective concrete slabs had slipped downward from the base of the pile supported seawall and the crack was along the joint between the protective concrete slabs and the base of the pile supported seawall. However, subsequent detailed investigations of similarly positioned cracks indicate that the crack is positioned several feet above this joint and is within the concrete mass of the pile supported seawall.

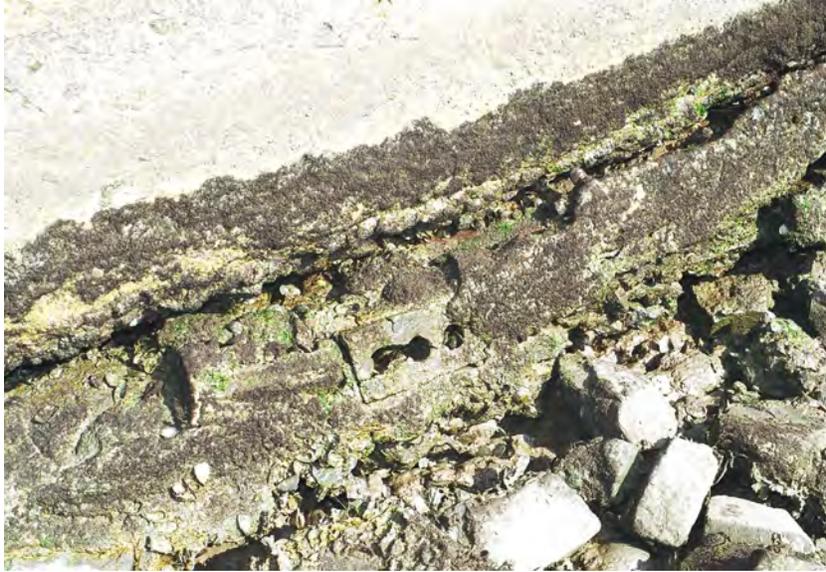
This is a view of the base of the Low Battery seawall in the vicinity of 86 Murray Boulevard. It was initially believed that the protective concrete slabs had slipped downward from the base of the pile supported seawall and the crack was along the joint between the protective concrete slabs and the base of the pile supported seawall. However, subsequent detailed investigations of similarly positioned cracks indicate that the crack is positioned several feet above this joint and is within the concrete mass of the pile supported seawall.

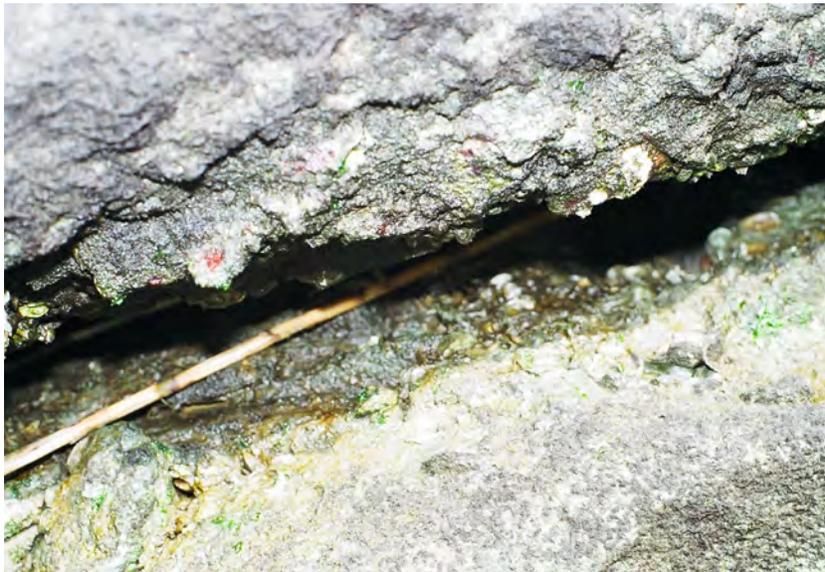
This is a close-up view at the base of the Low Battery seawall in the vicinity of 86 Murray Boulevard. It was initially believed that the protective concrete slabs had slipped downward from the base of the pile supported seawall and the crack was along the joint between the protective concrete slabs and the base of the pile supported seawall. However, subsequent detailed investigations of similarly positioned cracks indicate that the crack is positioned several feet above this joint and is within the concrete mass of the pile supported seawall.

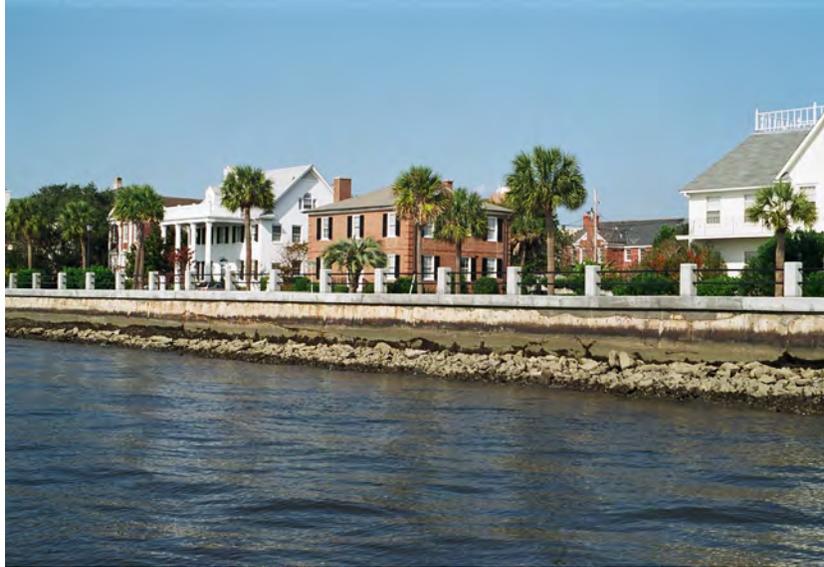
This is a view of the general conditions of the Low Battery seawall in the vicinity of 94 Murray Boulevard. Note the horizontal cracks just below the coping extend for the entire width of the photograph. Note the severe cracks in face of seawall extend for entire width of the photograph. Also, note the sections of rebuilt coping with the corroded steel bolts projecting outward below the coping.

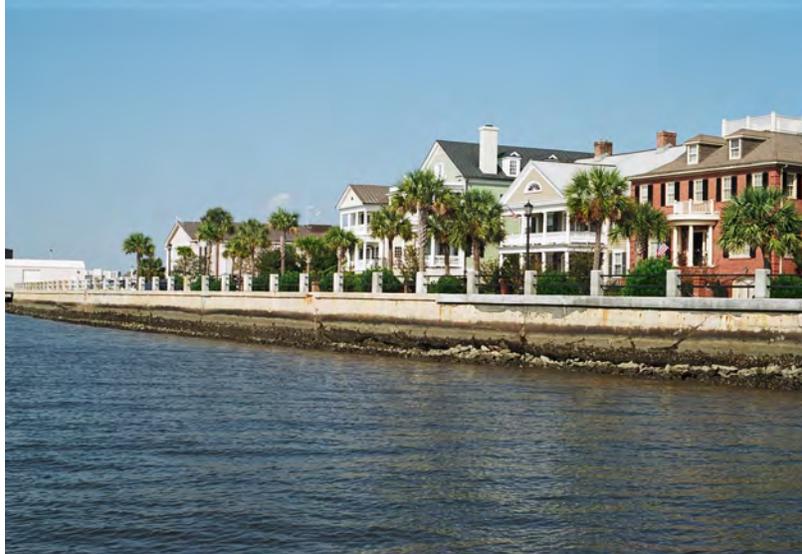
This is a view of the general conditions of the Low Battery seawall in the vicinity of 100 Murray Boulevard. Note the severe cracks in face of seawall on the right side of the photograph. Note the sections of rebuilt coping with the corroded steel bolts projecting outward below the coping on the right side of the photograph.

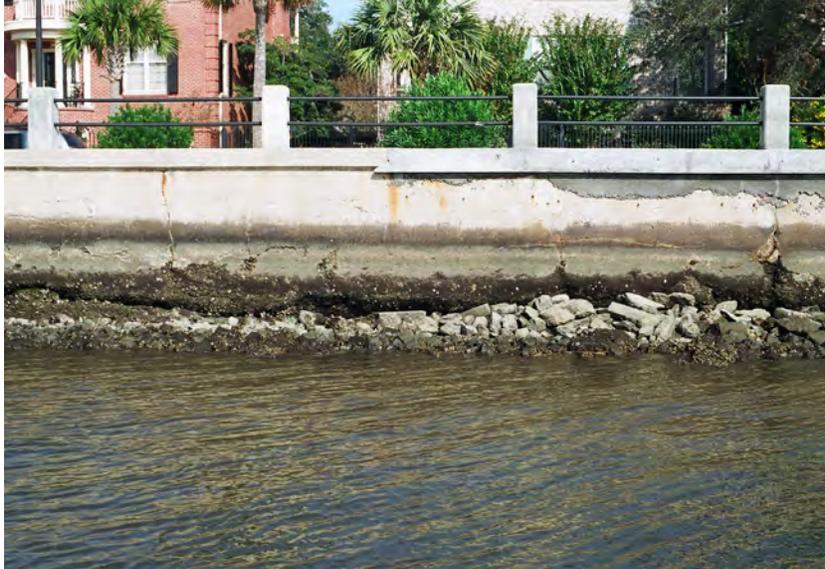
This is a view of the general conditions of the Low Battery seawall in the vicinity of 100 Murray Boulevard. It was initially believed that the protective concrete slabs had slipped downward from the base of the pile supported seawall and the crack was along the joint between the protective concrete slabs and the base of the pile supported seawall. However, subsequent detailed investigations of similarly positioned cracks indicate that the crack is positioned several feet above this joint and is within the concrete mass of the pile supported seawall.

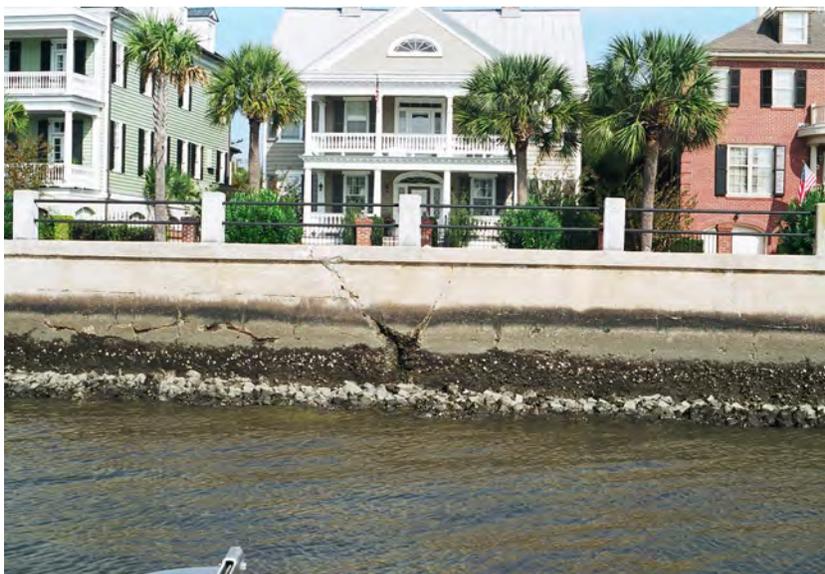
This is a view of the general conditions of the Low Battery seawall in the vicinity of 104 Murray Boulevard. Note the severe cracks in face of seawall on the left side of the photograph.

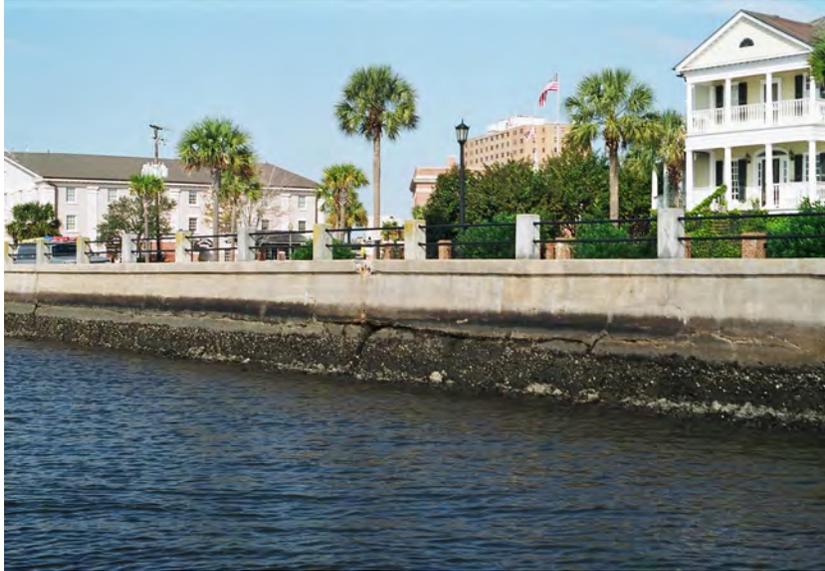
This is a view of the general conditions of the Low Battery seawall in the vicinity of 108 Murray Boulevard. It was initially believed that the protective concrete slabs had slipped downward from the base of the pile supported seawall and the crack was along the joint between the protective concrete slabs and the base of the pile supported seawall. However, subsequent detailed investigations of similarly positioned cracks indicate that the crack is positioned several feet above this joint and is within the concrete mass of the pile supported seawall.

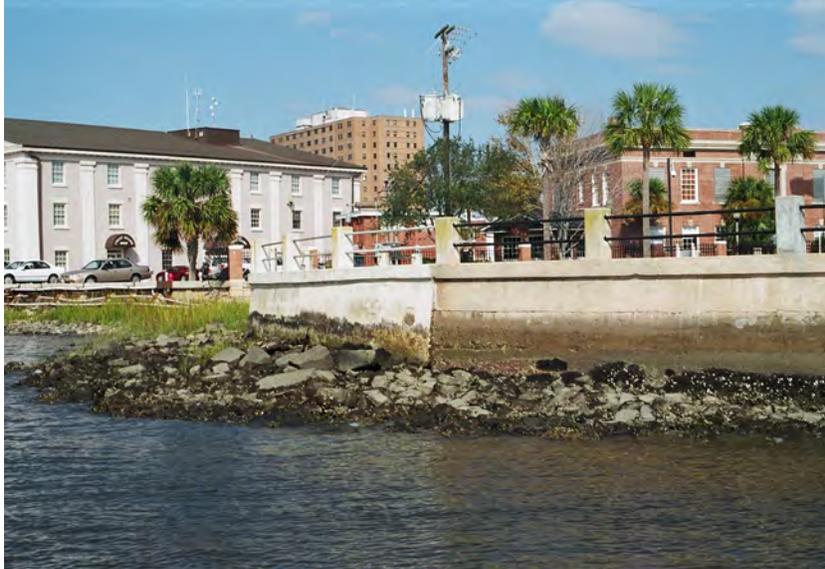
This is a view of the general conditions of the Low Battery seawall in the vicinity of Tradd Street and the Coast Guard Base. Note the horizontal crack approximately two feet below the coping extends the width of the photograph.

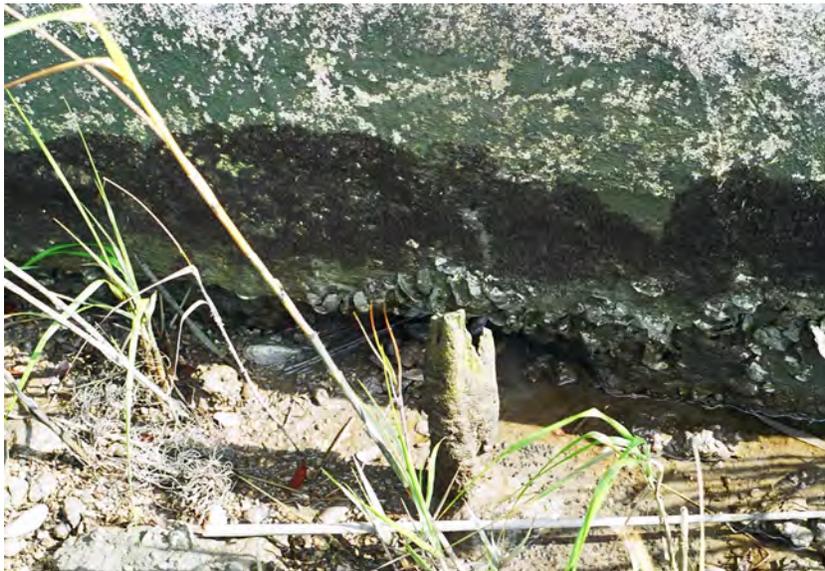
This is a close-up view of the Low Battery seawall in the vicinity of Tradd Street and the Coast Guard Base. This section of the seawall appears to have been more recently constructed than the remainder of the Low Battery seawall.
