Charleston Seawall Repairs: The Low battery Seawall Rehabilitation Project

Appendix C

Lower Battery Seawall Replacement
City of Charleston
Charleston SC
PROJECT NO. 15619015

Test Pit Observation

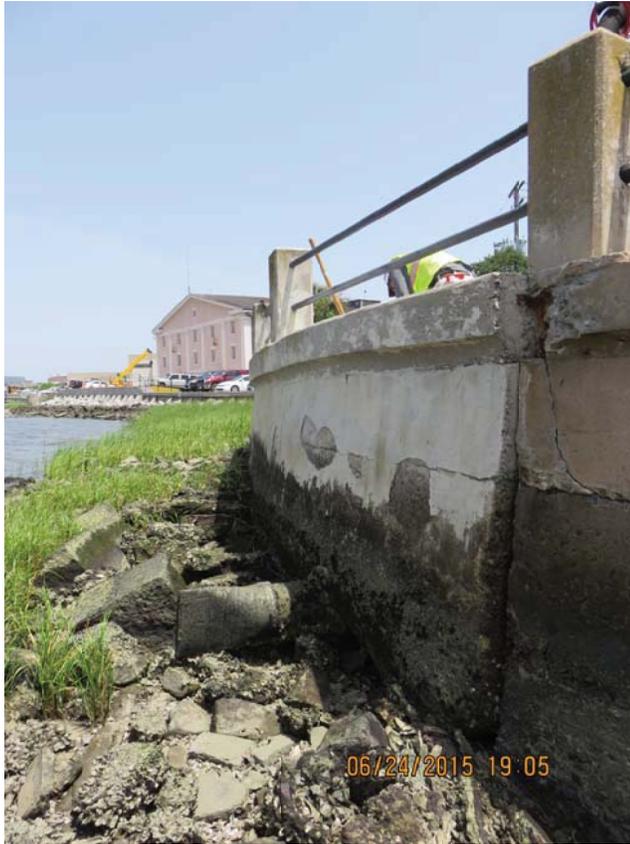
PHOTOGRAPH: 1

Face of Seawall at location near Sta. 1+00 (TP-1)

Note different concrete color, potentially indicating different construction period, or a recent repair. Joint is displaced about 2 inches. Wall is curved in this area.

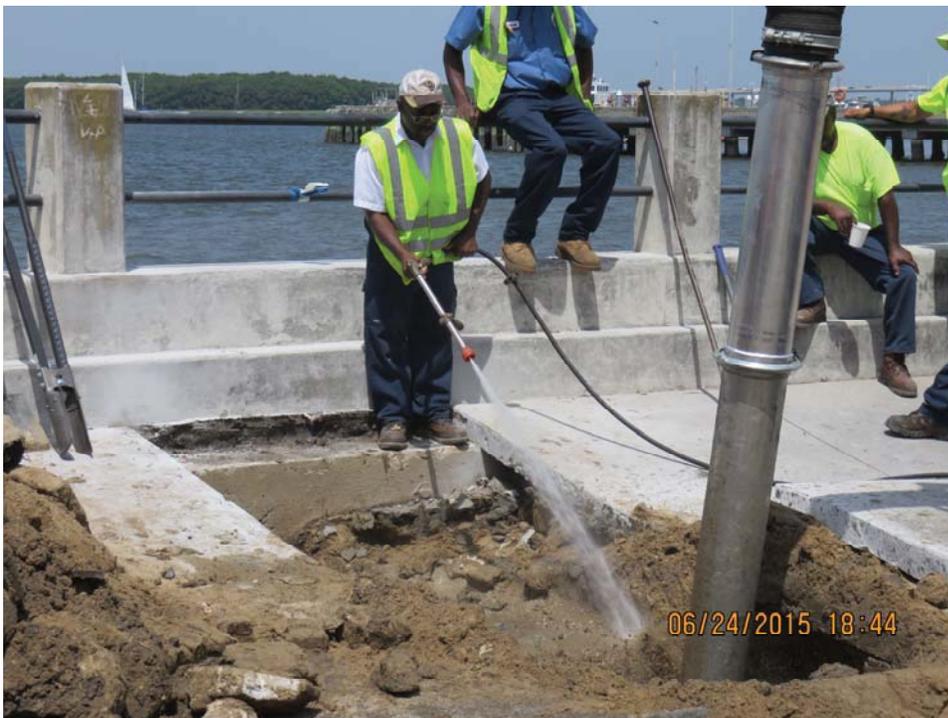
PHOTOGRAPH: 2

Approx. Sta. 0+91 (TP-1)

Excavation of TP-1. The exposed seawall did not match the existing drawings geometry.

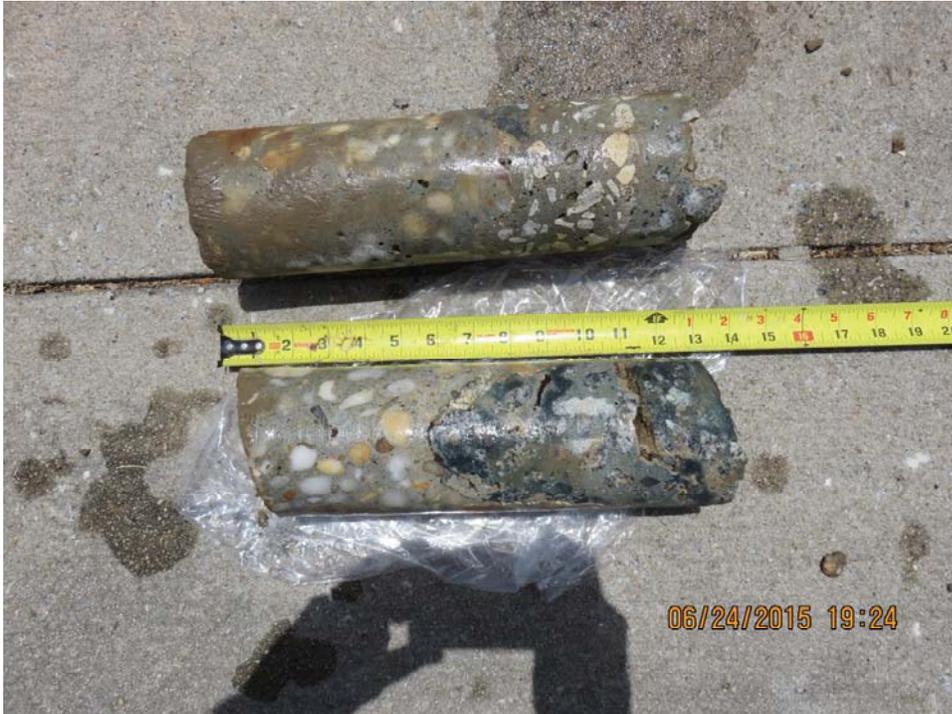
PHOTOGRAPH: 3

Approx. Sta. 0+91 (TP-1)

Core taken from a 12-inch reinforced slab on grade floating on top of the seawall with no apparent connection or purpose.

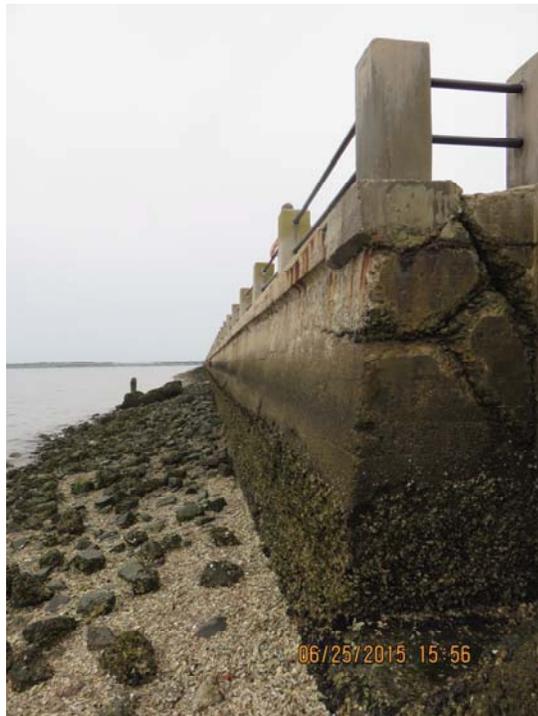
PHOTOGRAPH: 4

Face of seawall looking west near the steps

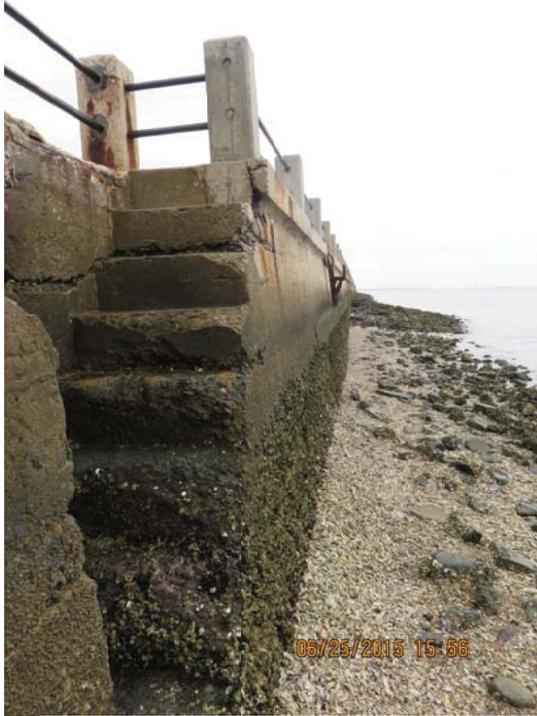
PHOTOGRAPH: 5

Face of seawall looking east near the steps

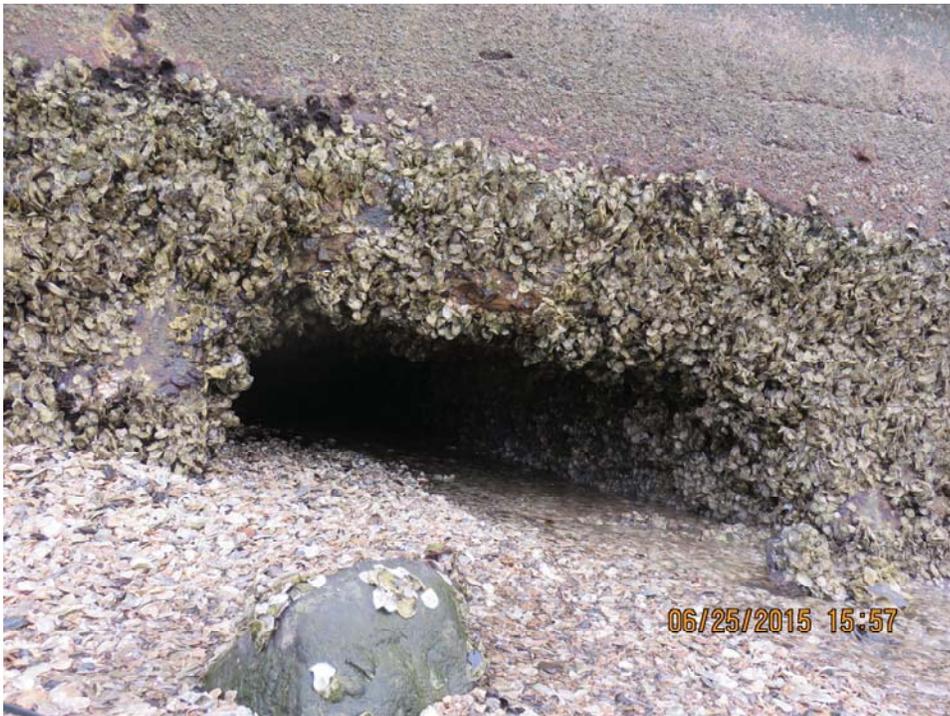
PHOTOGRAPH: 6

Rectangular drain at the face of the seawall near the steps

Drain section appears to be half full with sediments and shells. The geometry of this drain correlates very well with existing drawings.

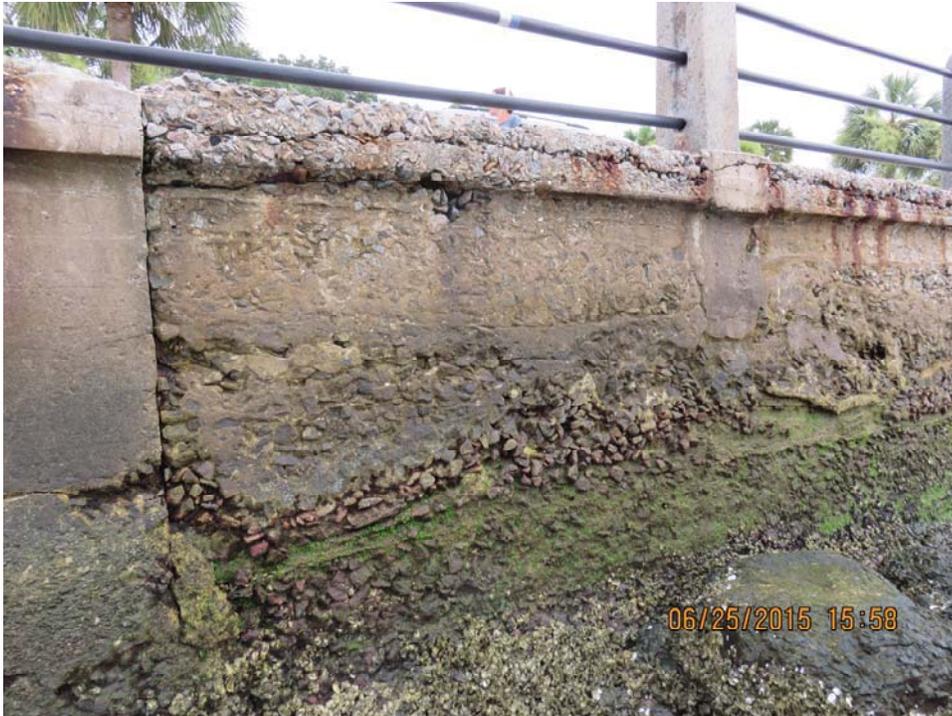
PHOTOGRAPH: 7

Face of Seawall near King Street

Note different concrete deterioration and railing pedestal type, potentially indicating different construction period. Right (East) Seawall constructed from 1909 to 1911. Left (West) Seawall constructed from 1917 to 1919.

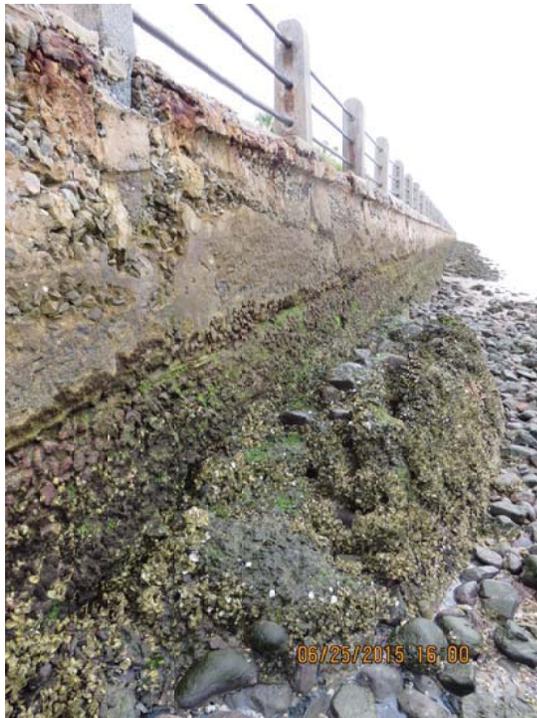
PHOTOGRAPH: 8

Face of Seawall near King Street,
Phase I of Construction (1909-1911)

Note concrete seal overpour.

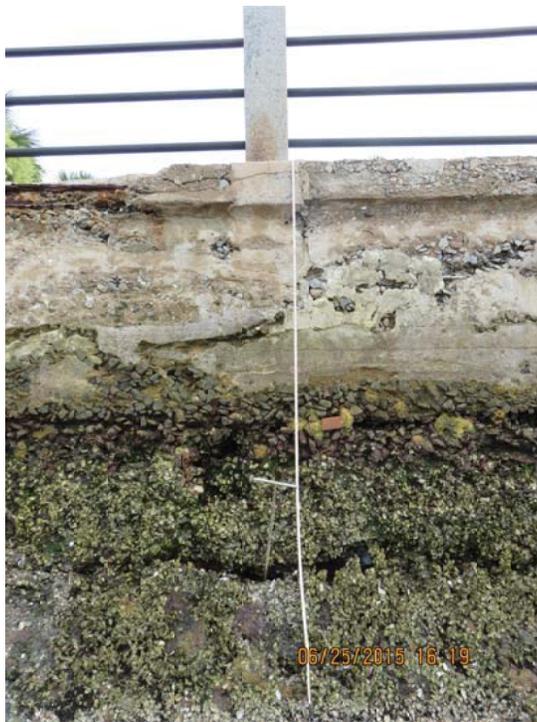
PHOTOGRAPH: 9

Face of Seawall near King Street

Note horizontal opening on concrete face. Hammer blows on top portion sounded as solid concrete. Hammer blows on lower portion sounded hollow. Crack location is approximately half way between water stain for MHW water table and low tide during observation. This correlates very well with location of seawall joint with concrete veil.

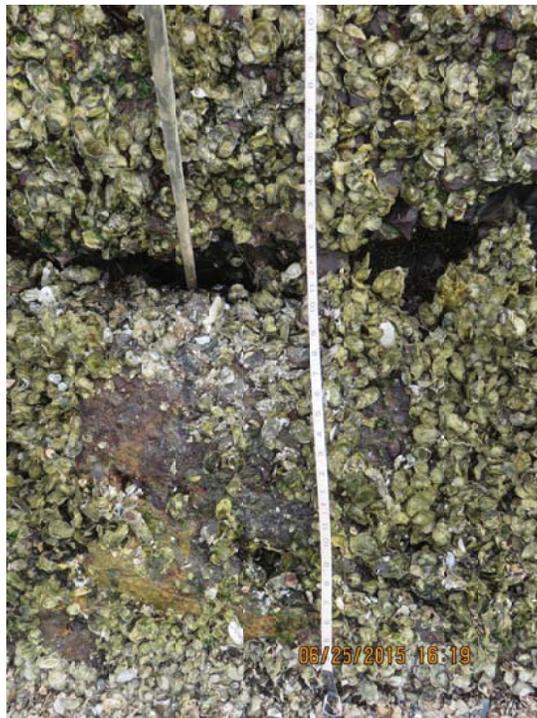
PHOTOGRAPH: 10

Face of Seawall near King Street

Close up of horizontal crack. Probe hit something slightly softer than concrete after approximately 1 foot of penetration into crack. Concrete thickness below crack appears to be 6 inches thick. Recommended to core a concrete sample below the crack.

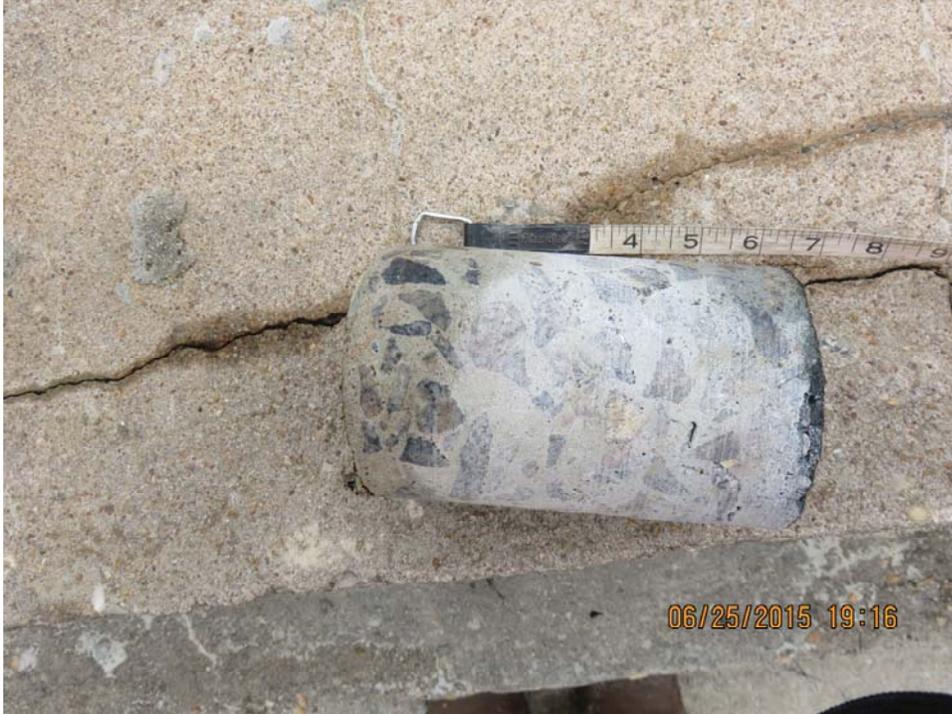
PHOTOGRAPH: 11

Face of Seawall near King Street

Concrete core below horizontal crack on Seawall face. The concrete core is 6-inch thick and wood was attached to the backs side of the core. This is potentially a confirmation that the crack is actually the joint between the mass seawall concrete and the concrete veil with timber sheeting behind.

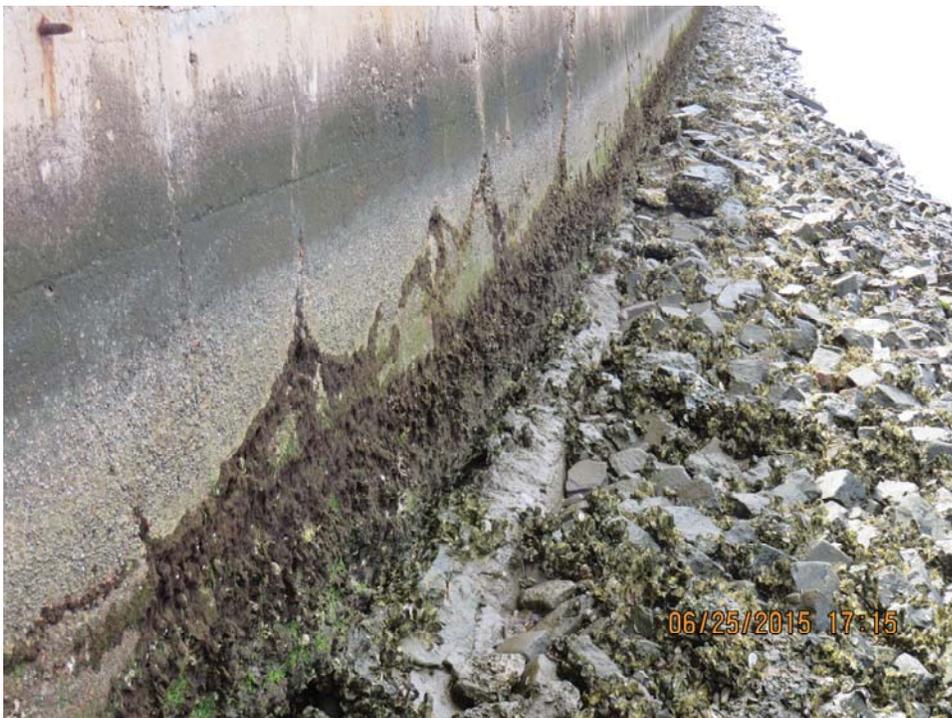
PHOTOGRAPH: 12

Face of Seawall near Sta. 4+79 (TP-2) looking east.

Note approximately 12-inch diameter steel pipe running horizontally at the base of the wall.

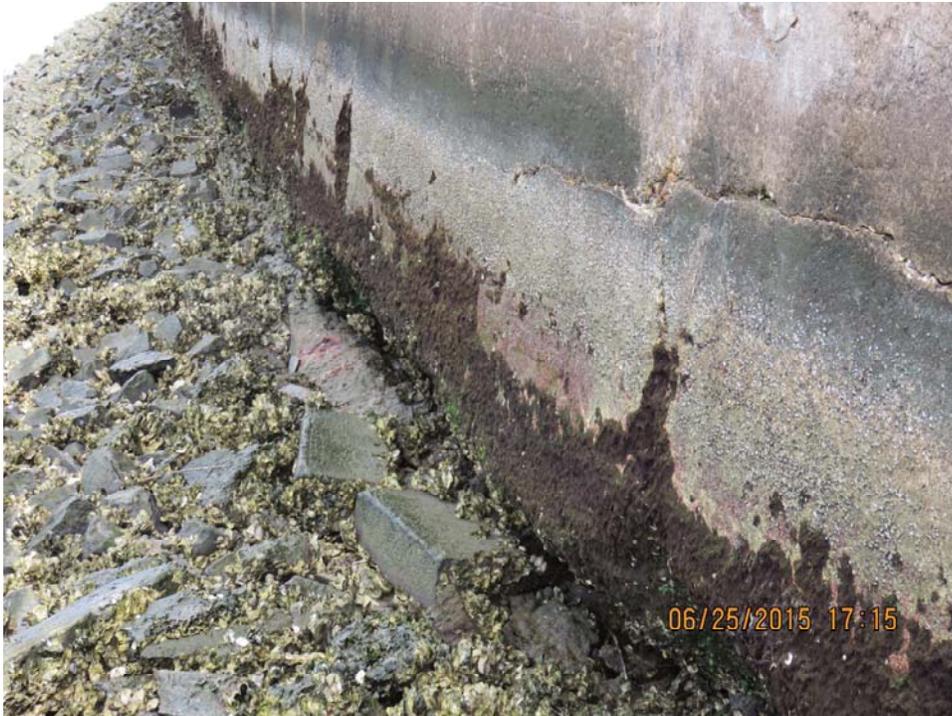
PHOTOGRAPH: 13

Face of Seawall near Sta. 4+79 (TP-2) looking west.

Note approximately 12-inch diameter steel pipe running horizontally at the base of the wall.

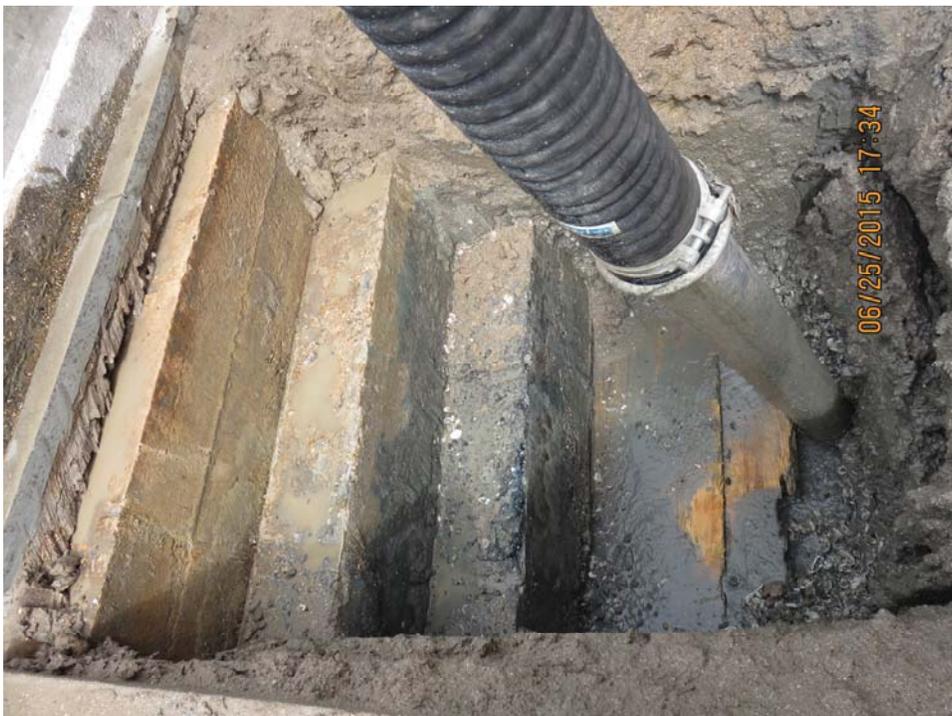
PHOTOGRAPH: 14

Exposed Seawall at Sta. 4+79 (TP-2).

Note stepping resembling the geometry indicated on the existing drawings, and the timber platform supporting the mass concrete seawall. Core was taken from the lower seawall step, and wood samples were taken from the timber platform and exposed pile below.

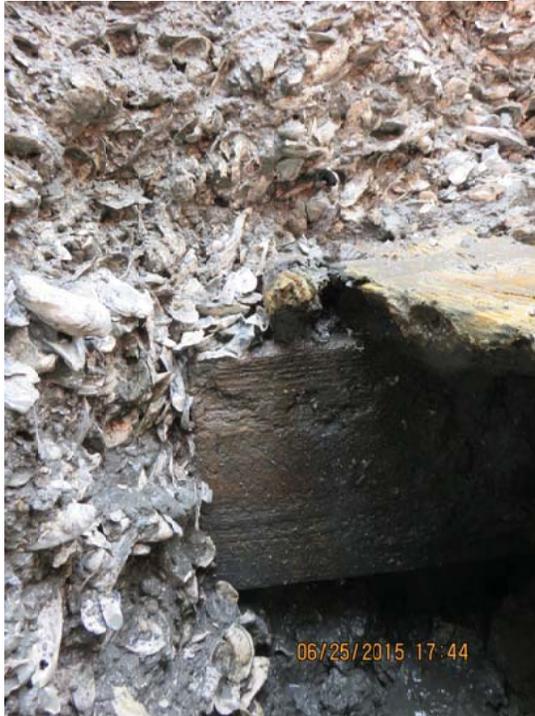
PHOTOGRAPH: 15

Exposed timber tie beam and pile at Sta. 4+79 (TP-2).

Note 12 inch high timber tie beam below timber platform. The timber pile is located behind the beam.

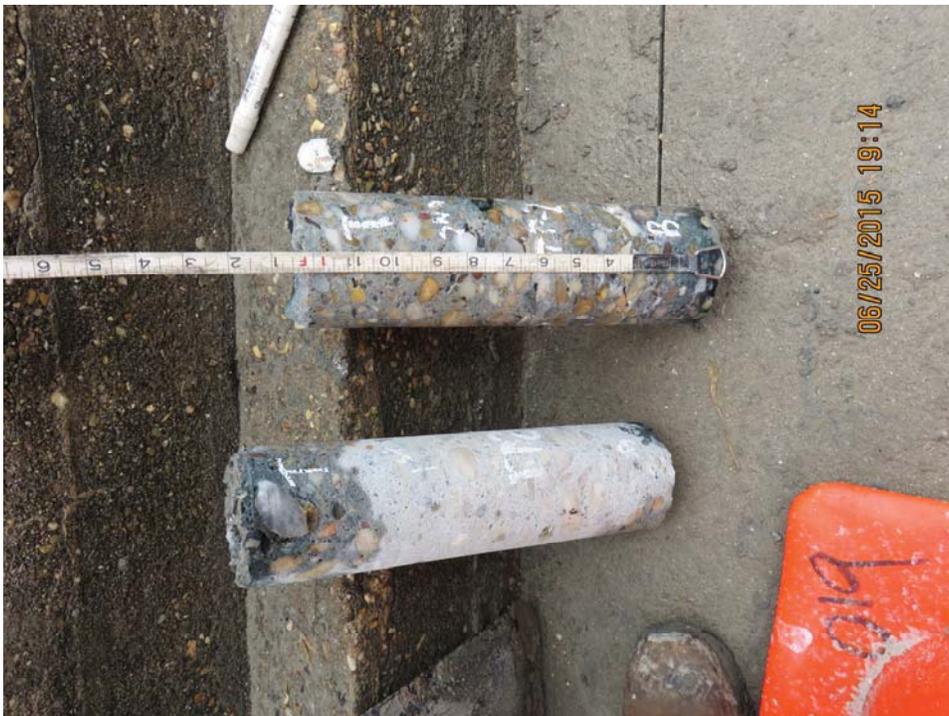
PHOTOGRAPH: 16

Concrete core sample of the lower seawall step at Sta. 4+79 (TP-2).

Corehole 2'-3" high divided in two pieces. Rest of timber platform was found attached to the bottom of the core.
