# **Appendix B**

Photographs of General Conditions  
from the “Walk-by” and “Float-by” Inspection  
of the Low Battery Seawall

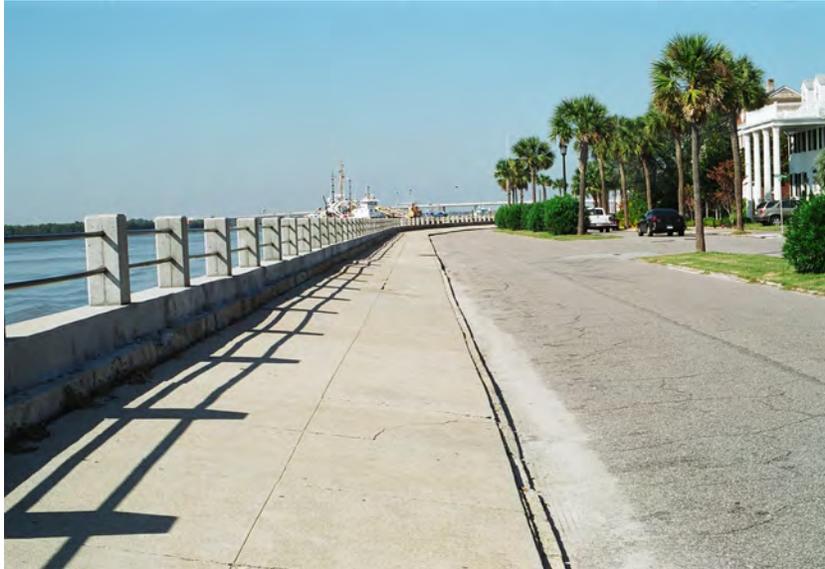
This is a view of the Low Battery seawall in the vicinity of 88 Murray Boulevard. Note the steep downward slope of the sidewalk toward the street. Also note the vertical waviness in the sidewalk.
